GROUNDWATER MONITORING REPORT

August 13, 1997

Peralta Maintenance Yard 501 5th Avenue Oakland, California

ACC Project No. 6045-014.00

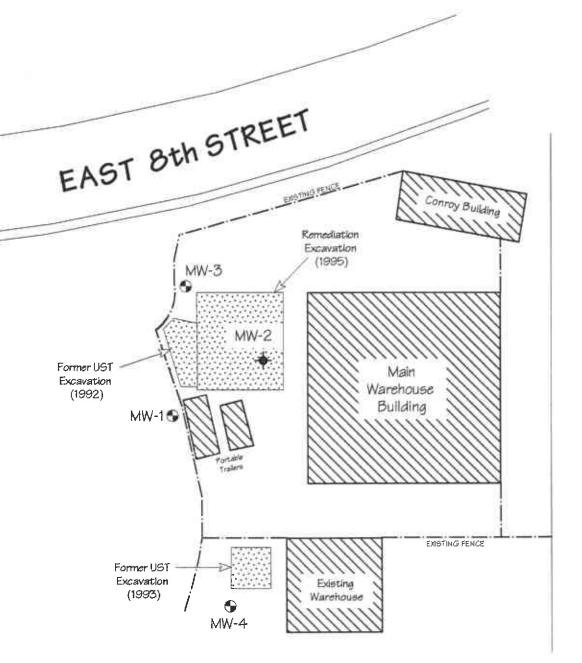
Figure Number: 2 Scale: 1" = 100'

Site Plan Peralta Community College District Maintenance Yard 501 5th Avenue, Oakland, California
