**ENVIRONMENTAL REPORT**  
**6601 and 6603 BAY STREET**  
Emeryville, California

Project No. PE90.005.02

July 1990

Subject: **ENVIRONMENTAL REPORT**  
Underground Storage Tank Removals  
6601 and 6603 Bay Street  
Emeryville, California.

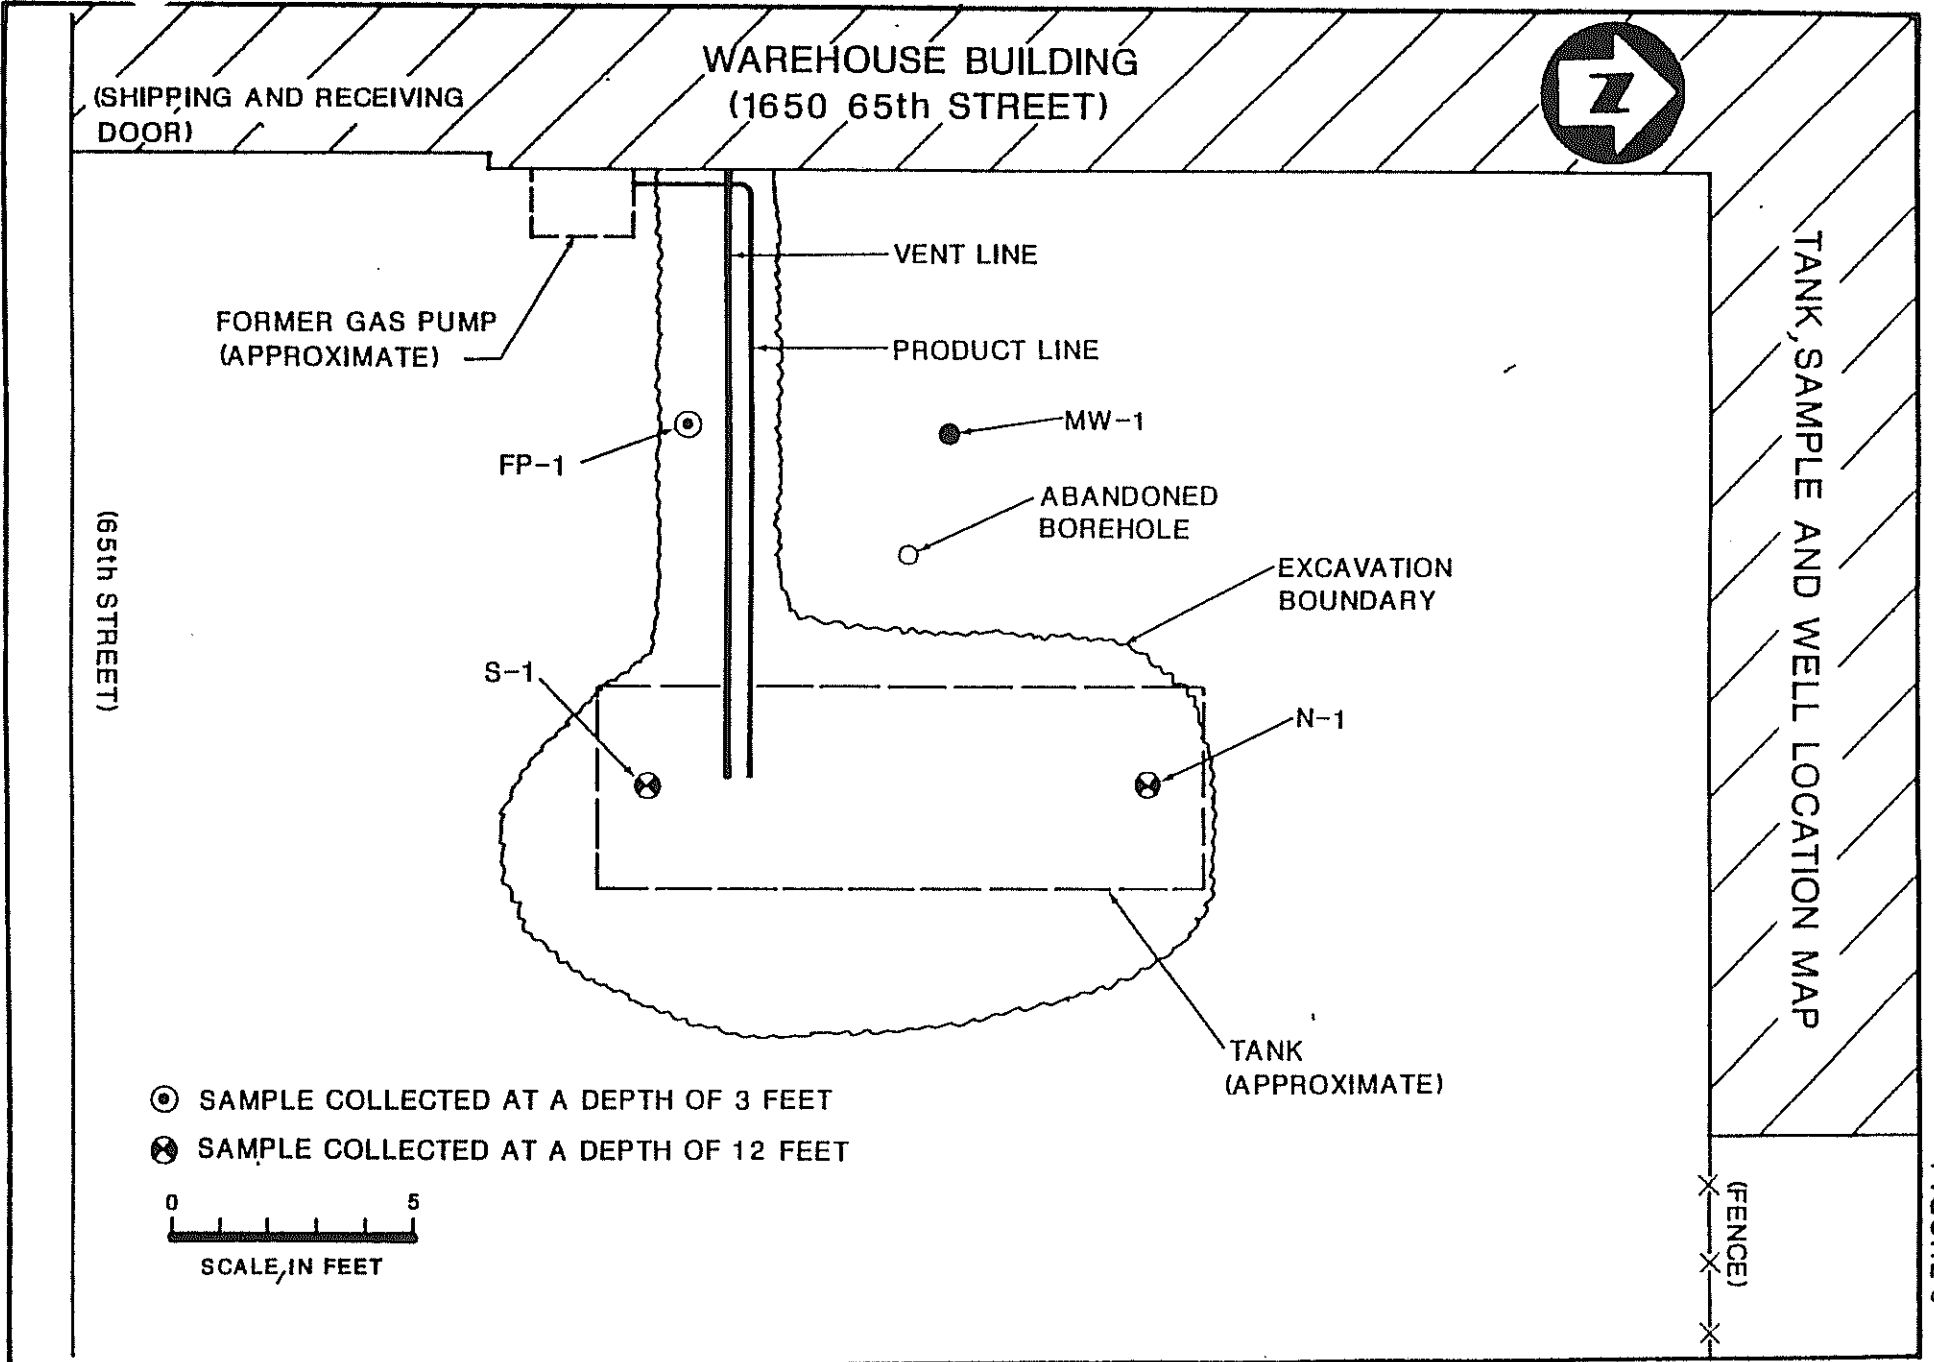
FIGURE 3

"CWC excavated the UST on 2 July 1987 and hauled it off-site. Figure 3 shows the excavation boundaries, tank and piping layout and soil sampling locations. A small volume of residual oily sludge was pumped from the tank prior to tank removal. Excavation began with removal of the vent and product line pipes; strong hydrocarbon odors emanated from soil removed from this area. A small amount of gasoline spilled from the product line piping during its removal. Excavation of the tank itself revealed no indication of contamination; the clayey soil and sandy fill excavated from around the tank exhibited no odor. Following completion of each excavation section, CWC immediately backfilled each excavated area with soil removed from that area. Documentation of the excavation in the form of copies of permits and shipping manifests has already been provided to BCC by Cleveland Wrecking Company. Photographic documentation of the excavation is presented in Appendix A.

"Well installation occurred on 27 July and began with drilling of a borehole roughly 3 feet west of the excavation. Metal scraps encountered 15 feet below ground surface caused drilling refusal and required abandonment of the initial borehole. A second borehole was drilled roughly three feet west of the initial borehole. This borehole was completed as the 30-foot deep monitoring well MW-1. Figure 3 shows the locations of the abandoned borehole and Monitoring Well MW-1.

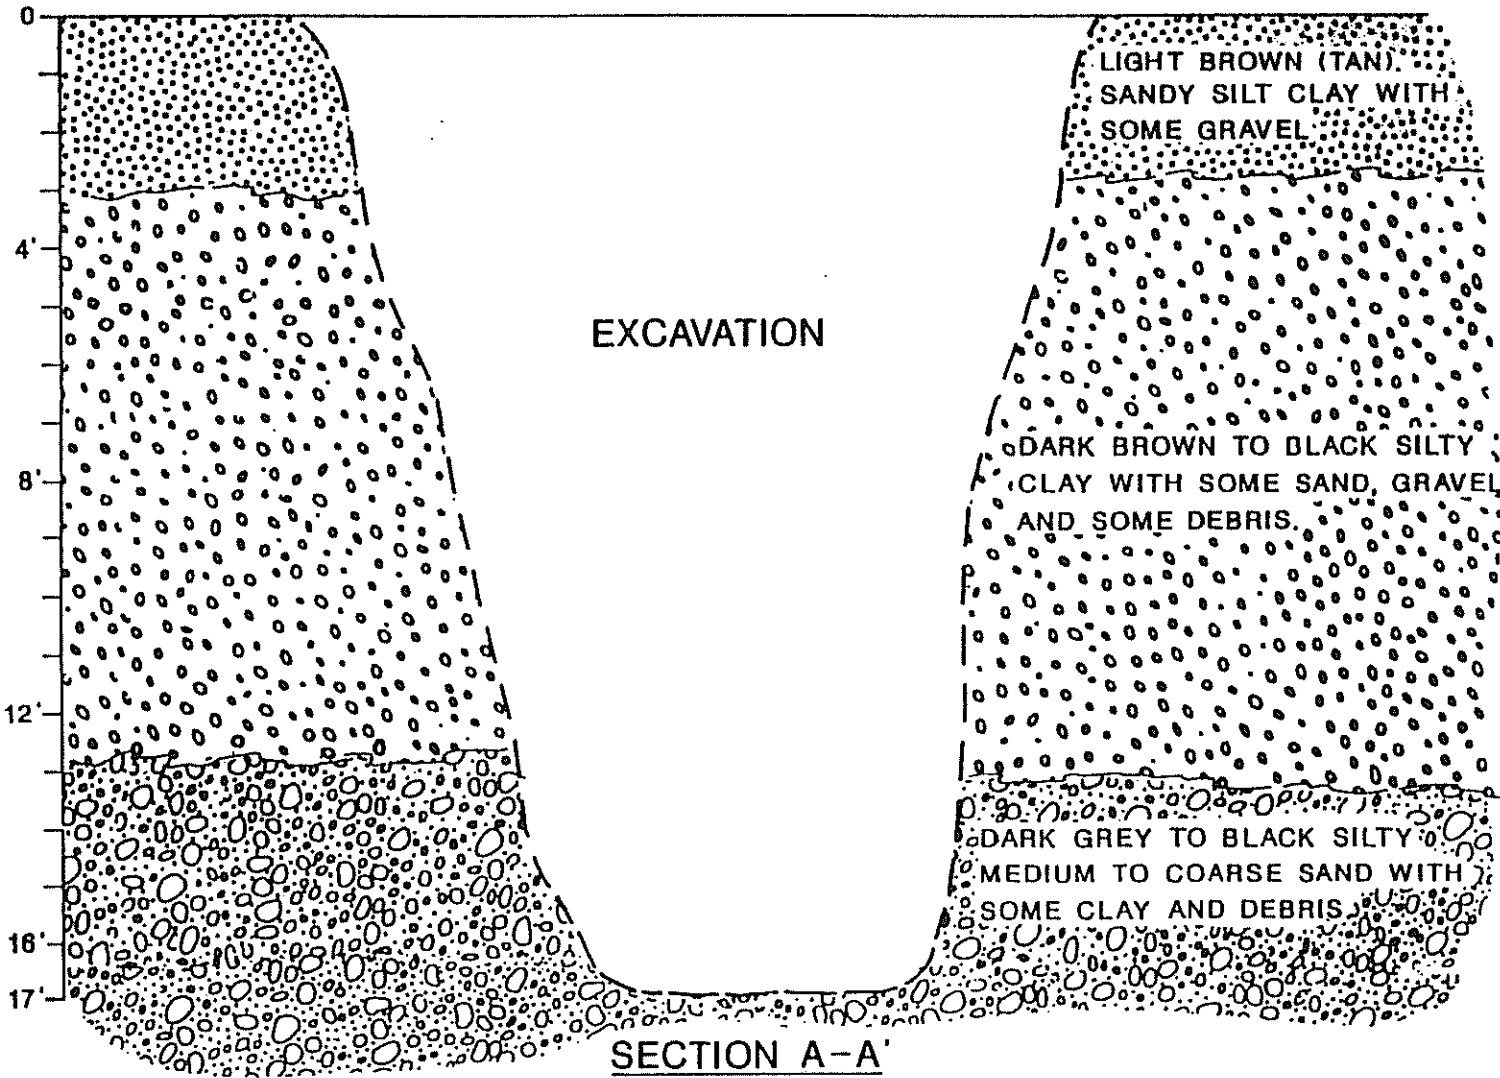
FIGURE 3

The upper four (4) feet of soil encountered during soil excavation consist of light brown (tan) sandy silt with some gravel. This layer of soil rests on dark brown to black silty clay with sand and gravel up to a depth of 13 feet. The bottom layer explored during the excavation consists of dark grey to black, silty, medium to coarse sand with some clay. Groundwater was encountered at a depth of 13.5 feet. A cross-section of the soil stratigraphy observed in the excavation is shown in Figure 3." (Page 4)

SECTION A-A'

SOIL STRATIGRAPHY ALONG EXCAVATION  
1650, 65th Street  
EMERYVILLE

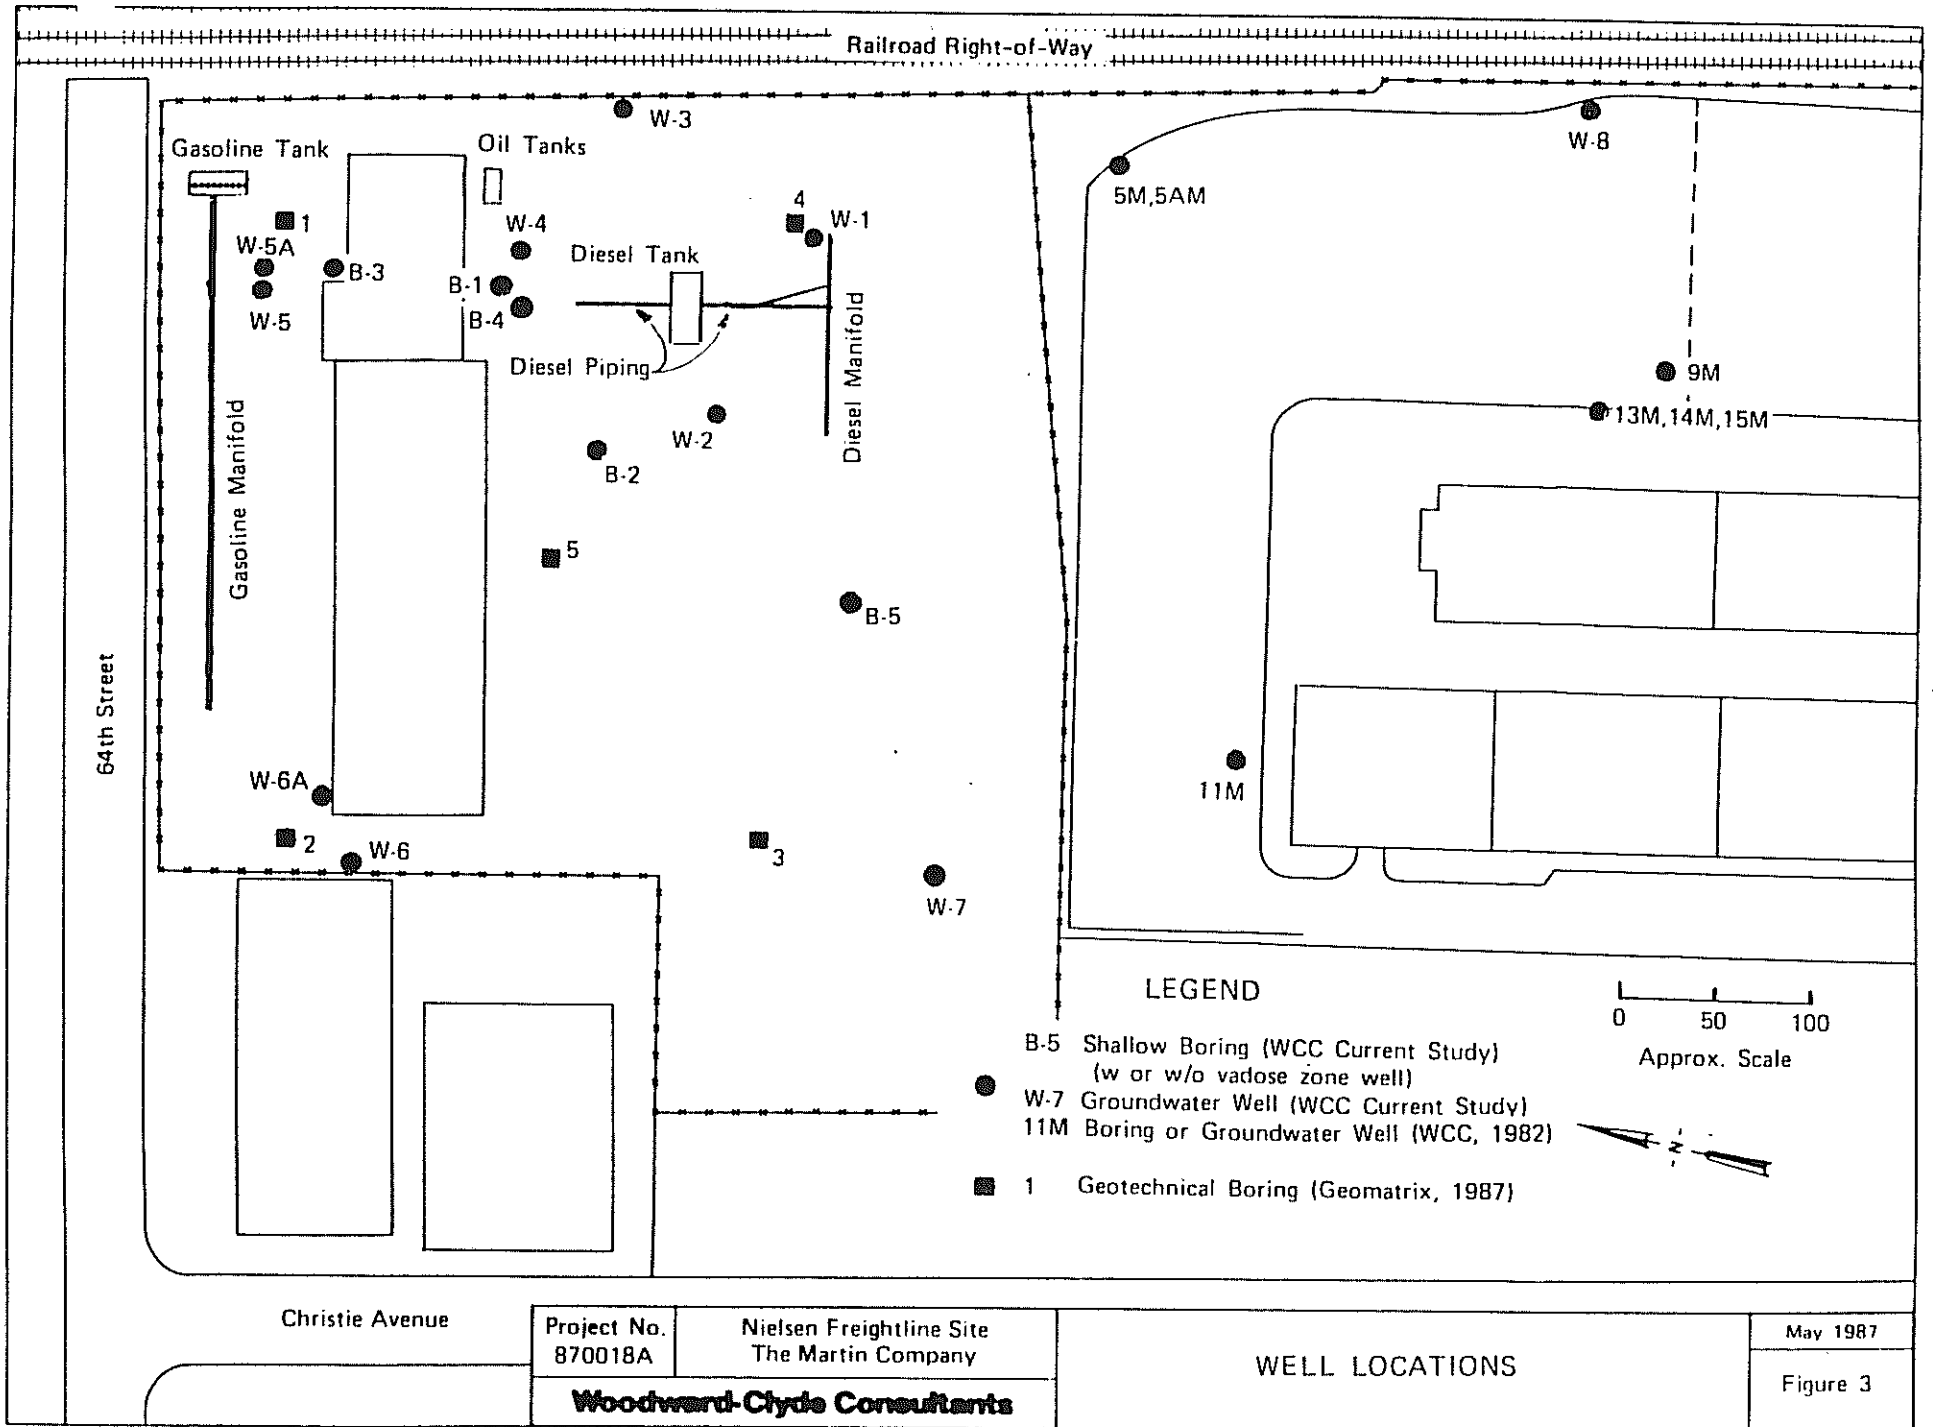
Figure 3

- B. "Native Soil. Several borings have been done on the Nielsen site by Geomatrix Consultants as part of the geotechnical study for the foundation of the proposed commercial building (Geomatrix, 1987). Several of these borings extend to a depth of approximately 30 to 32 feet. Based on these borings and WCC's drilling results, it appears that the underlying native soils to this depth are generally a stiff to very stiff sandy or silty clays or silts. There is an absence of the soft, compressible "recent Bay Mud" noted in prior explorations of the adjoining properties (WCC 1982, 1985). These fine-grained soils predominate to the depth of exploration of the Geomatrix study, although some sand was found in Geomatrix boring 3 (Figure 3) at a depth of 29 to 31.5 feet.

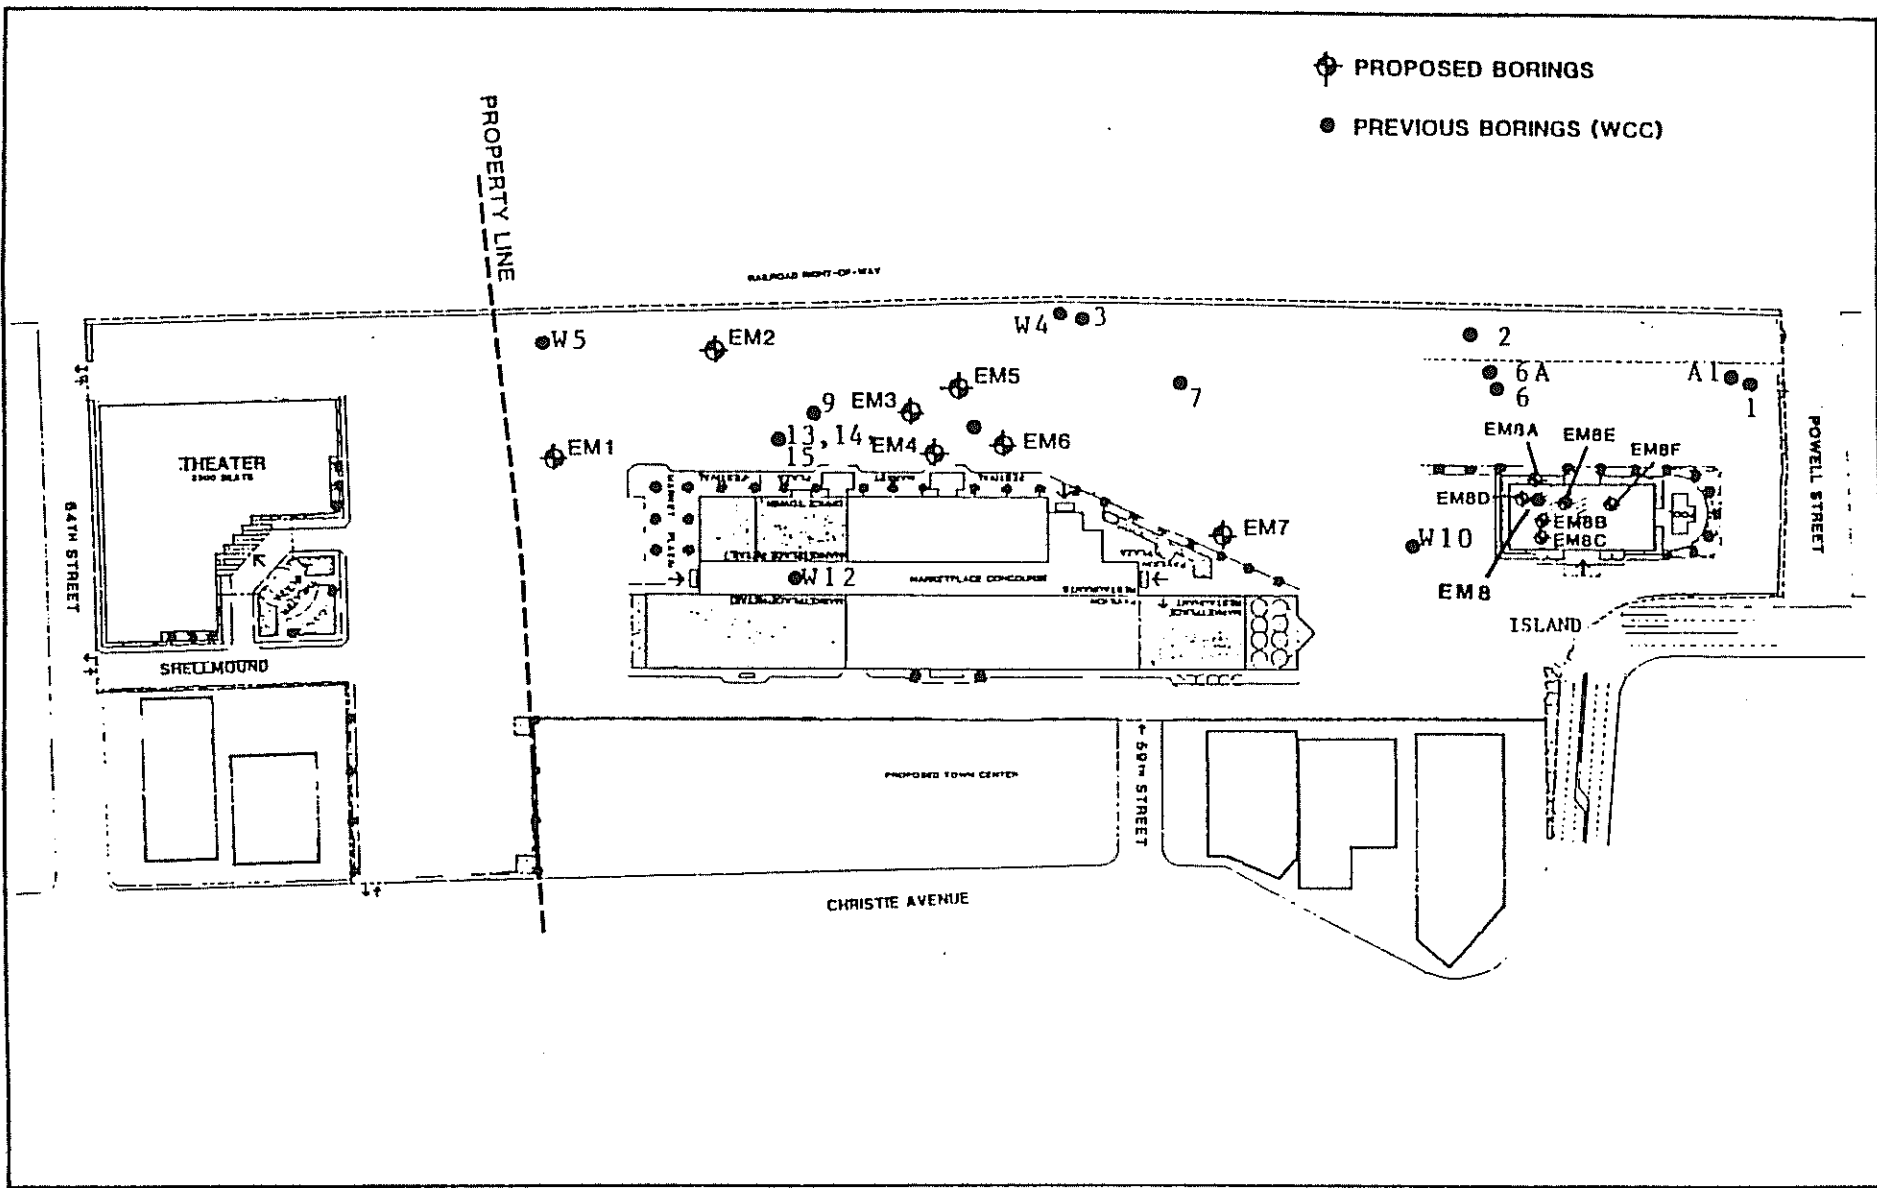
earth metrics	  SCALE 1" = 160'	<p>FIGURE 1. MARKETPLACE PROJECT SITE DETAILING BORING LOCATIONS</p>
--	---	--

- G. "Because the tar is not localized, but extends into the Marketplace site (to the north), excavation and removal would be difficult and costly." (Page 5-1)
- H. "Well No. 5 is filled with a waste petroleum product. It contains halogenated organics at the 433 ppm concentration. Sample analysis did not reveal detectable concentrations of PCBs.

Liquid waste should probably be pumped out of this Well No. 5 and containerized. Details of the pumping, testing, and clean up procedure should be drafted for Alameda County's approval prior to commencement of clean up activity." (Page 5-1)
