SITE CLOSURE REPORT

23rd Avenue Partners
1125 Miller Ave.
Oakland, California

October 3, 2002

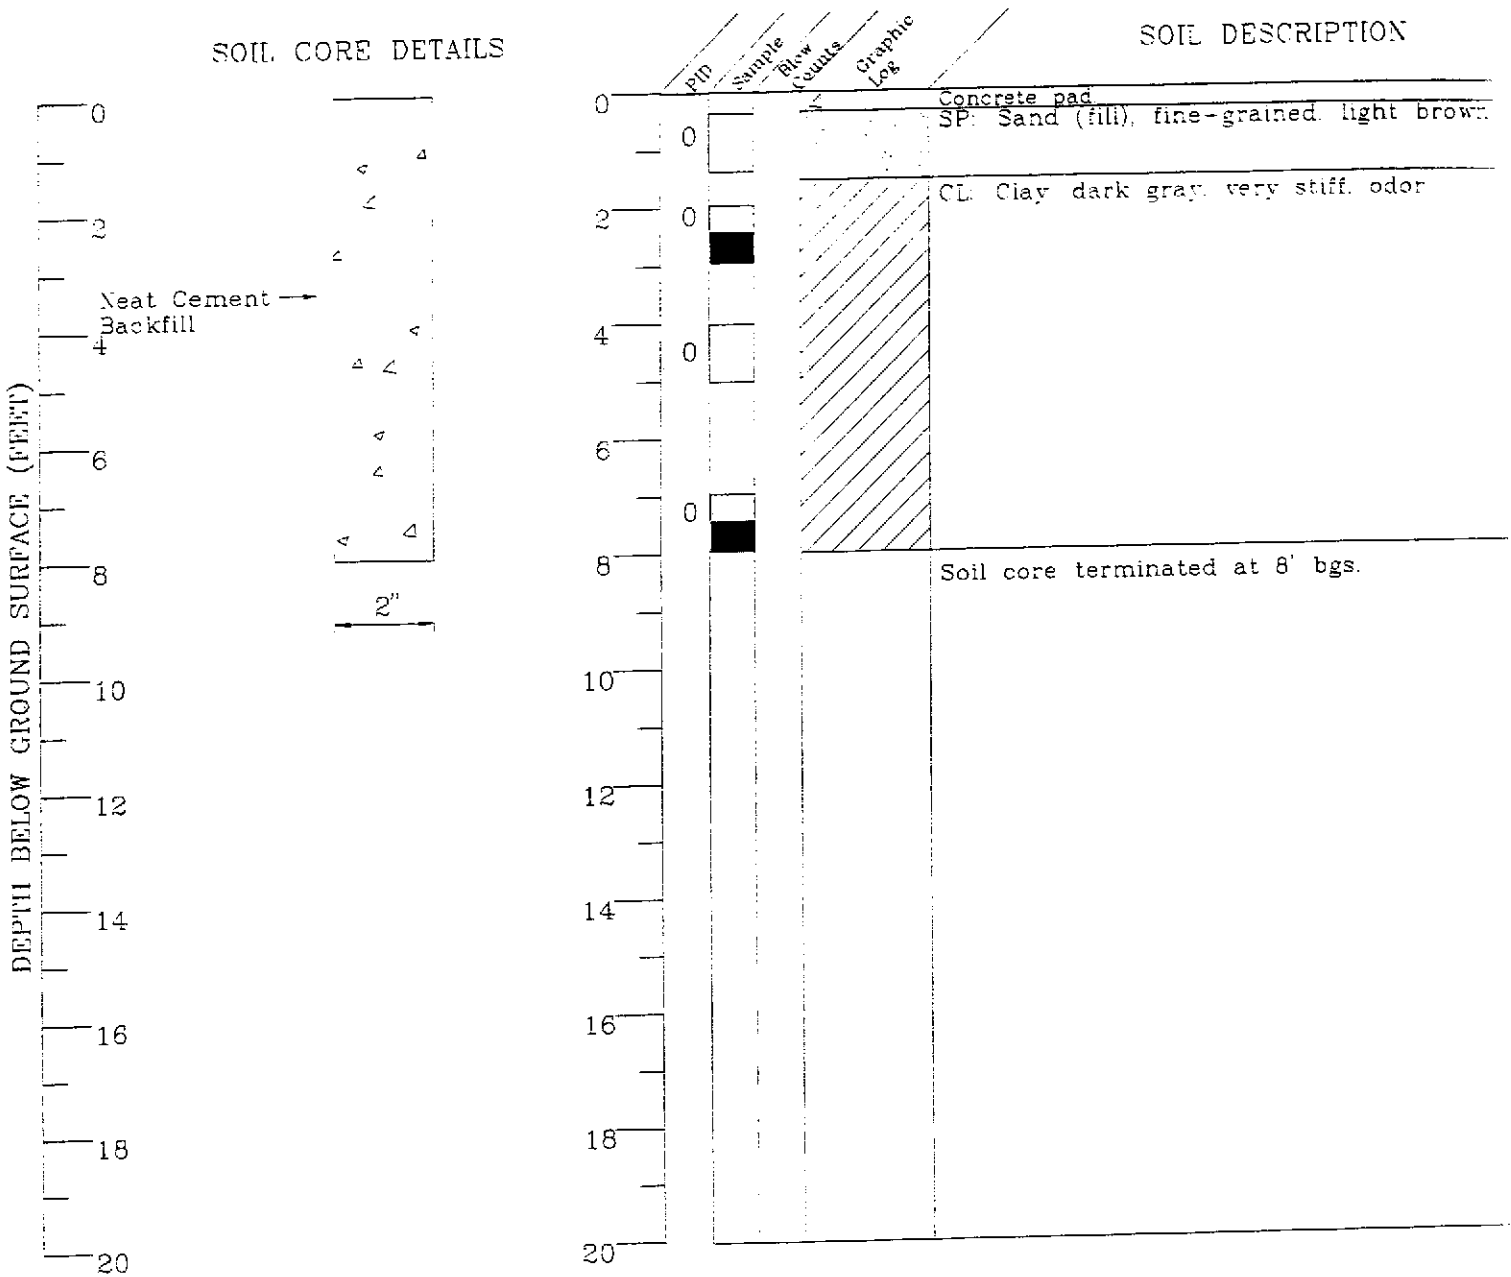
LOG OF SOIL BORING D1

Analytical Results Soil sample TW2-16.5' was found to contain 4,200 mg/kg TPHd and 1.4 mg/kg benzene. Soil sample TW3-17' was found to contain 2,700 mg/kg TPHd. Soil samples D1-3' and D1-8' were found to contain 3,400 and 34 mg/kg TPHd, respectively. Groundwater sample TW2-H₂O was found to contain 660 µg/L TPHd, 65 µg/L benzene, 2.4 µg/L, toluene, and 3.2 µg/L total xylenes. Groundwater sample TW3-H₂O was found to contain 800 µg/L TPHd and 0.9 µg/L benzene. The results were presented in an EBS Subsurface Exploration Report dated December 31, 2001.

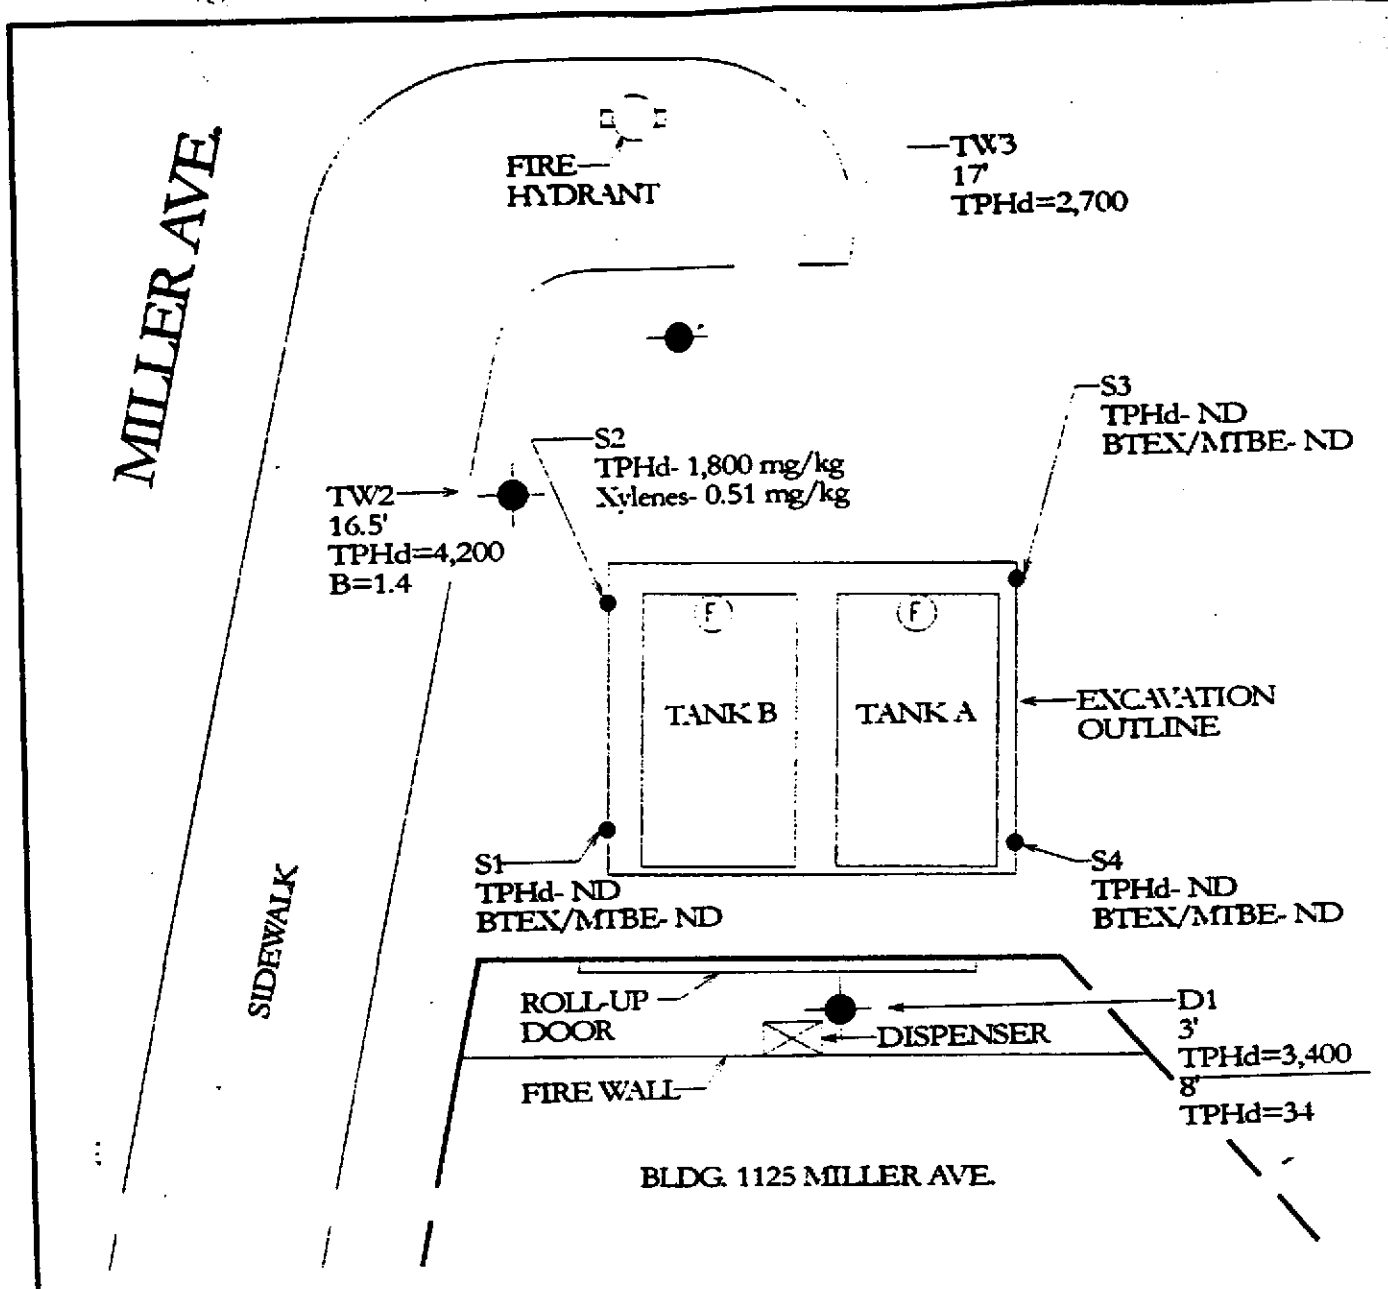
TW3
TPHd=800
B=0.90

TW2
TPHd=660
B=65
T=2.4
X=3.2
