Preliminary Site Assessment

Phase I (Modified)

Cal Mac Transportation Co

June 7, 2006

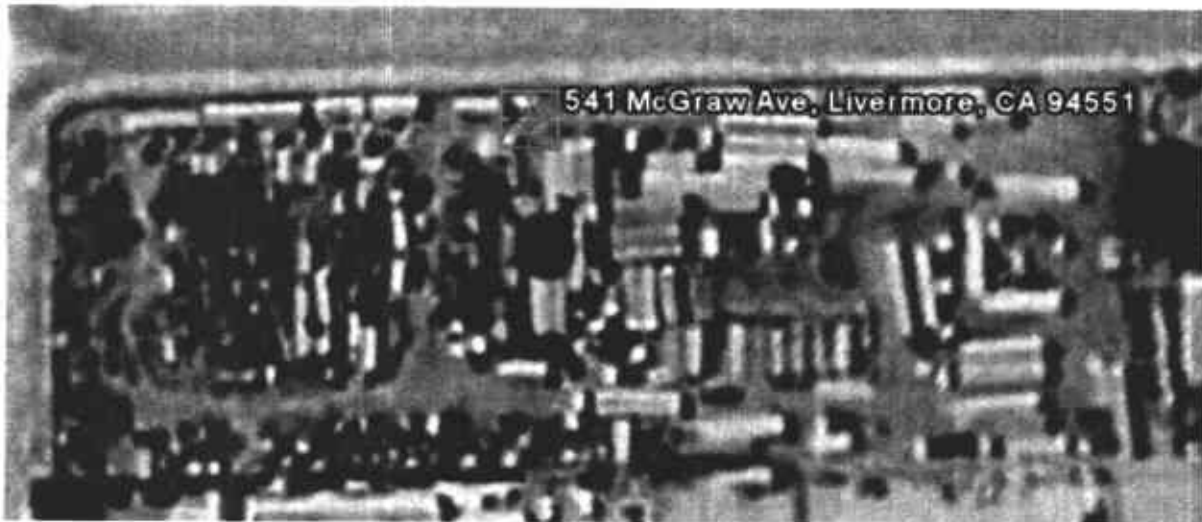
PICTURE 2. CROPPED FROM GOOGLE EARTH, ~ 2YRS. OLD.

Although difficult to see on copy, Picture 2 has tank on right center running parallel to property south side. Google photo is presumed to have been taken in circa 2004.

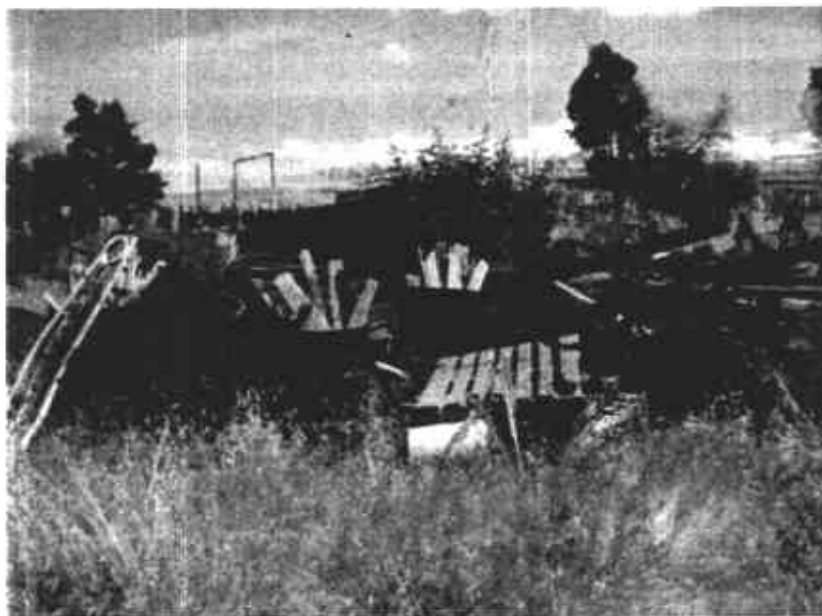
Although there are no visible signs of spills relating to the scrap metal or automobiles/ scrap trucks that are left onsite, it can be assumed that most of the vehicles have residual gasoline and other automotive fluids that may be released while loading or in transport. Vehicles may be removed as scrap, but if possible, draining of fluids should be done on site by qualified personnel to avoid any potential highway spills. Many scrap metal firms have mobile car crushers and experienced teams that are skilled at this process.

Picture 16. Drums with scrap metal and miscellaneous scrap items
