September 12, 2005 Report 0298.R3

PREFERENTIAL PATHWAY/CONDUIT STUDY

Fuel Leak Site RO0000357

Snow Cleaners, Inc. 2678 Coolidge Avenue Oakland, California

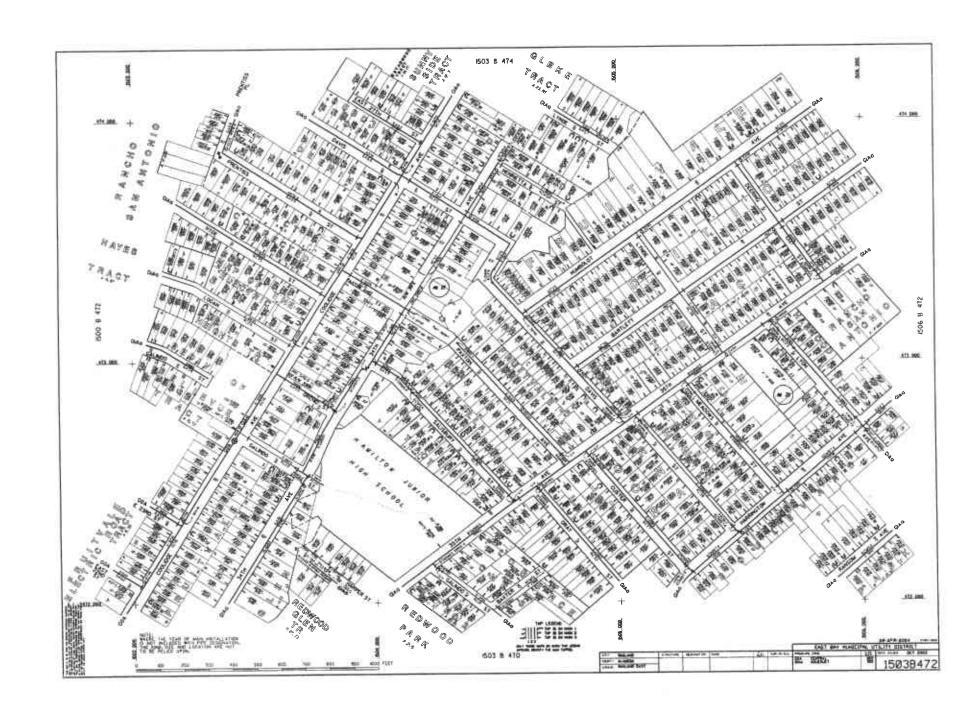
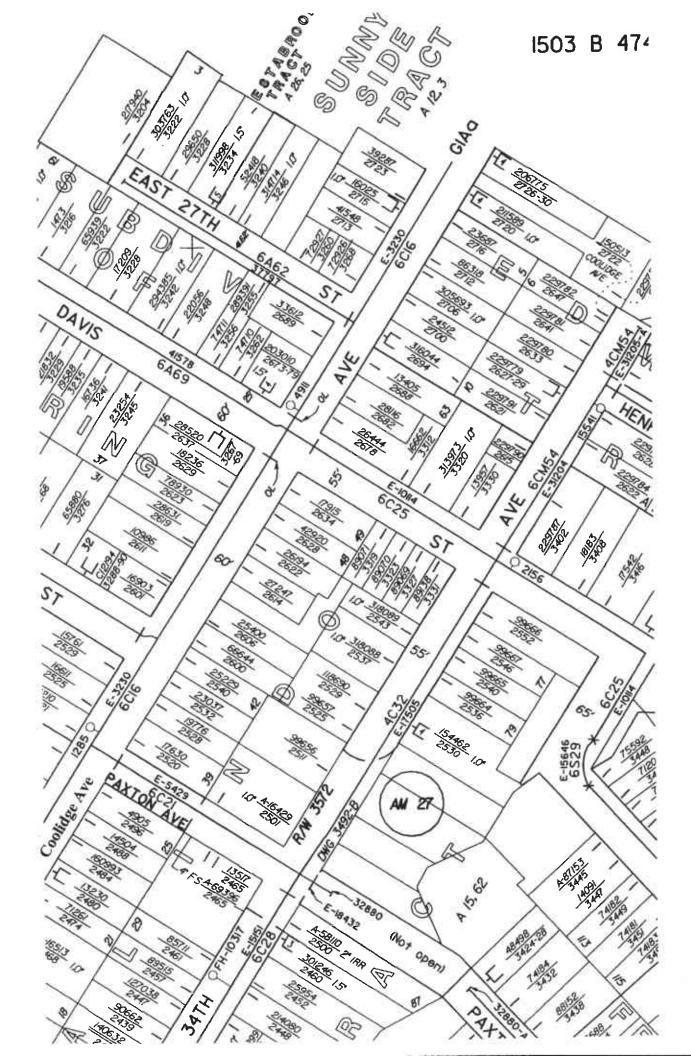
### EBMUD Water Supply Utility Map

A water pipe was located by AGS eight feet southwest of the curb. This water pipe is located along the entire length of Davis Street between Coolidge Avenue and 34<sup>th</sup> Avenue. There are six lateral connections to individual properties on the southeastern half of the block. This location is corroborated by the EBMUD utility map (see Appendix A).

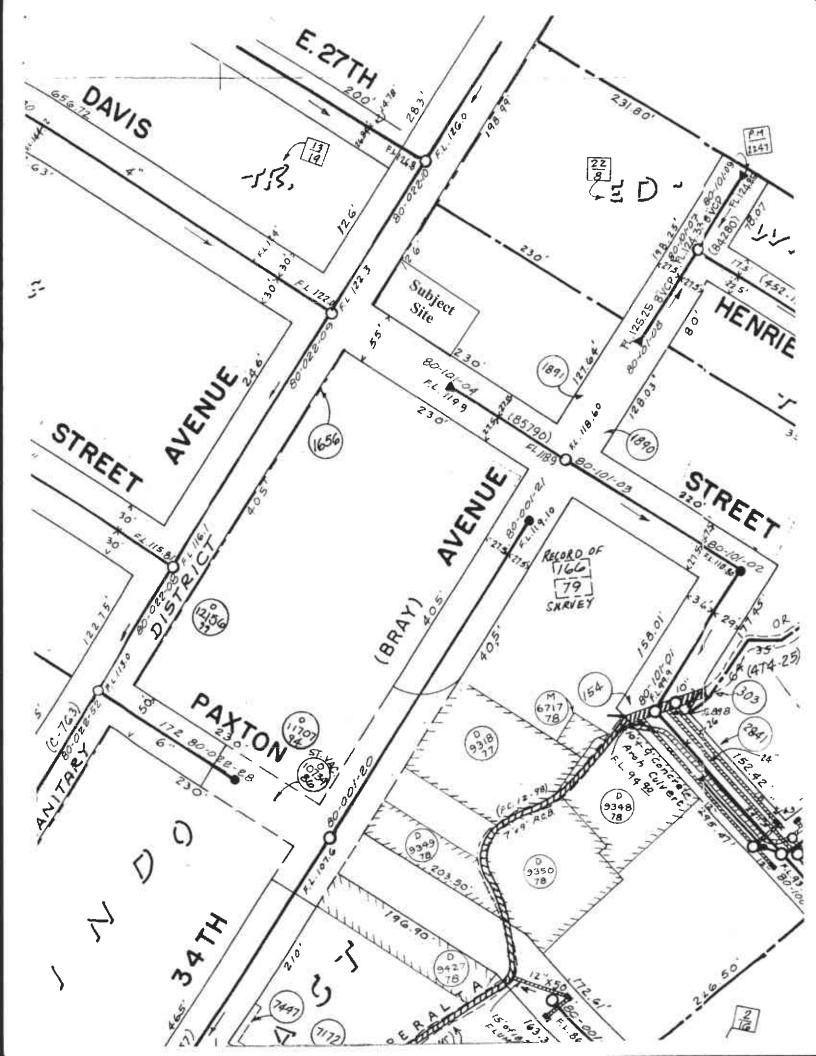
## COPWA Sanitary Sewer and Storm Drain Utility Map

A sanitary sewer pipe was located by AGS 18 feet northwest of the curb. This location is corroborated by a plan obtained from the COPWA (see Appendix B).

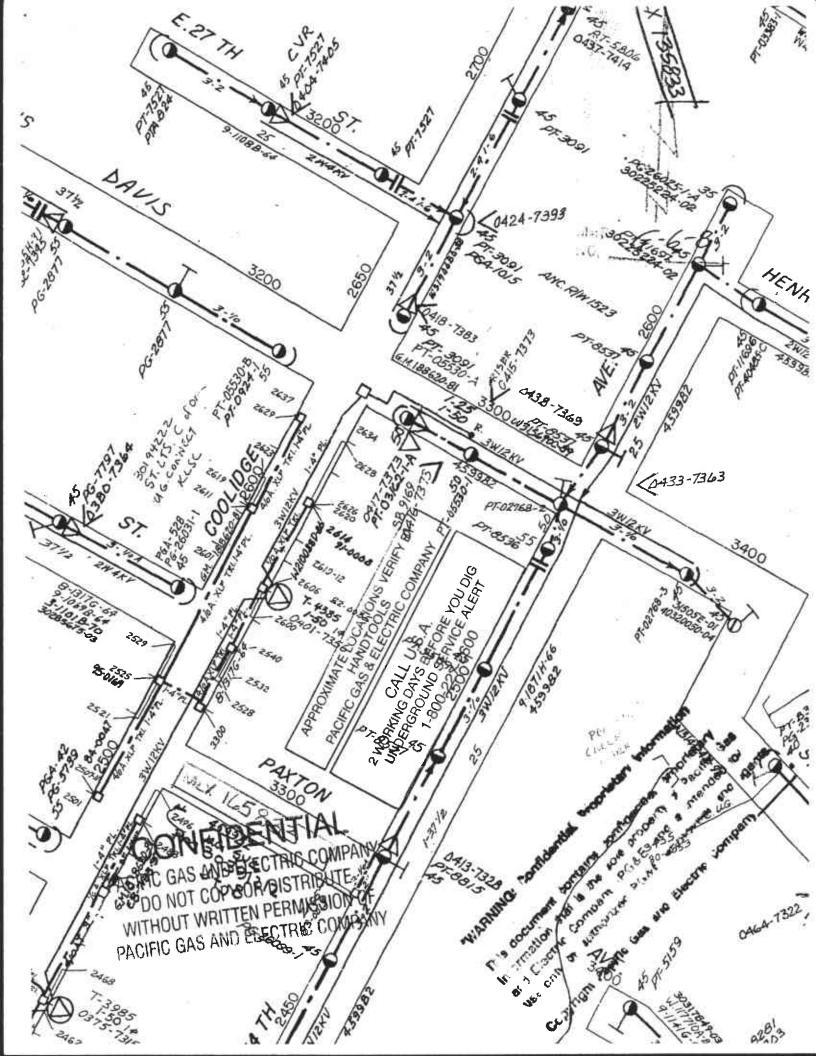
# Appendix D PG&E Electric Utility Map

Review of the AGS Utility Survey Map (Figure 3) shows that a telephone wire is located 5 feet southeast of the curb. This is corroborated by the map provided by SBC (see Appendix E). A comment on the AGS map, Figure 3, suggests that the electric and telephone service may be in the same trench directly in front of the Snow Cleaners building. The map provided by PG&E electric (see Appendix D) shows electrical wires as being overhead in this location.
