Report on Helium Leak Test of Underground Tanks
at American Can Company
on January 19, 1987

HELIUM LEAK TESTS

AMERICAN CAN COMPANY
OAKLAND

OCT. 21, 22, 1986

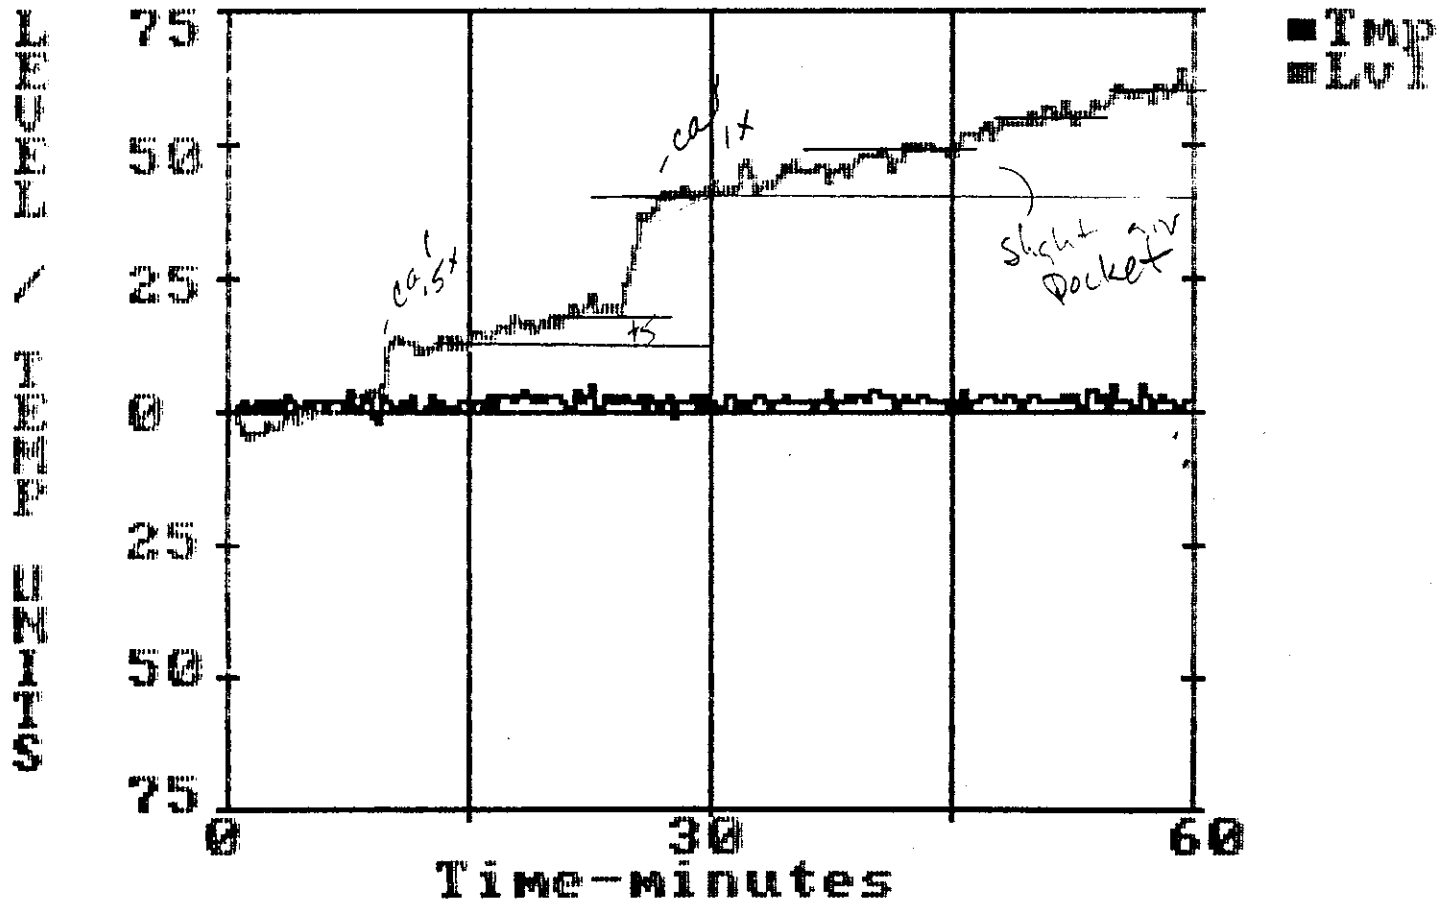
Tank 1 - SOLVENT

Tank	Cap.	Prod.	Tank	Line	P/L	High Cal	Low Cal	V/R	Prod+	Pump	Mat	P dia.
1	4500	Solvent	P	P	P	2209	2190	/	100	con	ST	2"2"
2												
3												
4												
5												
6

Additional information (i.e. weather, tanks uncovered?, re-test?)
 TANK COVERED -
 WEATHER - OVERCAST - COLD
