REPORT
ENVIRONMENTAL SERVICES
19051 LAKE CHABOT ROAD
CASTRO VALLEY, CALIFORNIA

JCH&A Job Number 650.1

Job Prepared for
Frederick C Divine Associates
1214 Lincoln Avenue
San Rafael, California 94901

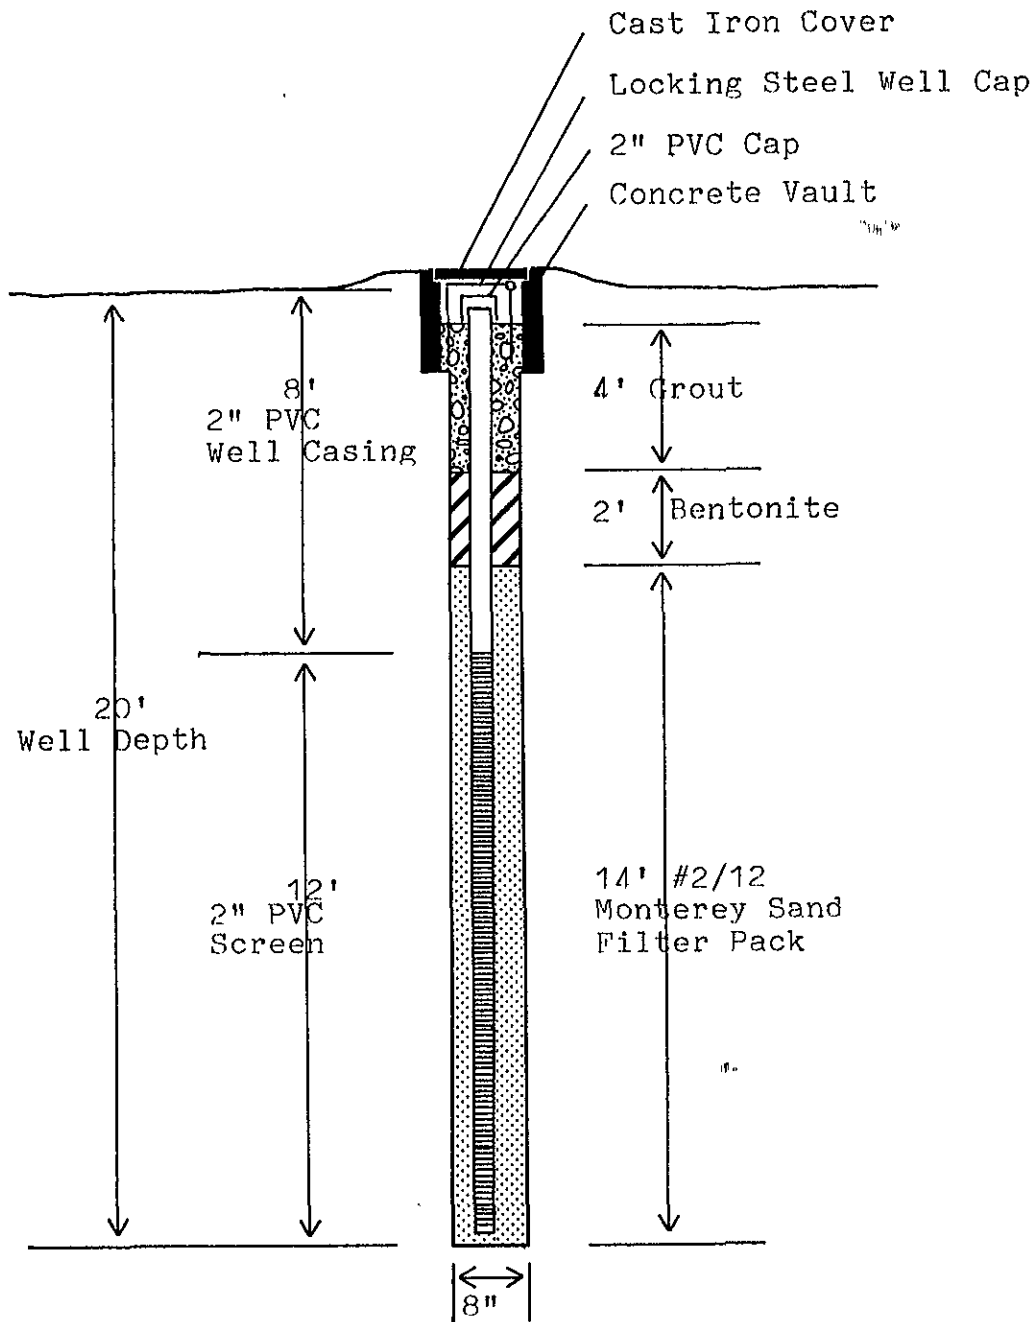
PLATE
1

We recommended and observed removal of contaminated soil and groundwater in the areas outlined on Plate 1. Soil in this area was removed and bedrock exposed at the bottom of the excavation. The excavation was sloped back to about 2-horizontal to 1-vertical (2:1). Excavated soil below 3-feet was stockpiled on the site and allowed to aerate. The groundwater was at the bottom of the excavation and was pumped into the soil stockpile. Some amounts of water seeped into the excavation after the initial pumping. This excavation was then pumped dry. We sampled and tested the water and soil at the bottom of the excavation. The results of the tests are shown on Plate 10. The excavation was then filled with "clean" soil, not excavated material. Fill was placed in lifts, moisture-conditioned to near optimum, and compacted to at least 90-percent relative compaction.

Test Boring and Monitoring Well
 Location Plan
 19051 Lake Chabot Road
 Castro Valley, California
