Pacific Dry Dock and Repair Company Yard II

Oakland, California

Laboratory Analytical Results for Groundwater Samples Collected on June 21, 1995 and TGSP Samples Former Pacific Dry Dock & Repair Company Yard II Facility Oakland, California

April 1995 Analytical Results for Area 5  
 Pacific Dry Dock & Repair Company Yard II  
 Oakland, California

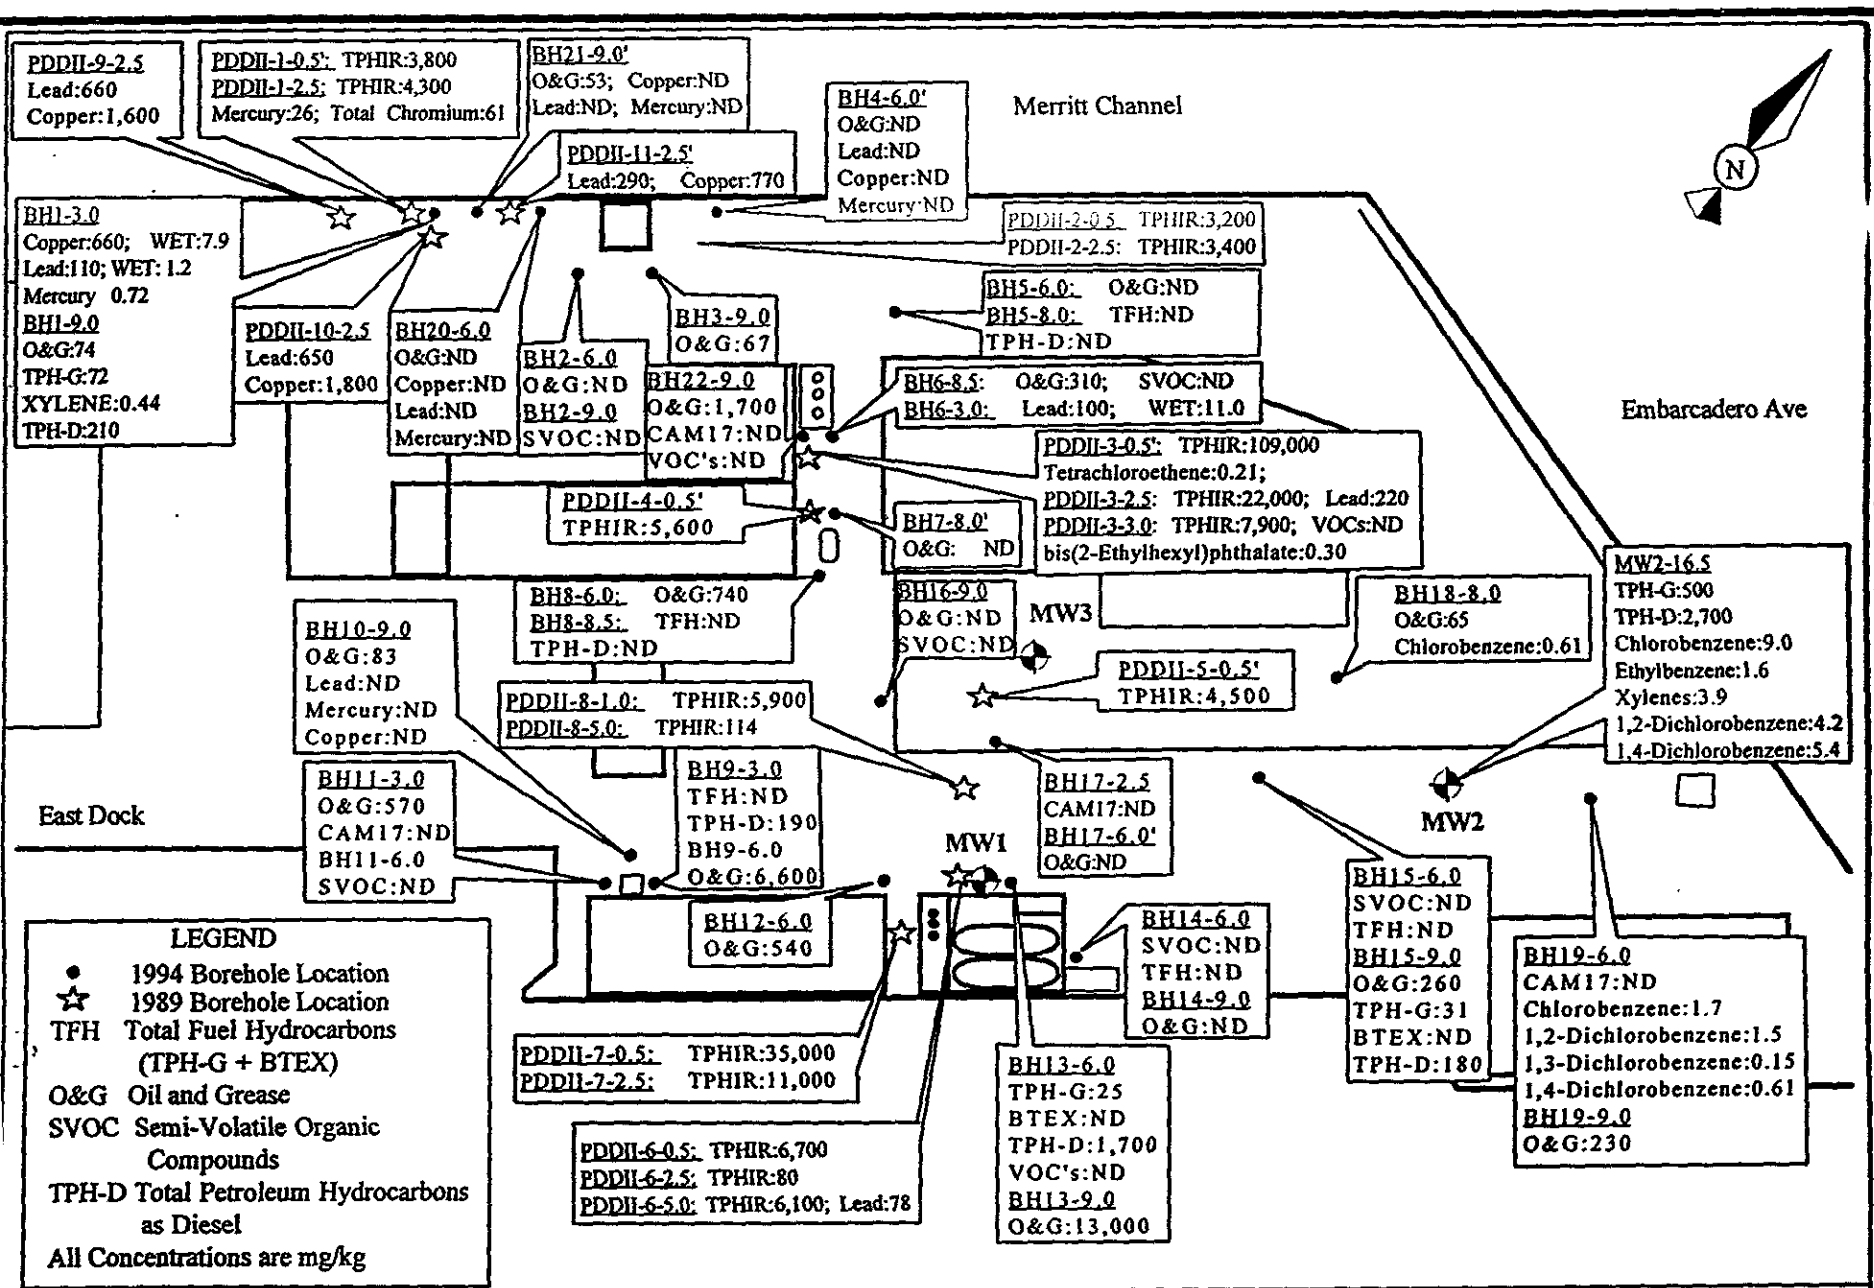
Figure 2

April 1995 Analytical Results for Areas 1, 2, and 6  
Former Pacific Dry Dock Facility & Repair Company Yard II  
Oakland, California

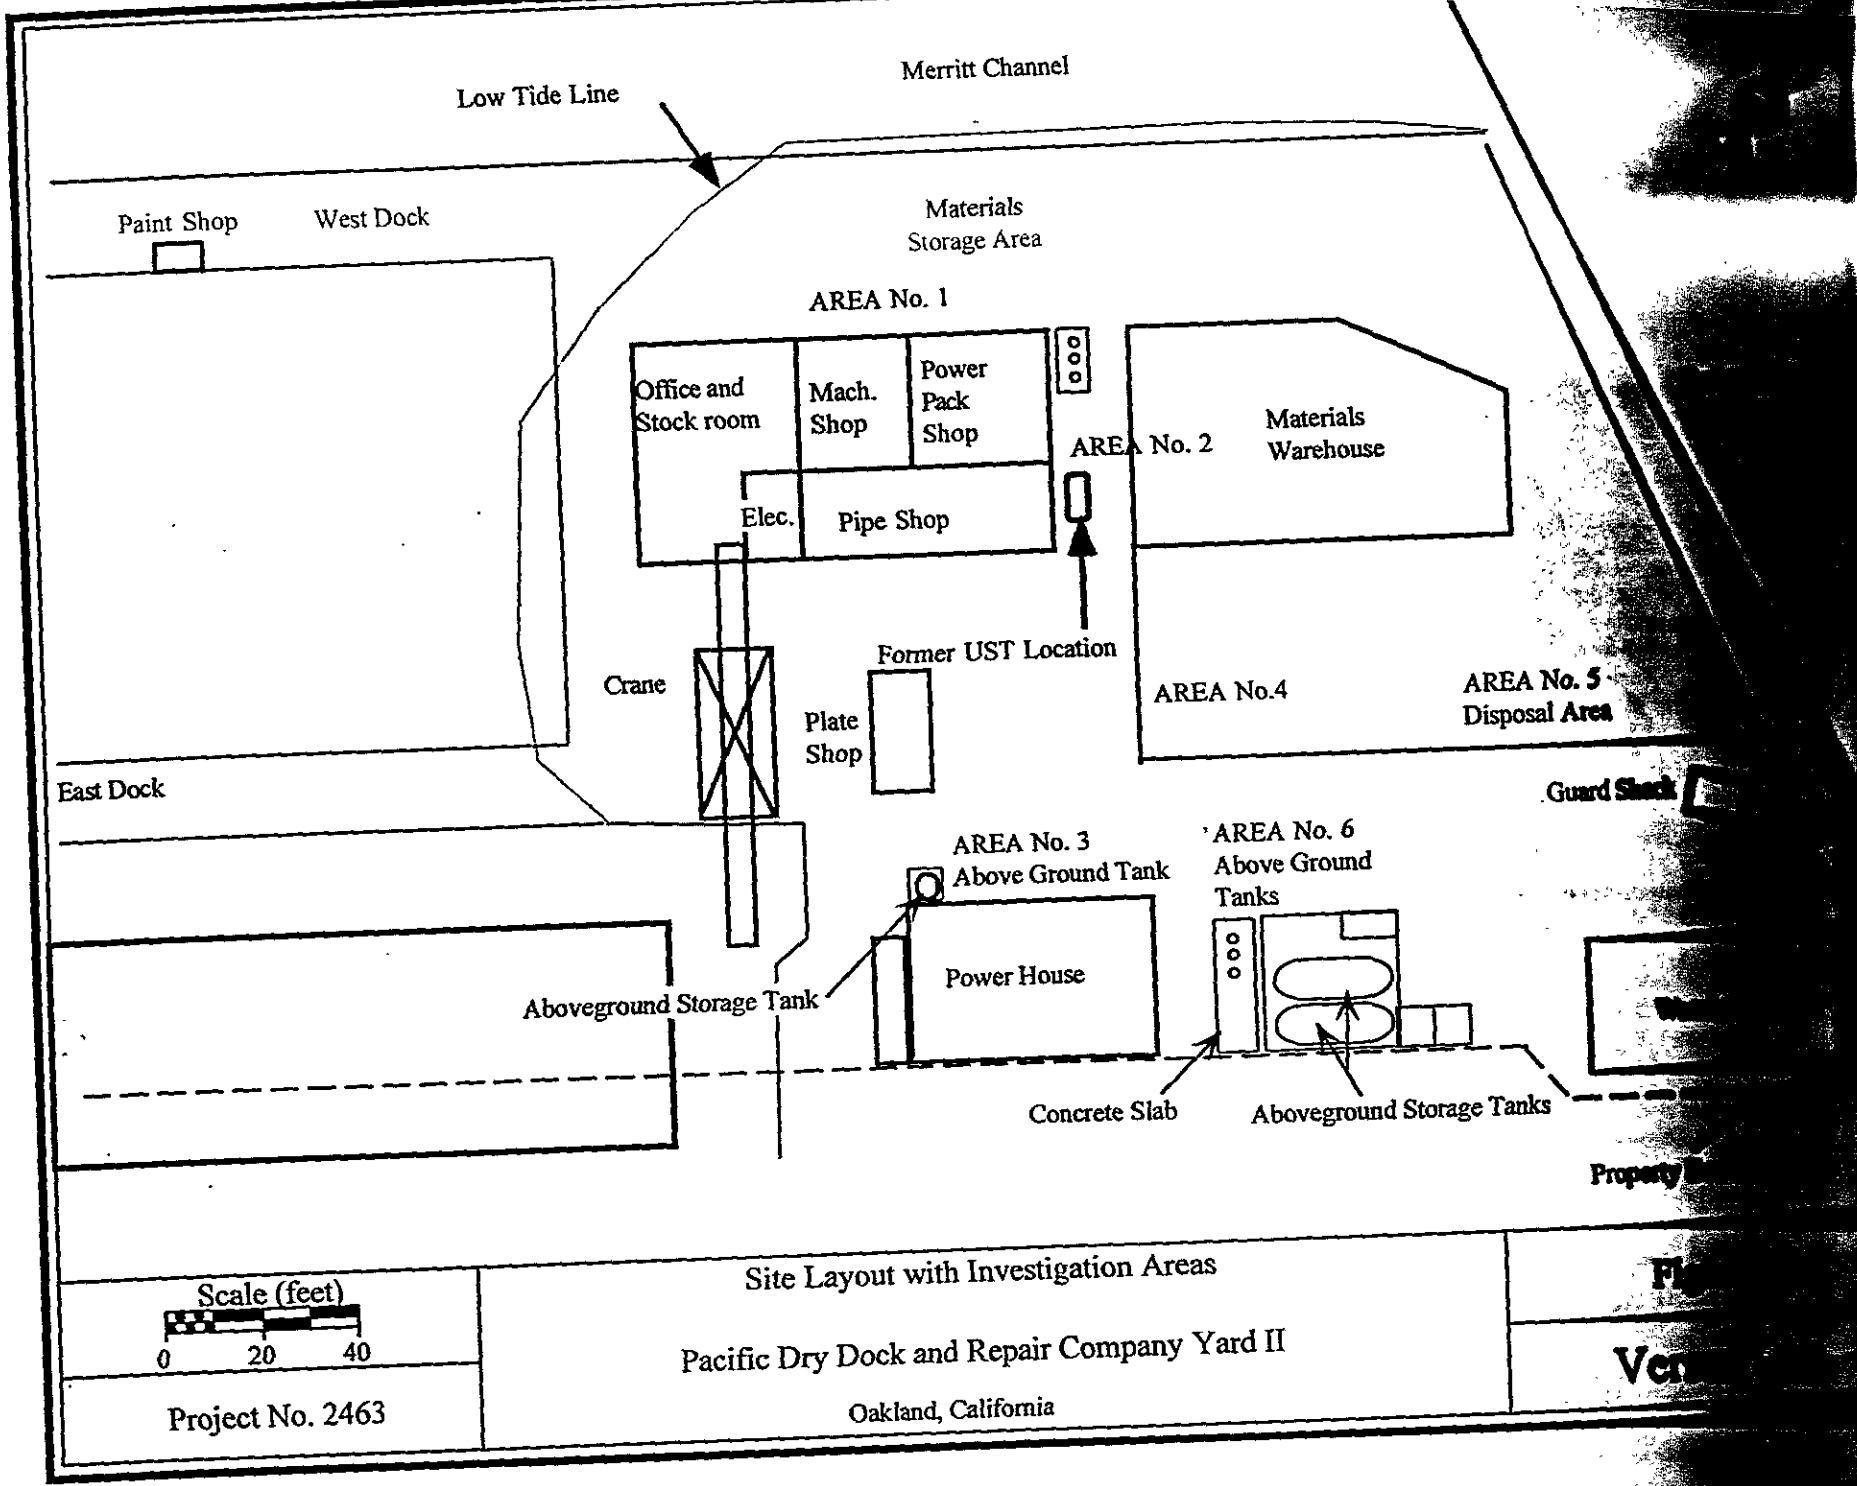
FIG. 1  
 Ver.

Site Layout with Investigation Areas  
 Pacific Dry Dock and Repair Company Yard II  
 Oakland, California

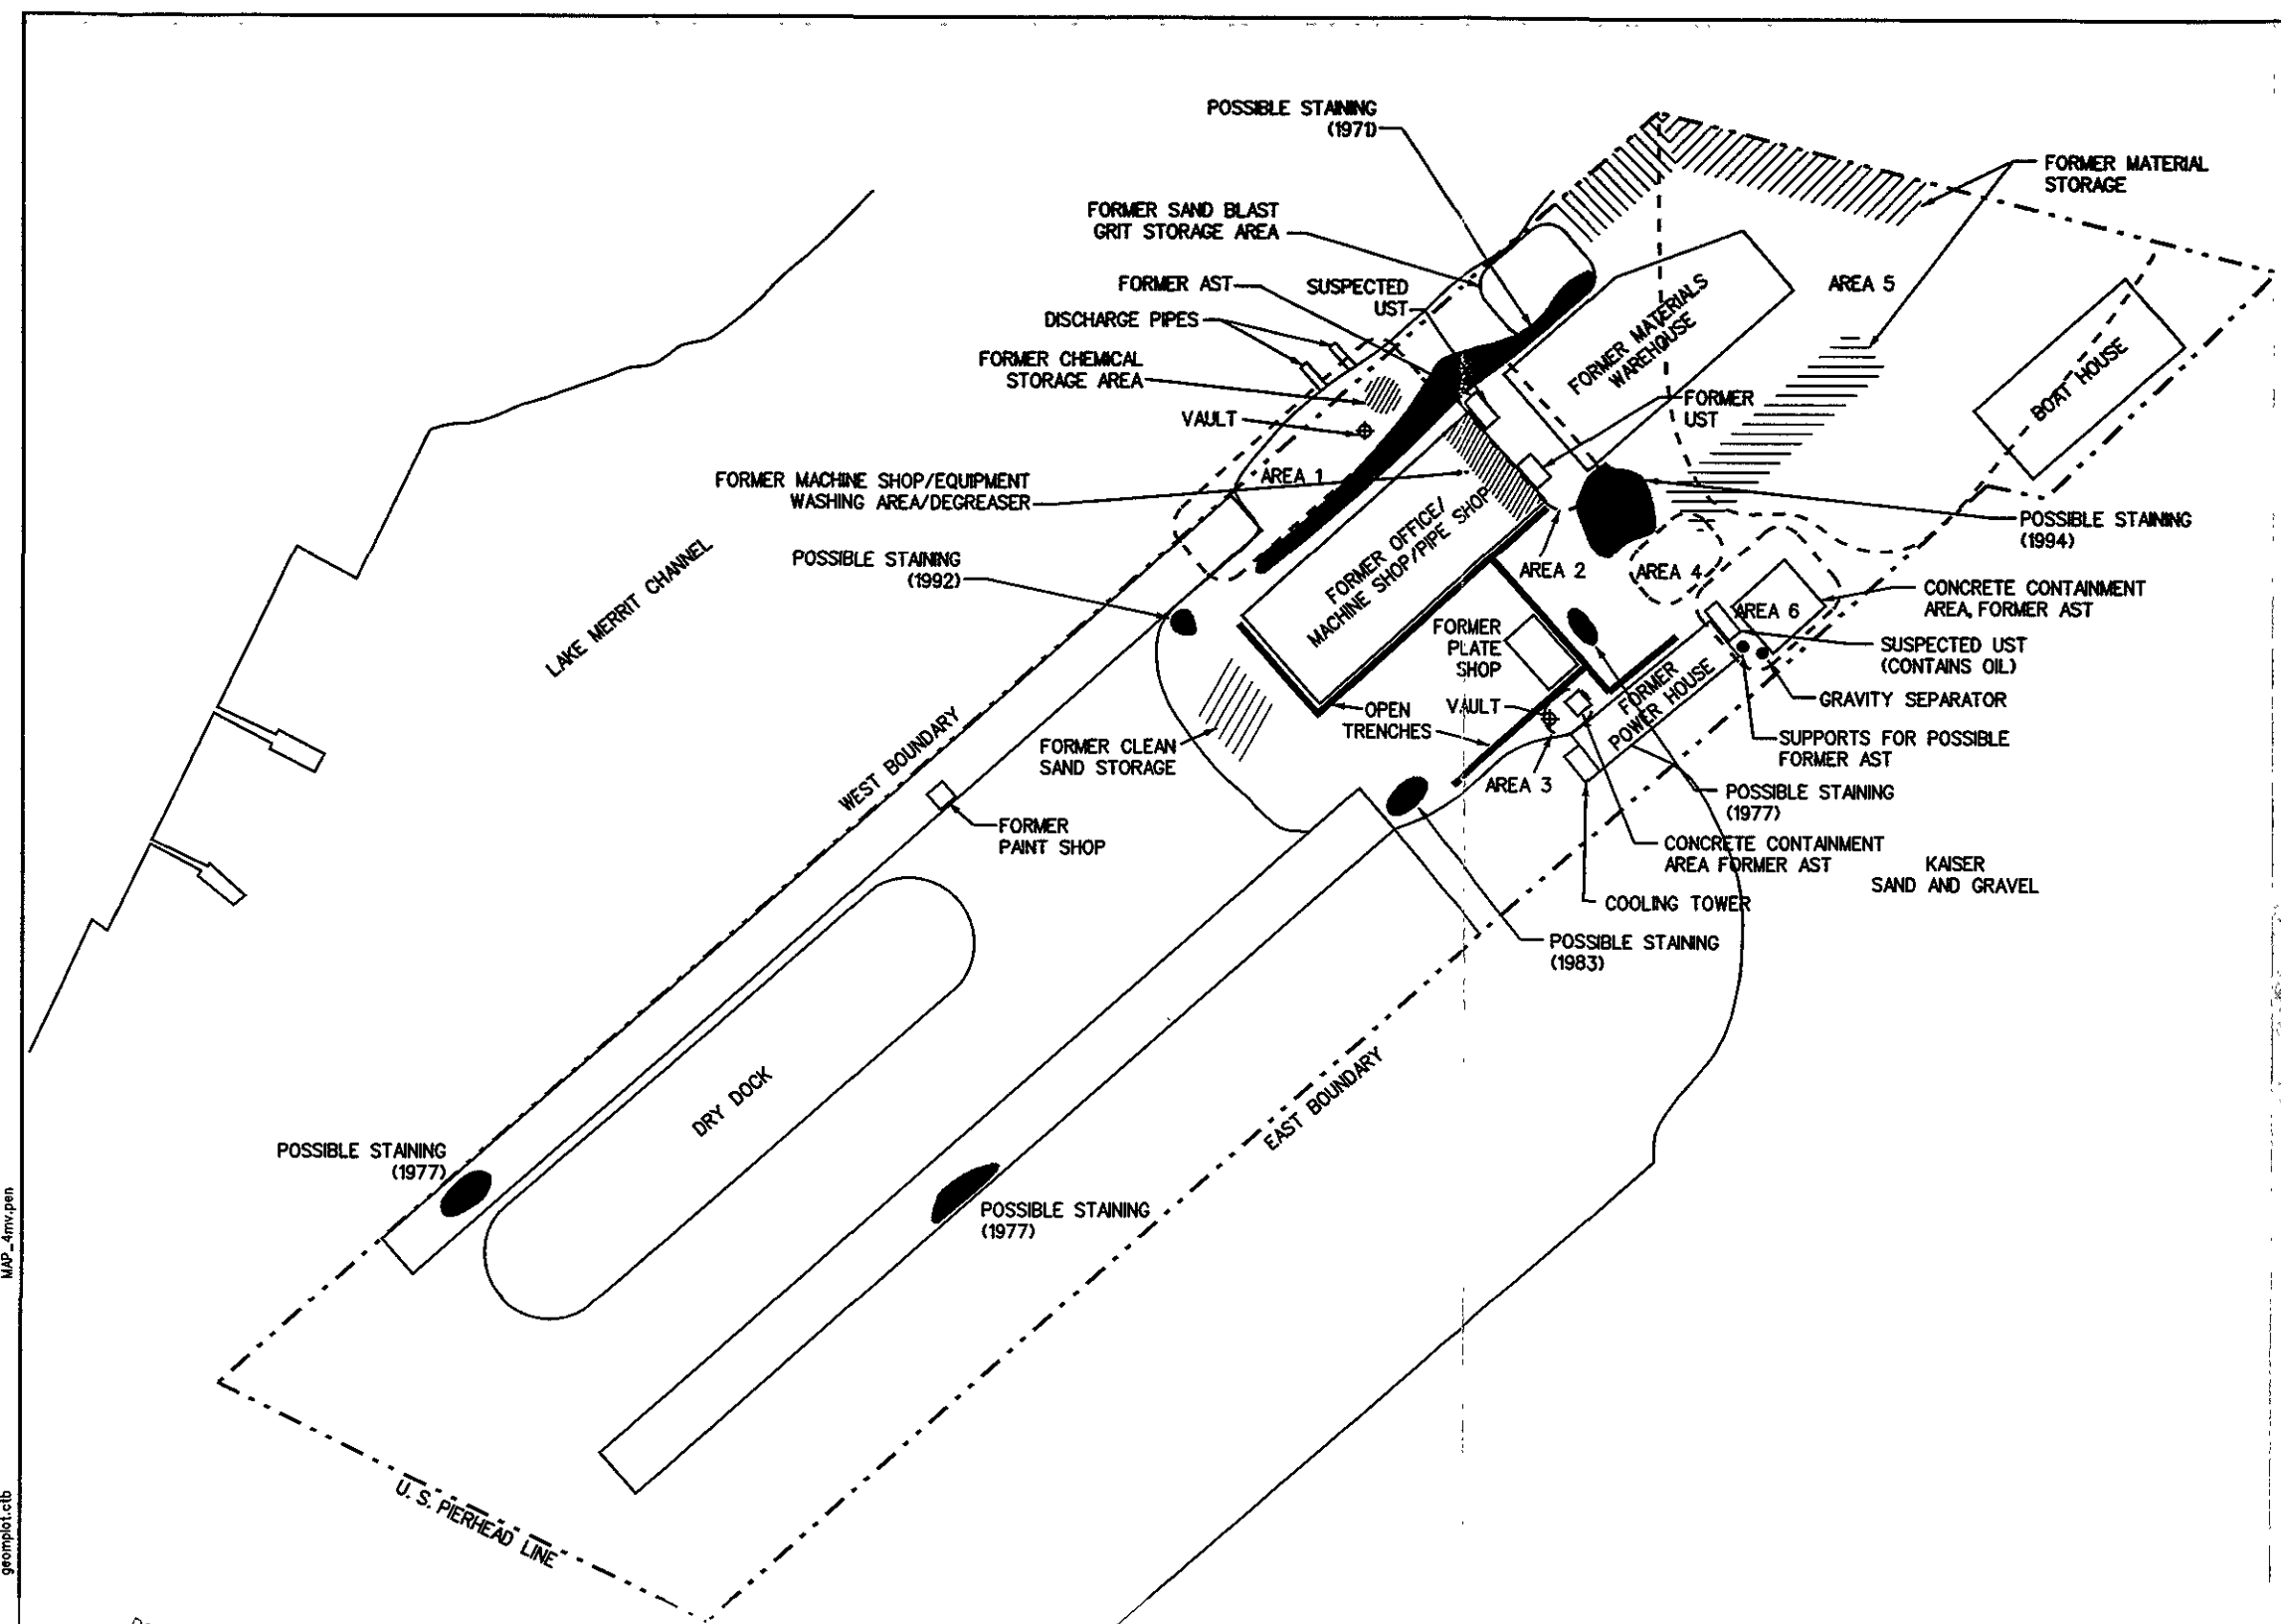
<p><b>CURRENT AND HISTORICAL SITE FEATURES</b> Pacific Dry Dock and Repair, Yard II 321 Embarcadero Oakland, California</p>		
  GEOMATRIX	Project No. 3999	Figure 1
