RE: Internal Inspection and UTG Report for
Corwood Car Wash 6973 Village Pkwy Dublin, CA

INTERNAL TANK INSPECTION AND UTG REPORT FOR:

CORWOOD CAR WASH
6973 VILLAGE PARKWAY
DUBLIN, CALIFORNIA
94568

MARCH, 1990

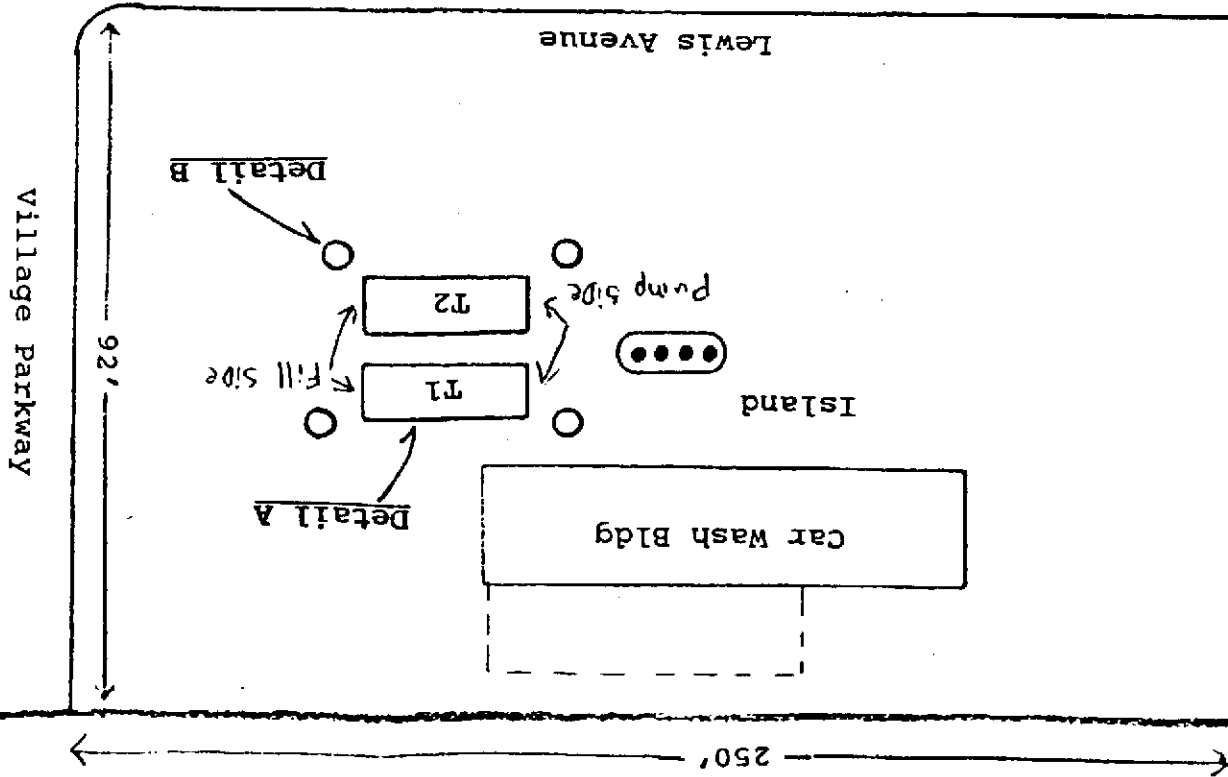
- Scope Of Work:
- 1) Tanks to be Interior Lined per attached Armor Shield Specifications. Detail A
 - 2) Cathodically protected with an impressed current cathodic protection system. Detail B
- Cathodic Anode
- Tank #1 & Tank #2 10K UST's

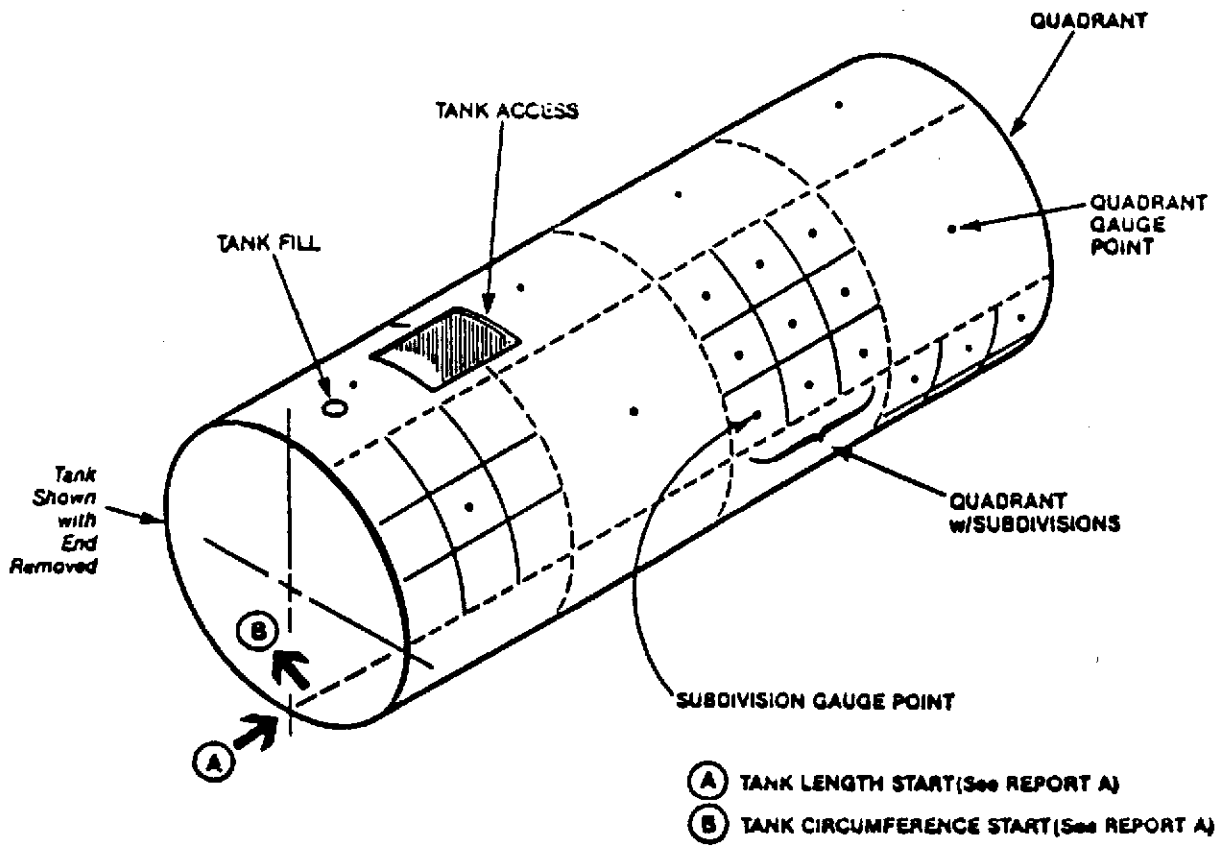
- Ⓐ TANK LENGTH START (See REPORT A)
- Ⓑ TANK CIRCUMFERENCE START (See REPORT A)
