A Report Prepared For:

PRELIMINARY SITE ASSESSMENT HARBOR BAY LANDING SHOPPING CENTER ALAMEDA, CALIFORNIA

October 18, 1993

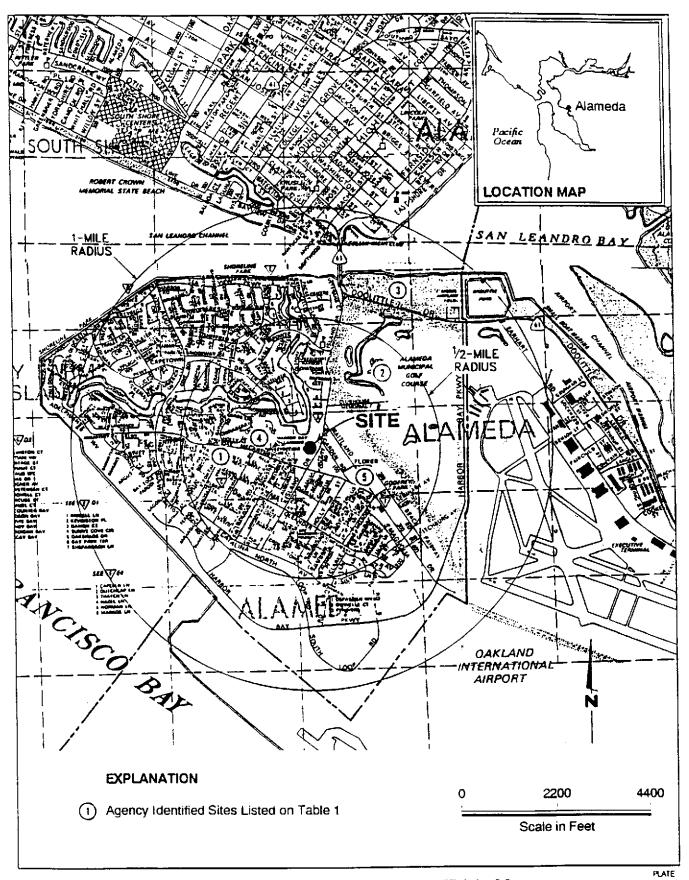
Site and Vicinity Map Harbor Bay Landing Shopping Center Alameda, California

- Normandy Project, Mecartney Road (Site 1 on Plate 1) This leaking UST site is situated approximately 1/3-mile downgradient from the subject site. Based on RWQCB file information, a leaking UST was discovered and removed from this former agricultural property (aka Ratto Farm) during grading activities in 1987. Subsequently, petroleum hydrocarbon contaminated soil in excess of 1,000 ppm was excavated and removed from the site and a groundwater monitoring well was installed. Initial sampling of the well revealed low to moderate levels of total petroleum hydrocarbons. The most recent sampling of this well during February 1991 indicated non-detectable levels of TPH-g, toluene, ethylbenzene, and xylenes; benzene was detected at 0.53 ppb. Based on the downgradient location of this site and the low to non-detectable levels of petroleum hydrocarbon constituents present in groundwater, the Normandy Project site does not present a significant environmental concern for the subject property.

- Alameda Municipal Golf Course, Clubhouse Memorial Drive (Site 2 on Plate 1)
 This site is located approximately 1/3-mile northeast and crossgradient from the subject site. According to Alameda Fire Department and RWQCB records, two gasoline USTs were removed from this site in 1991. Free floating product was found on groundwater in the excavation area. Petroleum hydrocarbon impacted soil was excavated and three groundwater monitoring wells were installed in the vicinity of the former USTs. Quarterly groundwater monitoring performed at this site since at least September 1992 revealed non-detectable levels of TPH-g and gasoline constituents in the groundwater. The most recent groundwater sampling event took place during May 1993. Based on groundwater monitoring data from this site, it is considered unlikely that this facility poses a significant environmental concern to the subject property.

- City of Alameda Disposal Site, North of Doolittle Drive (Site 3 on Plate 1) Also referred to as Doolittle Landfill, this site is located approximately 3/4-mile northeast and crossgradient from the subject property and is listed on the Inactive Landfills database. Since closure of this landfill, the RWQCB has been involved in investigating potentially lead-contaminated seepage from this site. This inactive landfill is not expected to represent a potential environmental concern to the subject site, based on the crossgradient location.

- Peter Pan Academy, 3171 Mecartney Road (Site 4 on Plate 1) This facility is listed on the FINDS database and is located within 1/4-mile downgradient from the subject site. There have been no documented releases of hazardous materials at this location and therefore, this site does not represent a significant environmental concern for the subject property.

• Former Gas Station. 109 Maitland Drive (Site 5 on Plate 1) This site is located approximately 1/4-mile east of the subject property. According to Alameda Fire Department records, two USTs containing gasoline were installed for a gasoline station located at this site during the 1920's. The length of operation and details related to hazardous material storage and handling at the former gas station are unknown. Furthermore, it is unknown if USTs remain at this location and if any releases of petroleum hydrocarbons occurred. In our opinion, based on the distance of this property from the subject site, it is not likely that releases (if they occurred in minor to moderate amounts) would pose a significant impact to the subject site.

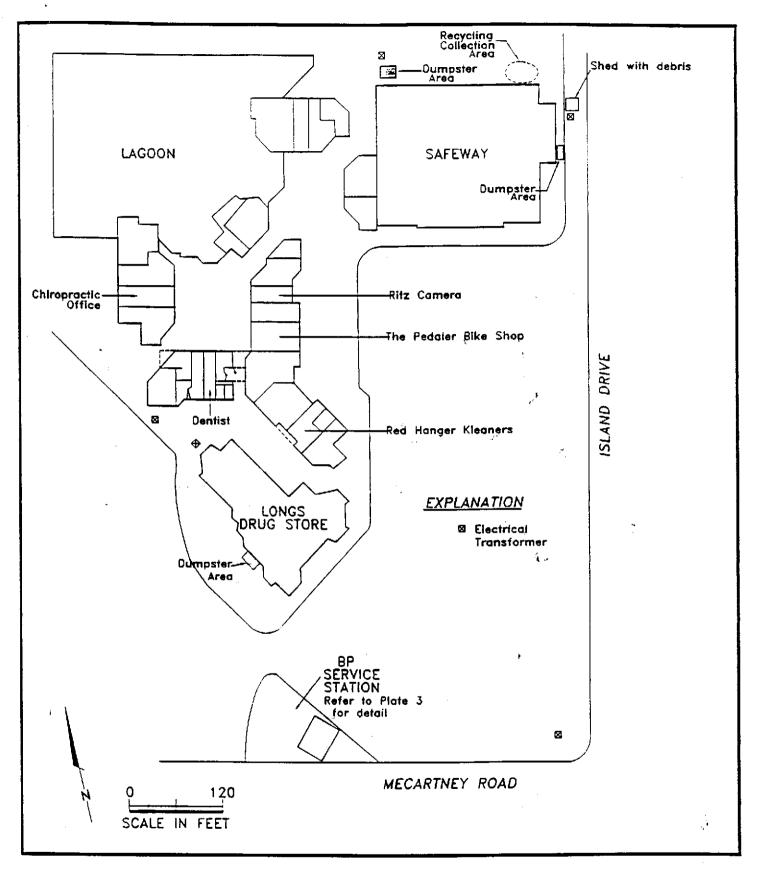
Site Layout Harbor Bay Landing Shopping Center Alameda, California

Other than minor quantities of janitorial cleaning supplies, ink, toner, paint, and (occasionally) oil located within shops and offices at the site, chemical usage appears to be limited to six tenants as discussed below. Plate 2 shows the location of these onsite tenants.
