October 25, 2000  
RGA Job # HSHI5835  
Report 0164.R6

**RE: MONITORING WELL REPLACEMENT REPORT**  
Hardage Construction Corporation Site  
5800 Shellmound Street  
Emeryville, CA 94608

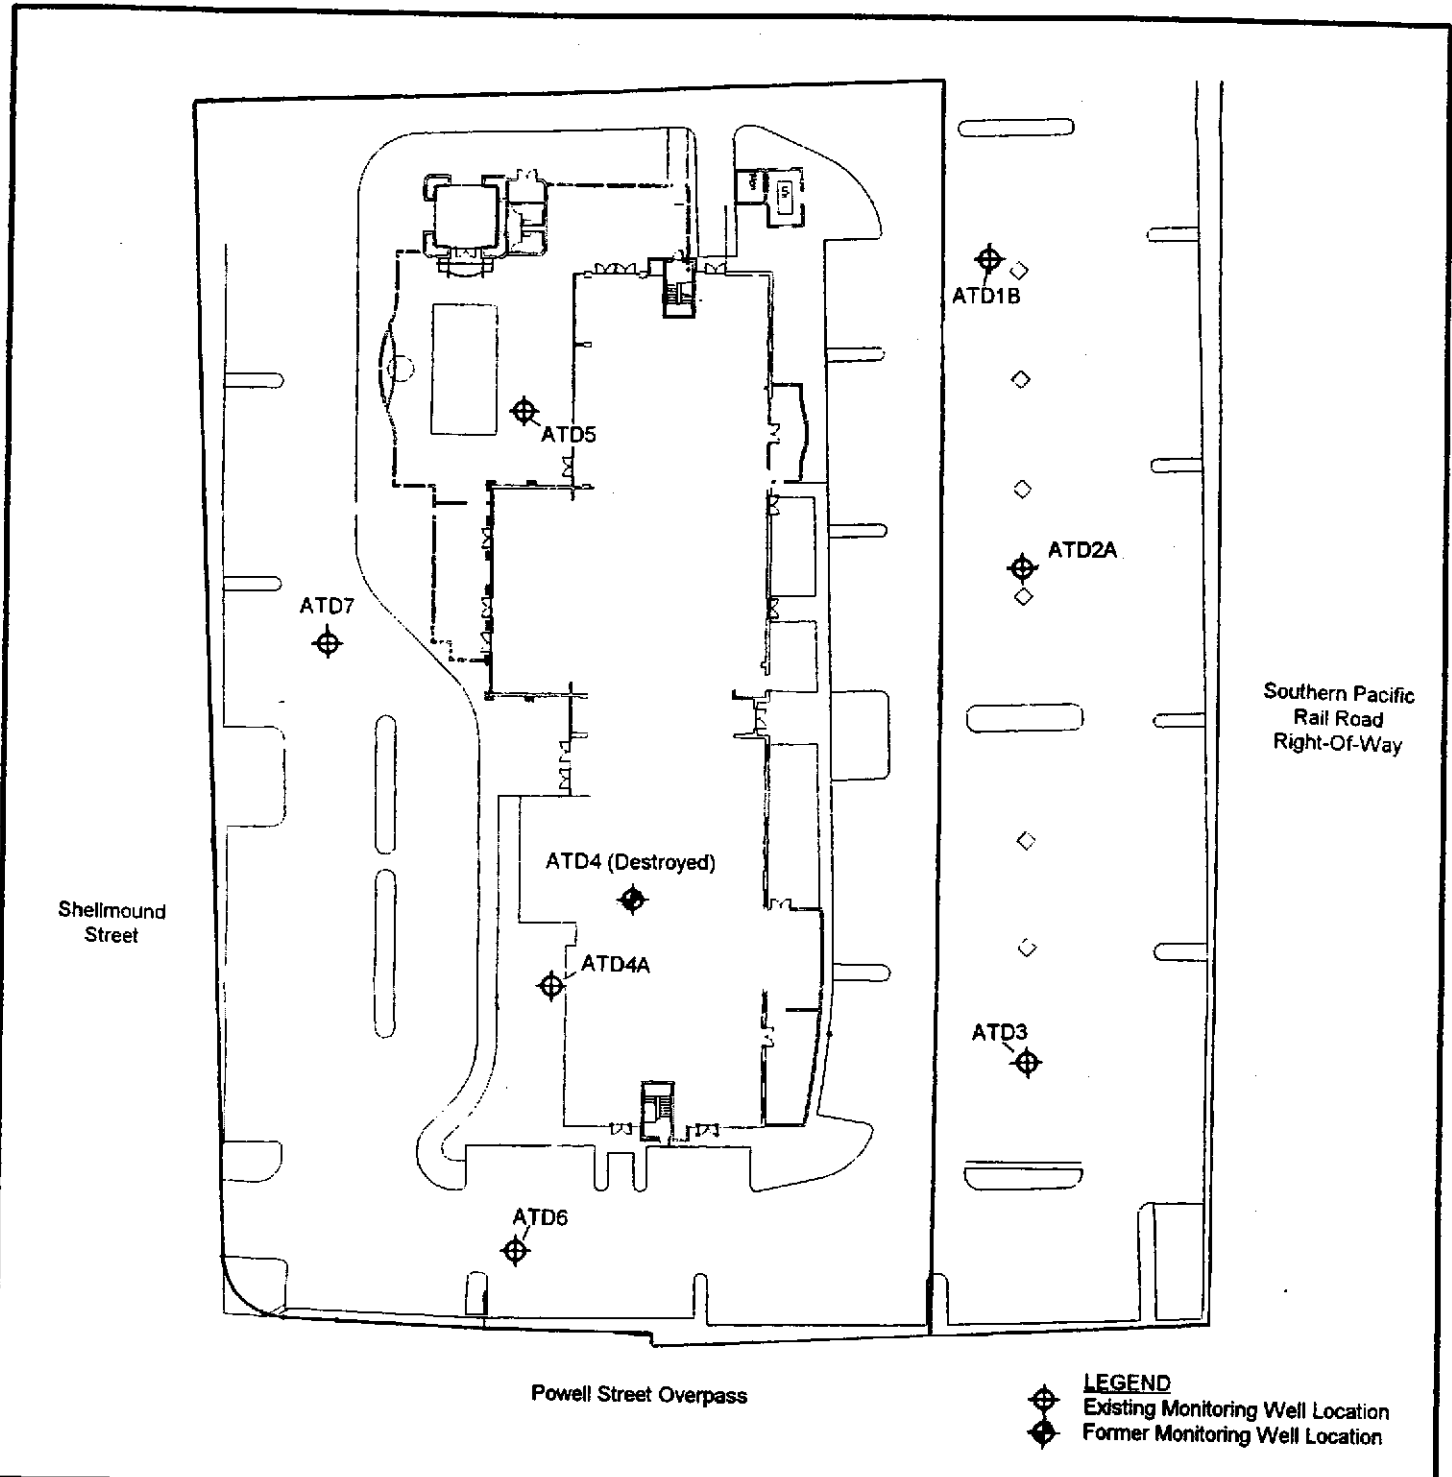
**FIGURE 2**  
**SITE PLAN**  
 Hardage Construction Corporation Site  
 5800 Shellmound Street  
 Emeryville, California

Recent quarterly monitoring and sampling activity revealed that one well in the system (ATD1A, shown on the attached Figure 1 – Site Plan) was partially full of sand. Documentation of attempts to flush and purge the sand out of ATD1A with clean water can be found in RGA's Report 0164.R5, "Quarterly Monitoring and Sampling Report," dated September 6, 2000. The sand in the well was the sand used for construction of the well filter pack. Based upon repeated attempts to remove the sand, it was determined that well replacement was appropriate. A Monitoring Well Replacement Work Plan (Letter 0164.L29) dated September 13, 2000 was submitted to the ACDEH for review and approval. The work plan was verbally approved by Ms. Susan Hugo of the ACDEH on September 19, 2000.

On October 2, 2000, RGA personnel oversaw the destruction of one groundwater monitoring well (monitoring well ATD1A) and installation of one replacement groundwater monitoring well, designated as ATD1B, in the same borehole. The locations of all of the monitoring wells at the subject site are shown on Figure 2.
