September 14, 1999

Re: 4331-39 MacArthur Blvd., Oakland, CA - Magnetometer Survey Results

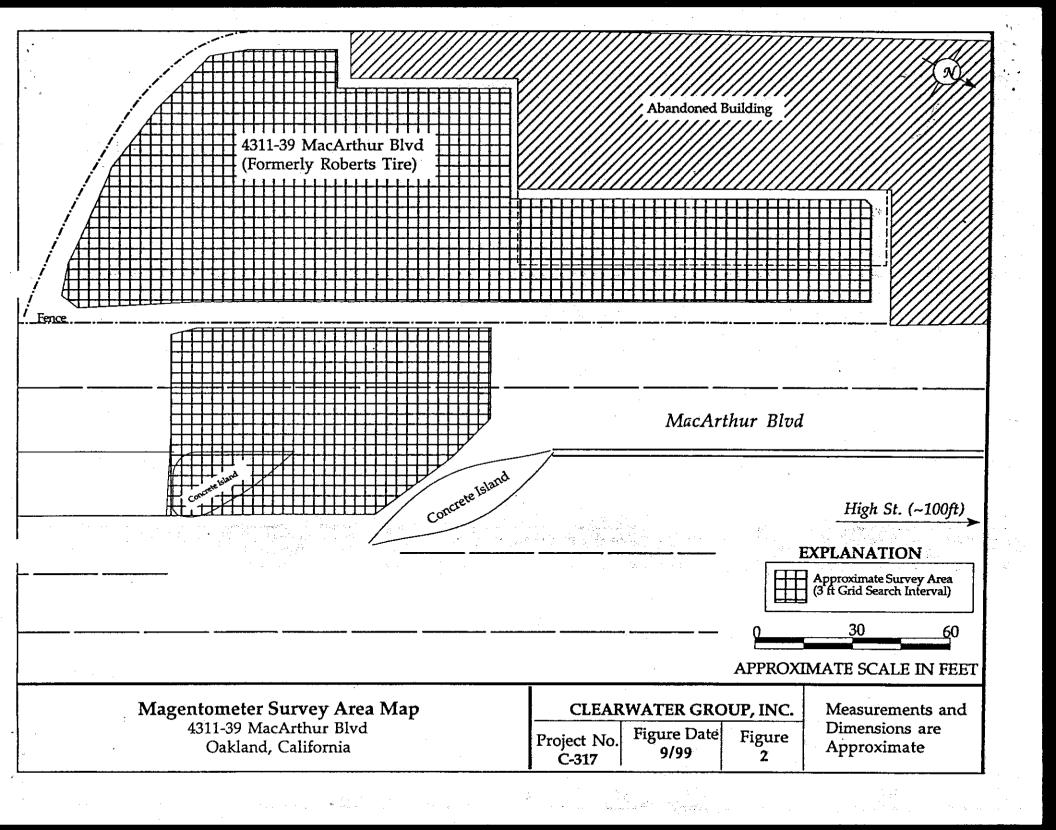
The results of the survey found five noteworthy metal-bearing objects in the survey area. Of the five objects, three could possibly be USTs. The five objects are shown on Figure 3, and are

The results of the magnetometer survey found five noteworthy metal-bearing objects on and adjacent to the subject site, three of which could possibly be USTs. Based on the size and shape of the objects found it can not be determined conclusively if the objects are USTs or not. Historic information indicates that USTs were once located in the surveyed area and documentation does not exist regarding their removal. Hence, it is possible that the objects located are USTs from the former fuel servicestation which operated at the subject site.
