Re: Phase I Environmental Site Assessment
3701 Martin Luther King Jr. Way
Oakland, California 94609

Phase I Environmental Site Assessment
3701 Martin Luther King Jr. Way
Oakland, California

November 21, 2002

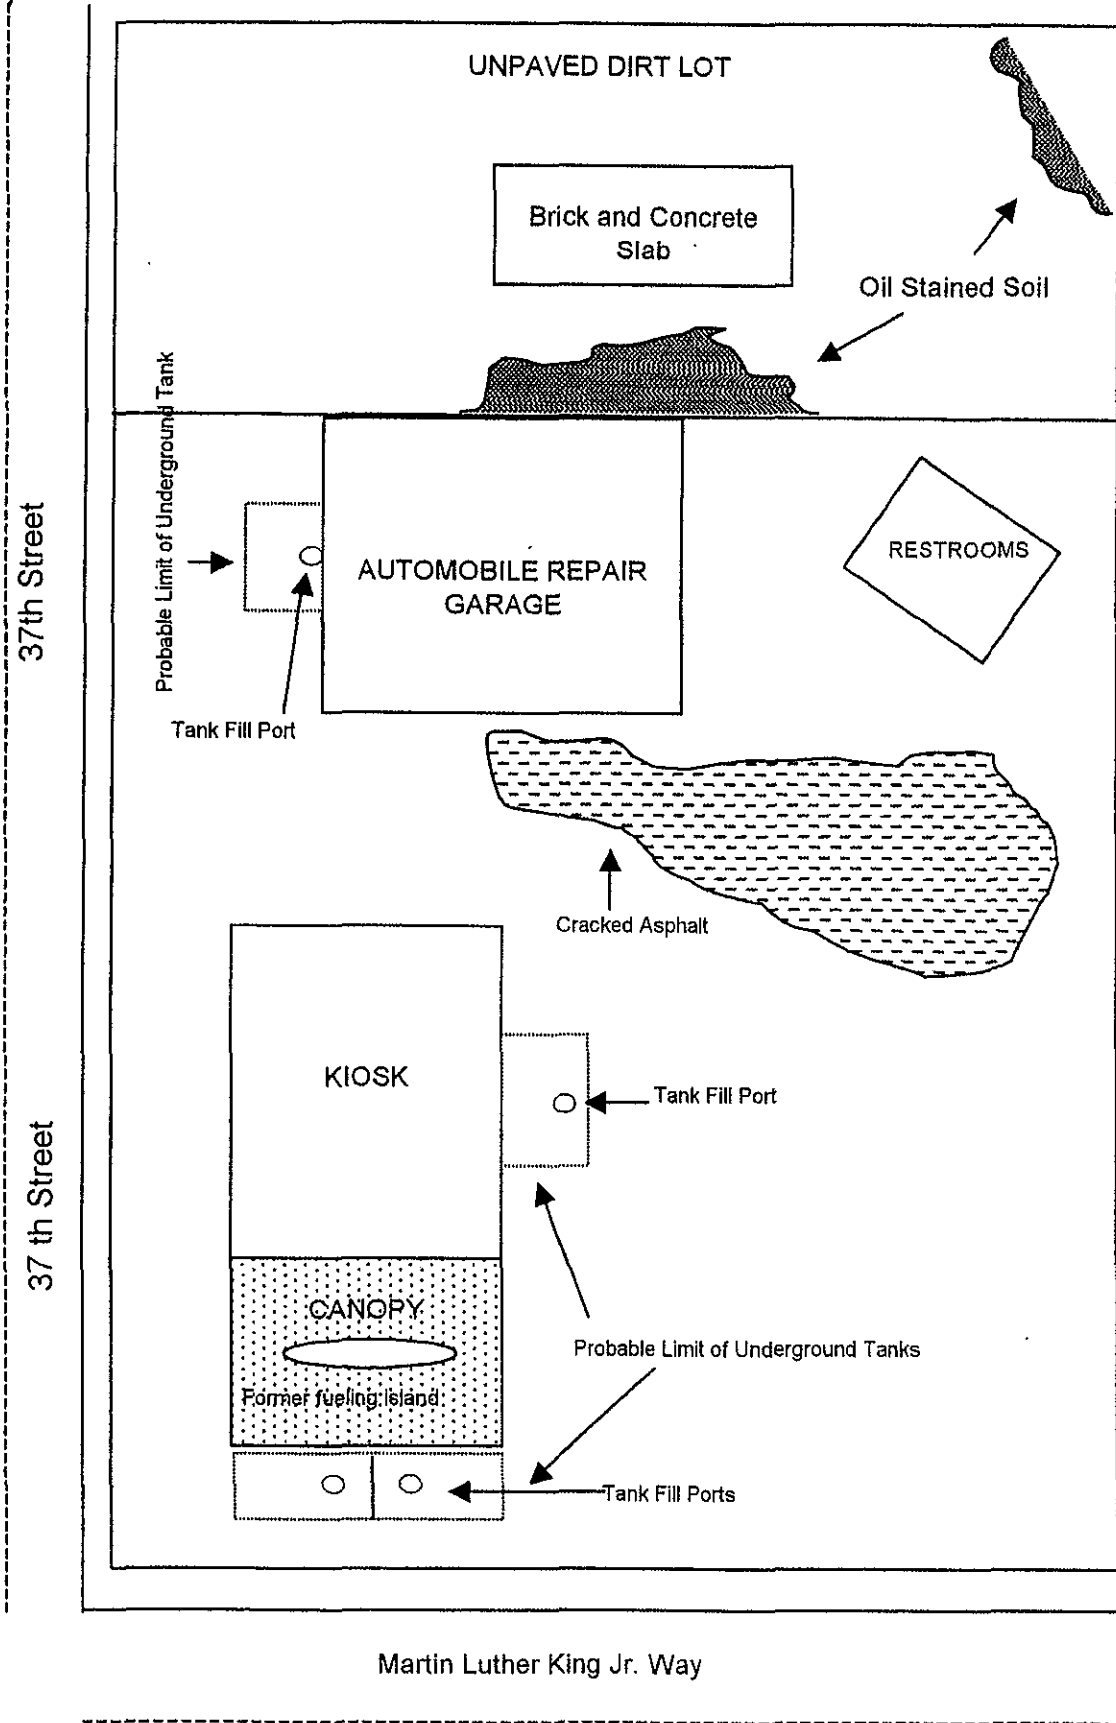
FIGURE 2: SITE PLAN: 3701 MARTIN LUTHER KING JR. WAY, OAKLAND, CALIFORNIA

Oil stained soil was observed at several locations in the unpaved area of the Property. The locations of stained soil are depicted in Figure 3.
