Report of Release  
and  
Interim Remedial Actions  
Report  
for  
Diesel Fuel Release  
located at:

**FCI DUBLIN**  
Federal Correctional Institution  
5701 8th st - Camp Parks  
Dublin, CA

by  
McElligott Consulting  
June 10, 2008

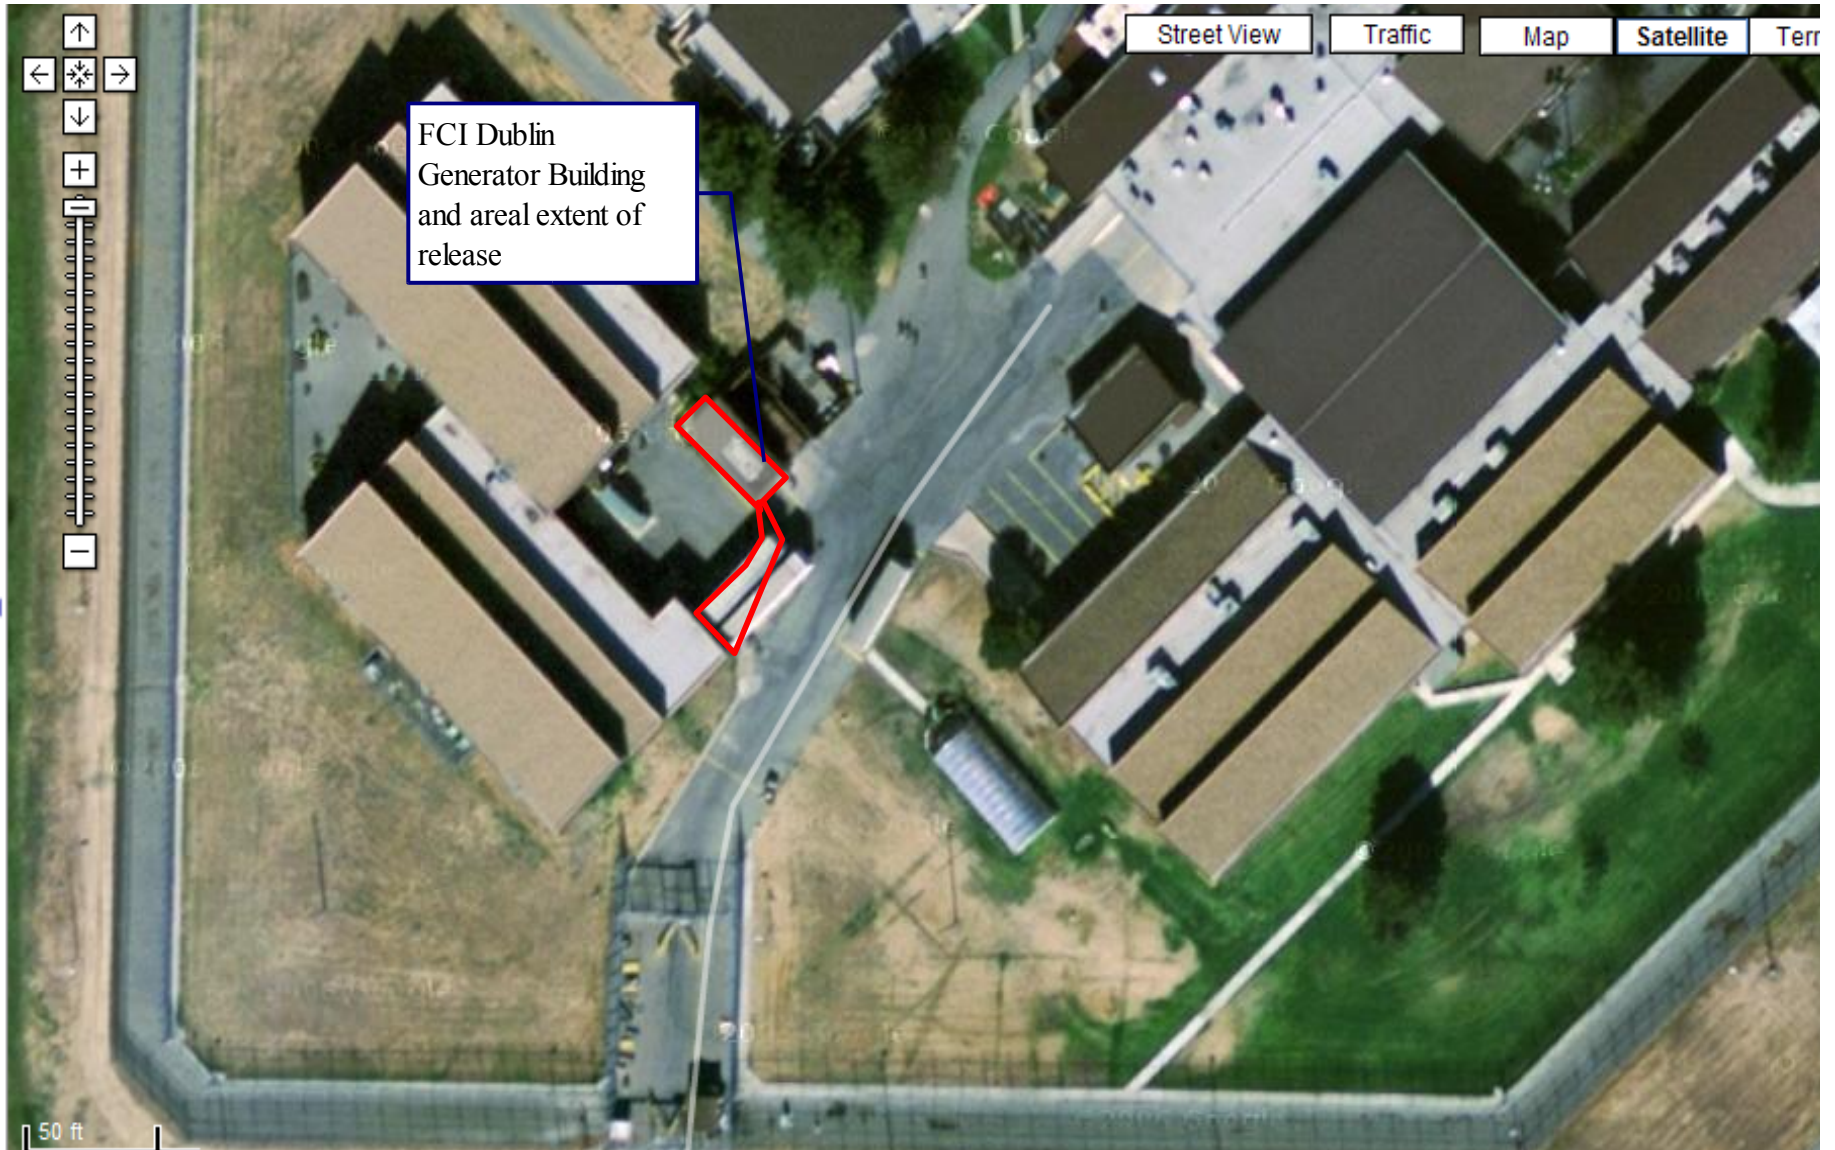
Figure 3: Site of Release, Generator Building, FCI Dublin

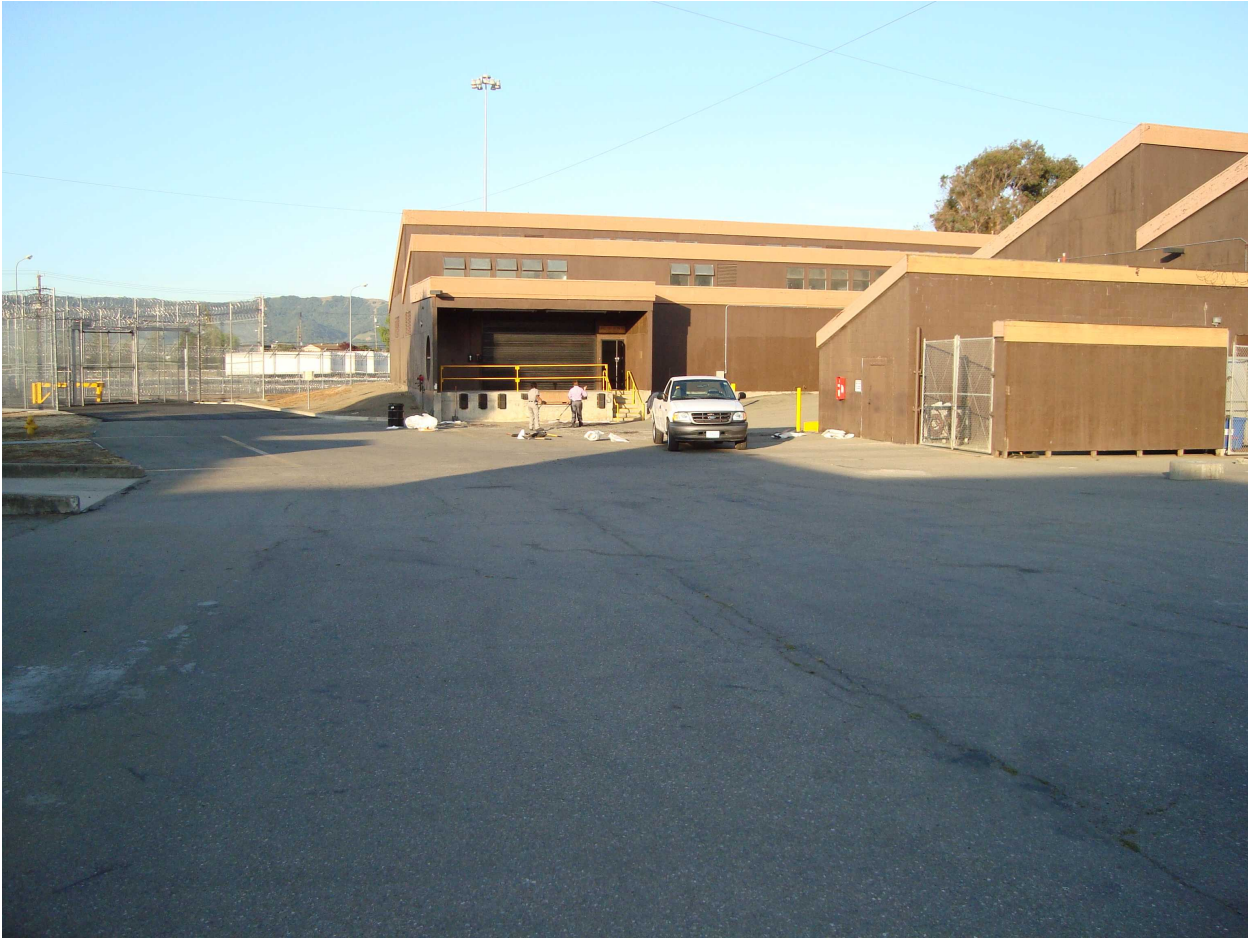
Photo 1: FCI-Dublin Generator Building on right behind chain link gate enclosure. Loading dock well in center, main gate to left. View is to west.

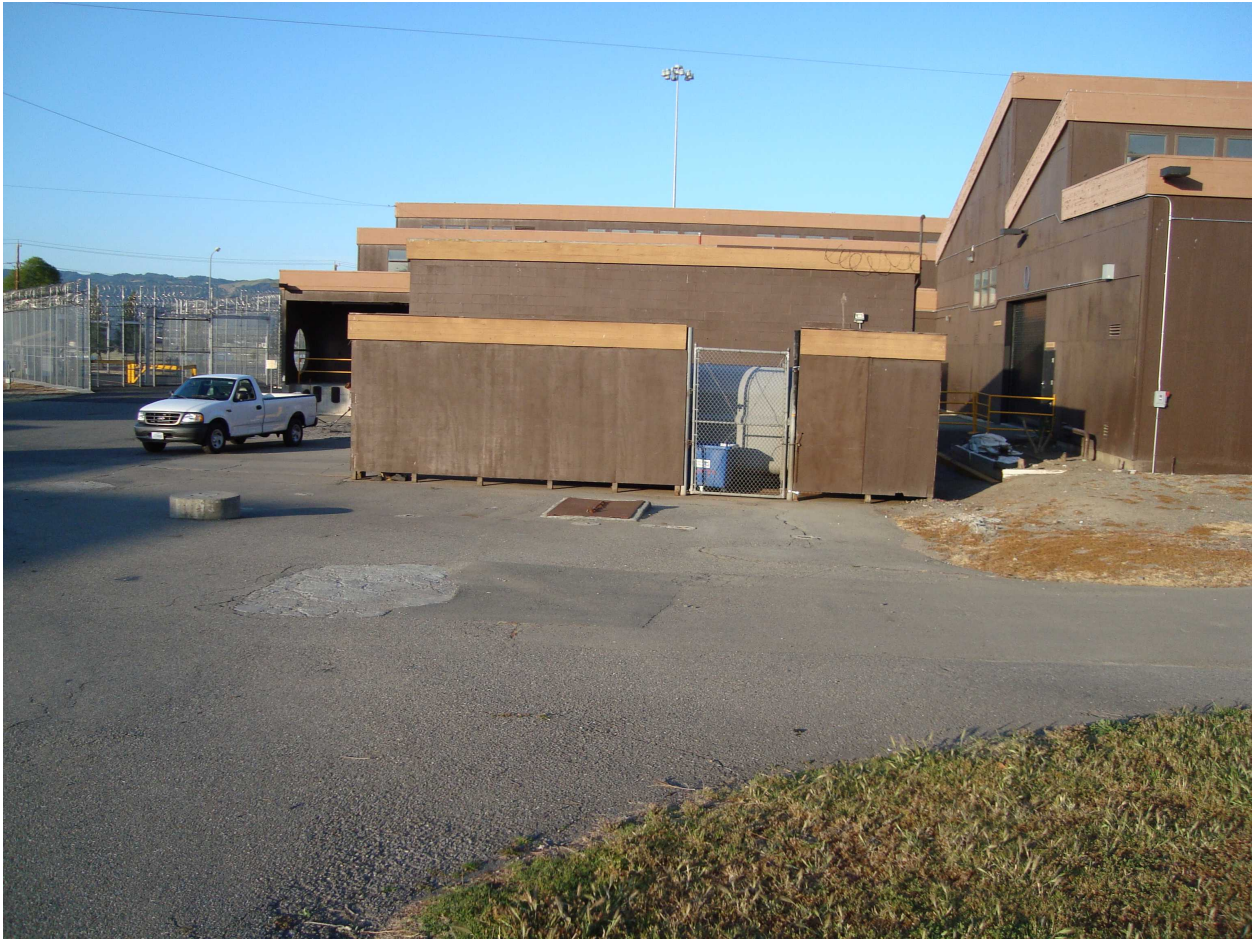
Photo 2: Generator Building behind chain link gate enclosure. Building Q to right, main gate to left. View is to west southwest.

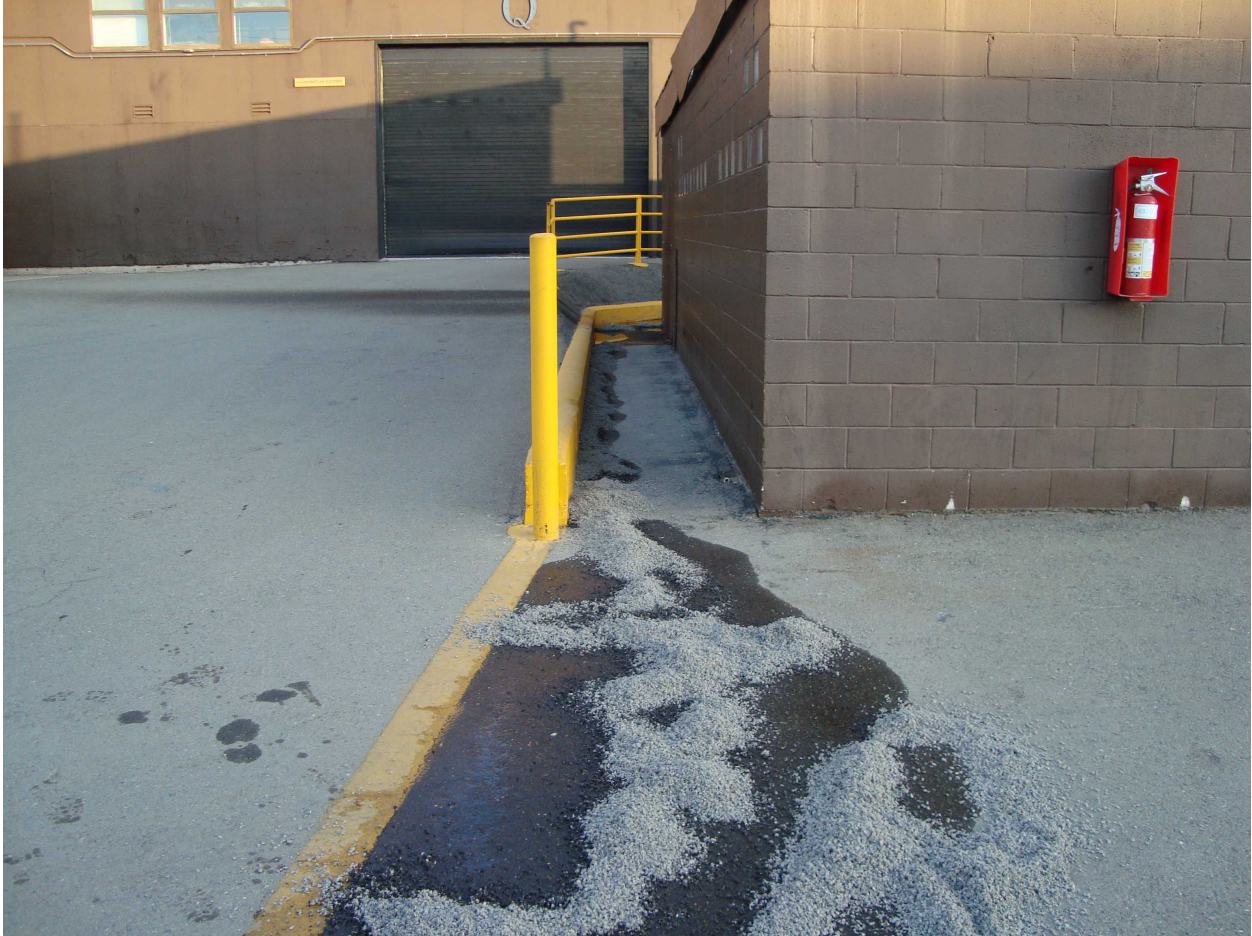
Photo 10: Generator Building, south side. View is to the north.

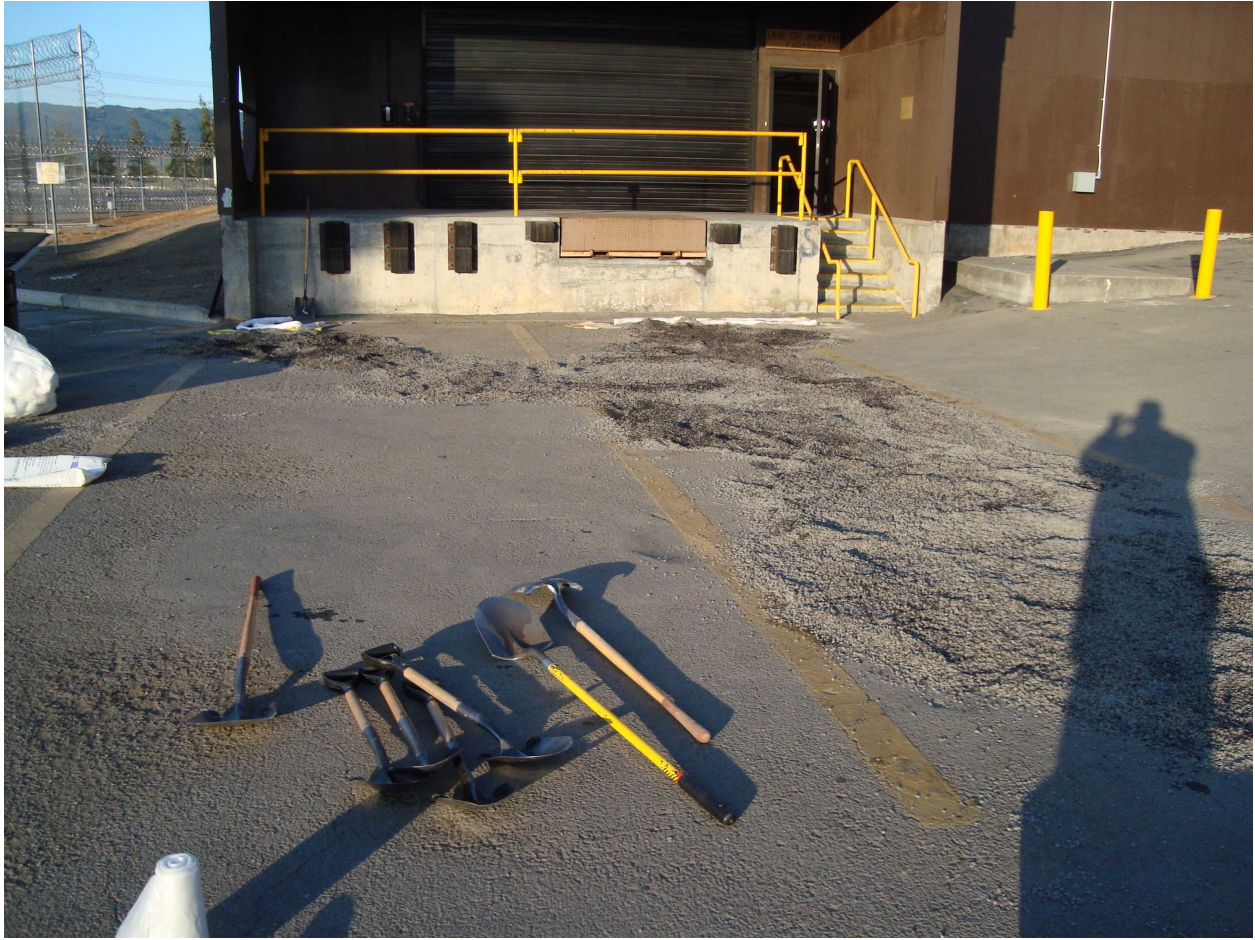
Photo 12: Loading dock and dockwell. View is to the north west.

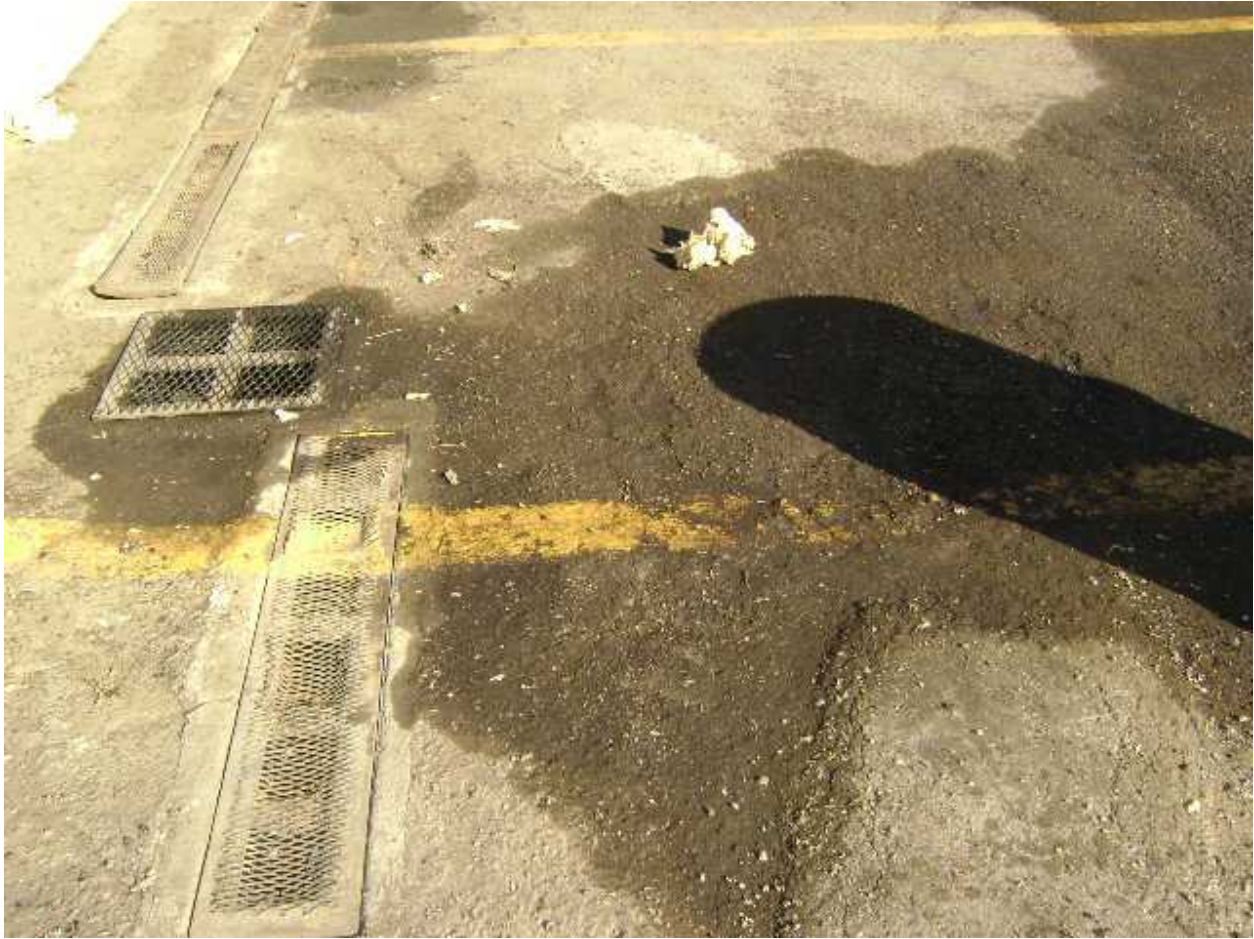
During the routine generator testing on April 25, 2008, the day tank supplying the emergency backup generator overflowed into the generator room, and then through the door sill on the north and ventilation opening on the west side of the generator room. The diesel fuel then flowed along the asphalt walkway between the building on the north and west sides, some of which entered the cold joints between the building foundation and walkway and the retaining wall and walkway, and into the underlying soil. Some of the fuel flowed along the west walkway south to the driveway and to the loading dock to the west. Some fuel migrated through the asphalt paving, and some entered the storm water collection trench running parallel to the dock. No fuel was observed in the catch basin serving the dockwell.

Photo 13: Dock well storm water collection trench and catch basin. View is to the northwest, parallel to dock.

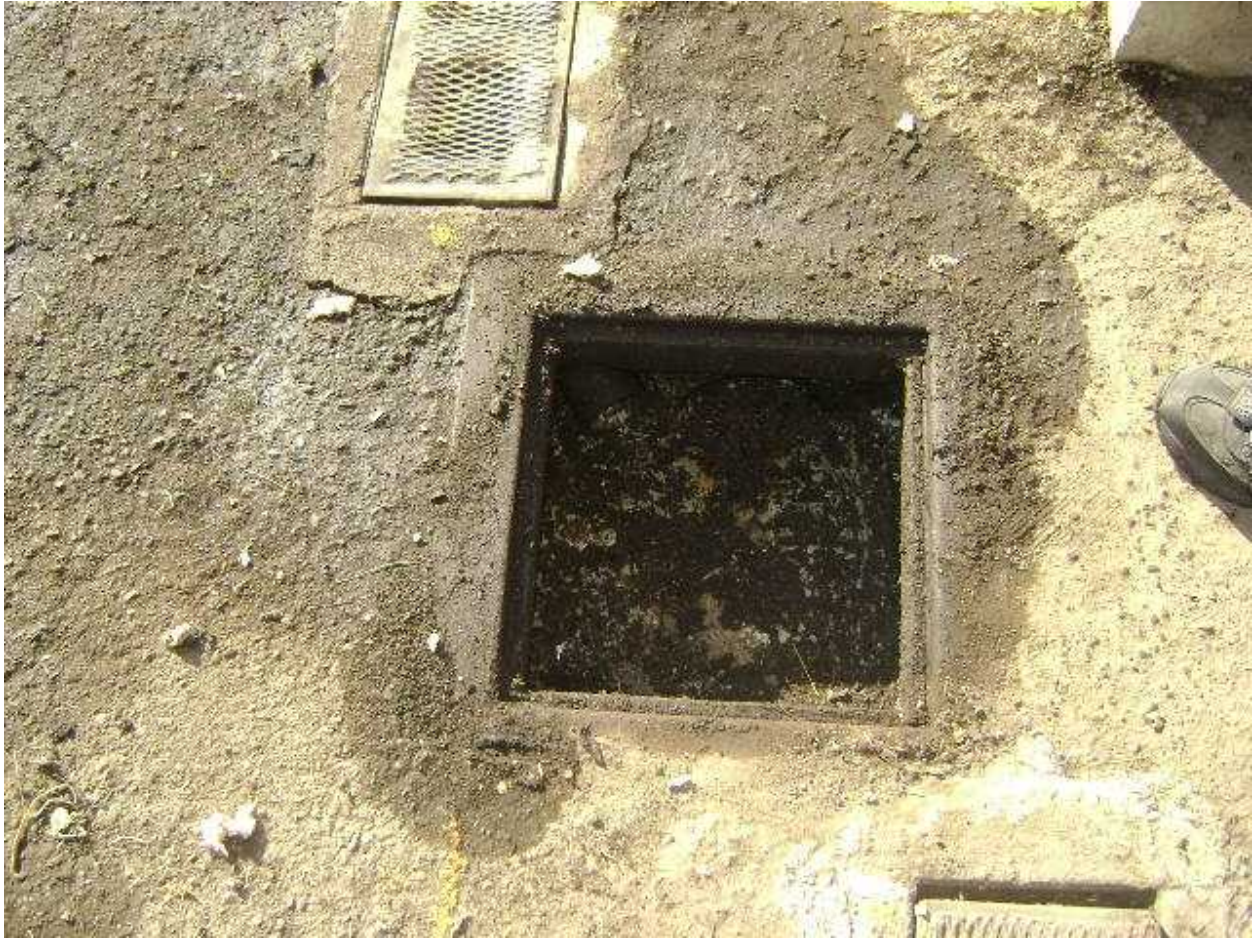
Photo 14: Dock well storm water catch basin. View is to the southwest, parallel to dock.

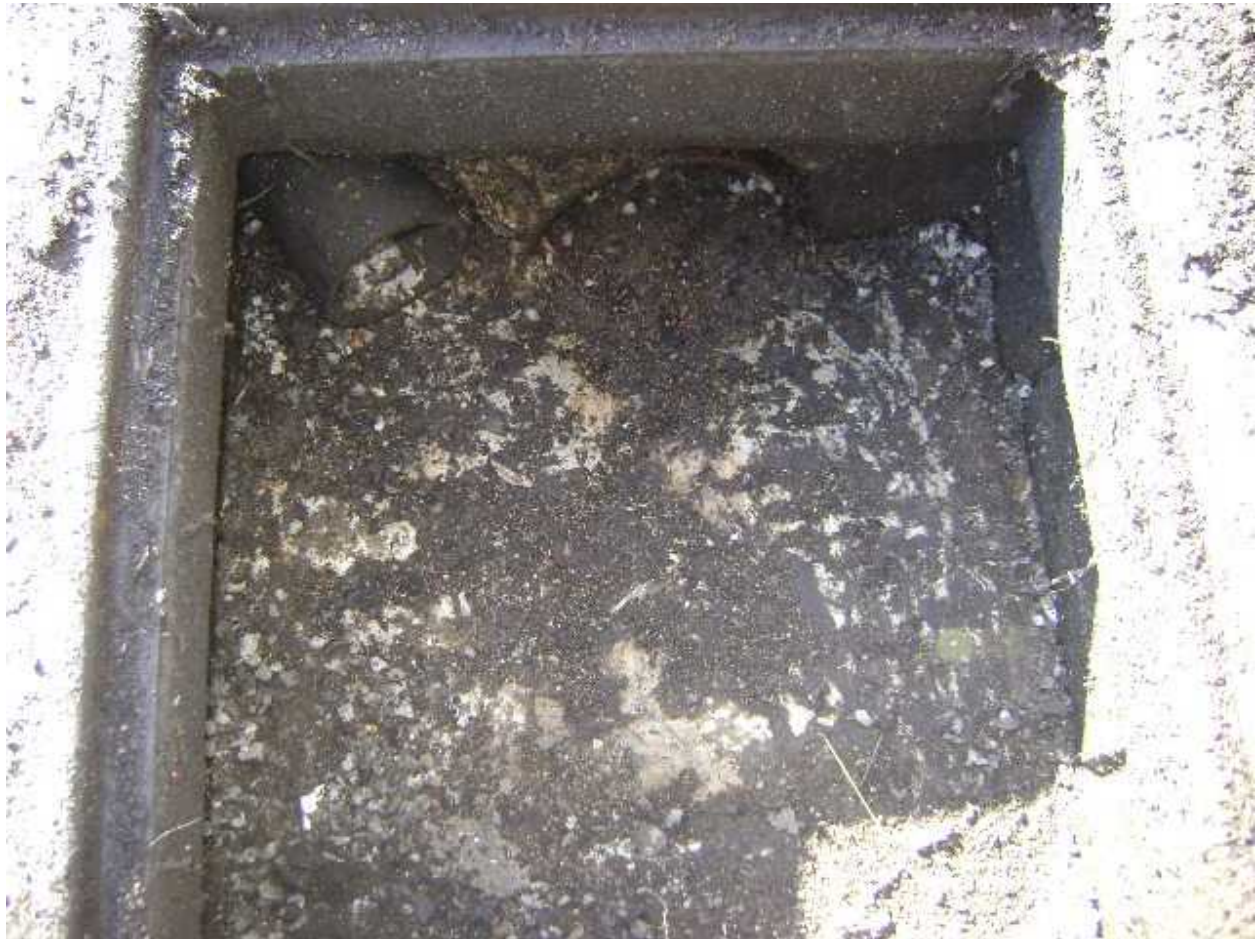
Photo 15: Dock well storm water catch basin detail. Pipe at top right corner conveys storm water from south trench segment to catch basin. Half-buried larger pipe at top center is catch basin connector to site storm water system. View is to south west.
