Re: TSA Oakland ARC Warehouse Building's basement's elevation and the configuration of the warehouse's three elevators.
The Salvation Army Adult Rehabilitation Center
601 Webster Street
Oakland, CA 94607

Subject: Report on Survey of Basement Elevation and Elevator Configuration
The Salvation Army ARC Building
601 Webster Street,
Oakland, California,
ACEH Fuel Leak Case No. RO3084
Geotracker Global ID T10000003428
ATC Project No: Z054000006

PHOTOS - Elevation Survey of Basement

PHOTOS - Elevators in ARC Building

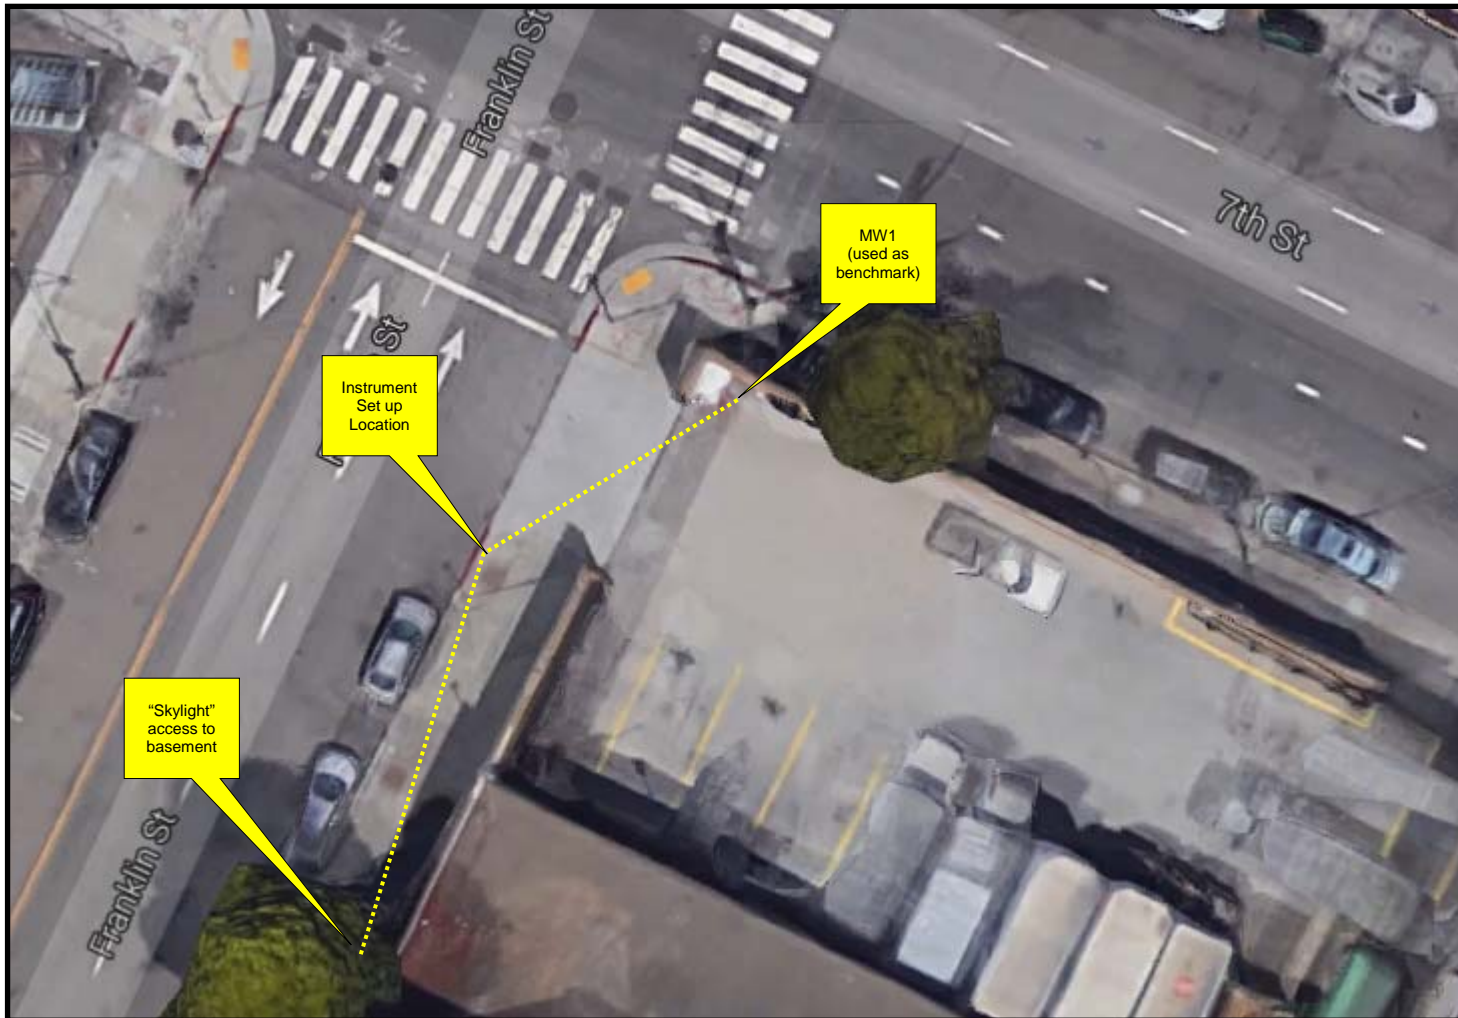
A foot print of the ARC building is included as **Figure 1**. A simple representation of the building profile is represented by **Figure 2**. A depiction of the line of site used to obtain the elevation is represented by **Figure 3**. The ARC Building Warehouse Basement Footprint with Elevator locations is represented by **Figure 4**.

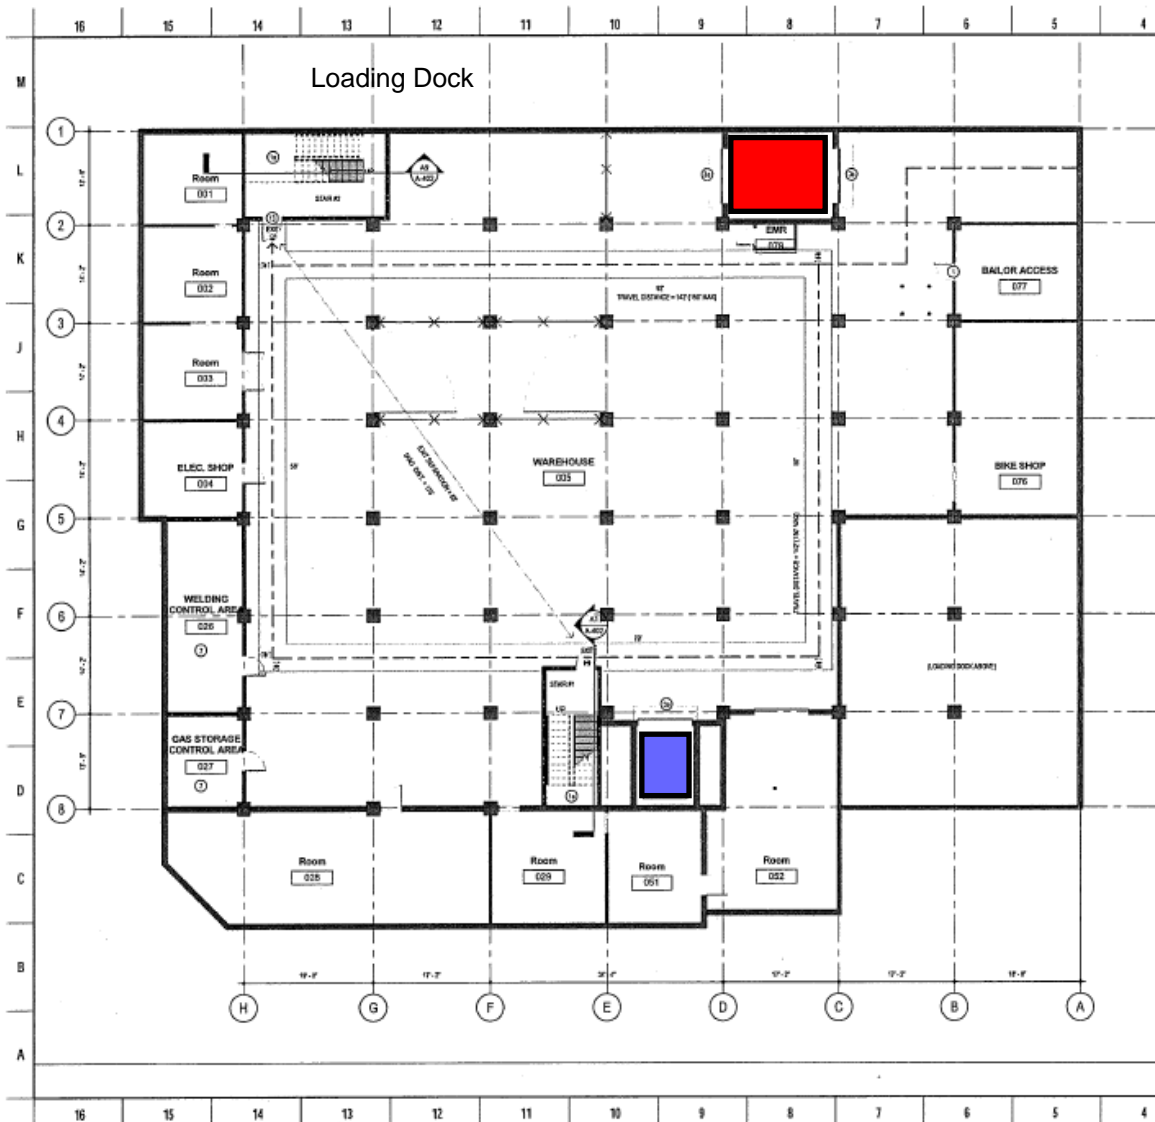
The donation elevator is located on the south side of the warehouse building near Sixth Street. This elevator is a traction-type elevator with the entirety of its lifting mechanisms located exclusively on the roof. The shaft for the donation elevator does extend below the plane of the basement floor approximately 5 to 7 feet. The portion of the shaft extending below the plane of the basement floor was visible. This portion of the shaft did not appear to contain any equipment and it was observed to be dry (**Photo 5**).

The freight elevator is located on the north side of the warehouse building near the truck enclosure loading dock. TSA sources say that this elevator is in need of repair so it currently is not operational. The shaft extended well below the basement floor but an exact distance could not be measured due to the limited access issues. The mechanisms for lifting were located in the space below the basement floor and this space was observed to be flooded (**Photos 7-8**). None of the available sources of information at TSA could confirm the existence or provide details about any sumps for this elevator.

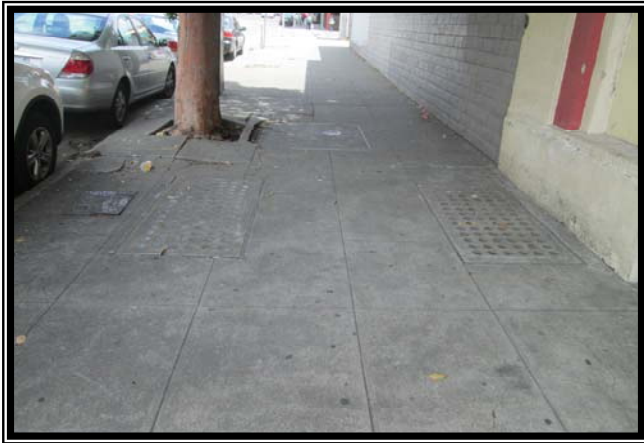
PHOTO 1:

Grid of sidewalk skylight used to access basement from sidewalk

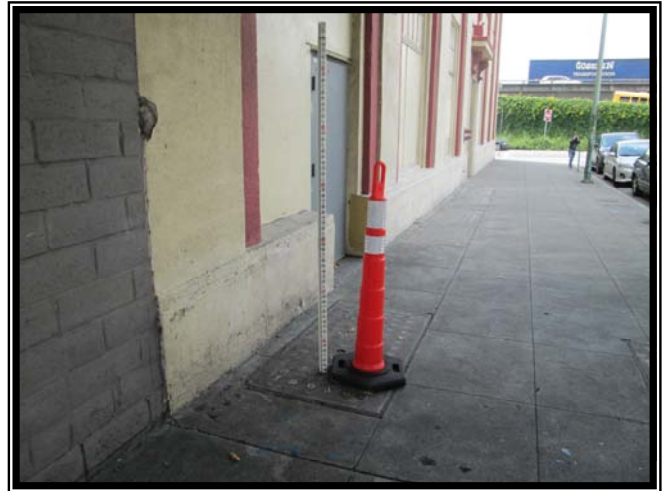
PHOTO 2:

Telescoping survey rod extending through void resulting from missing glass block used as part of sidewalk skylight

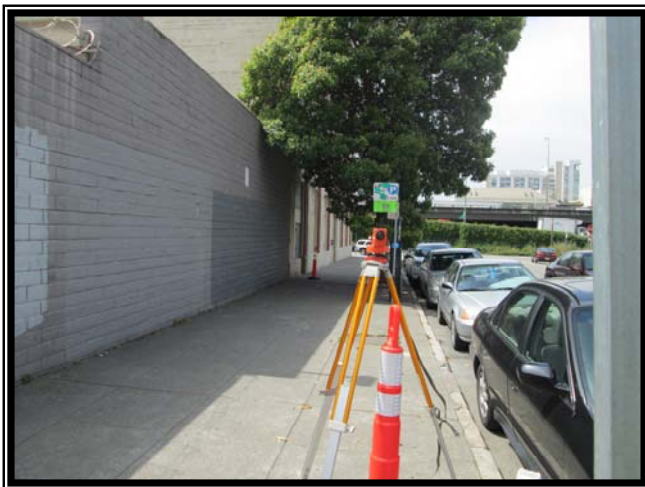
PHOTO 3:

Survey instrument set up on sidewalk along Franklin Street adjacent to the TSA ARC Warehouse Building

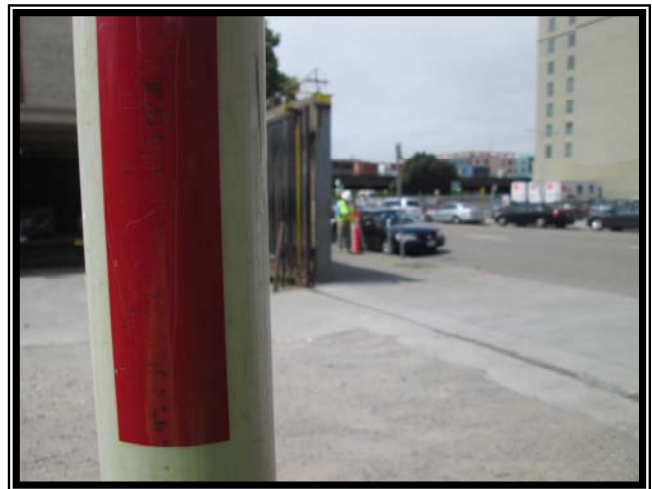
PHOTO 4:

View to survey instrument from where the survey rod is set up on MW1 being used as the benchmark.
