RE: Work Plan, Additional Subsurface Investigation, Properties at 760 22nd Street and 2201 Brush Street, Oakland, California 94612

June 6, 2012

**RESULTS OF SUPPLEMENTAL GEOPHYSICAL SURVEY
760 22nd STREET SITE
OAKLAND, CALIFORNIA**

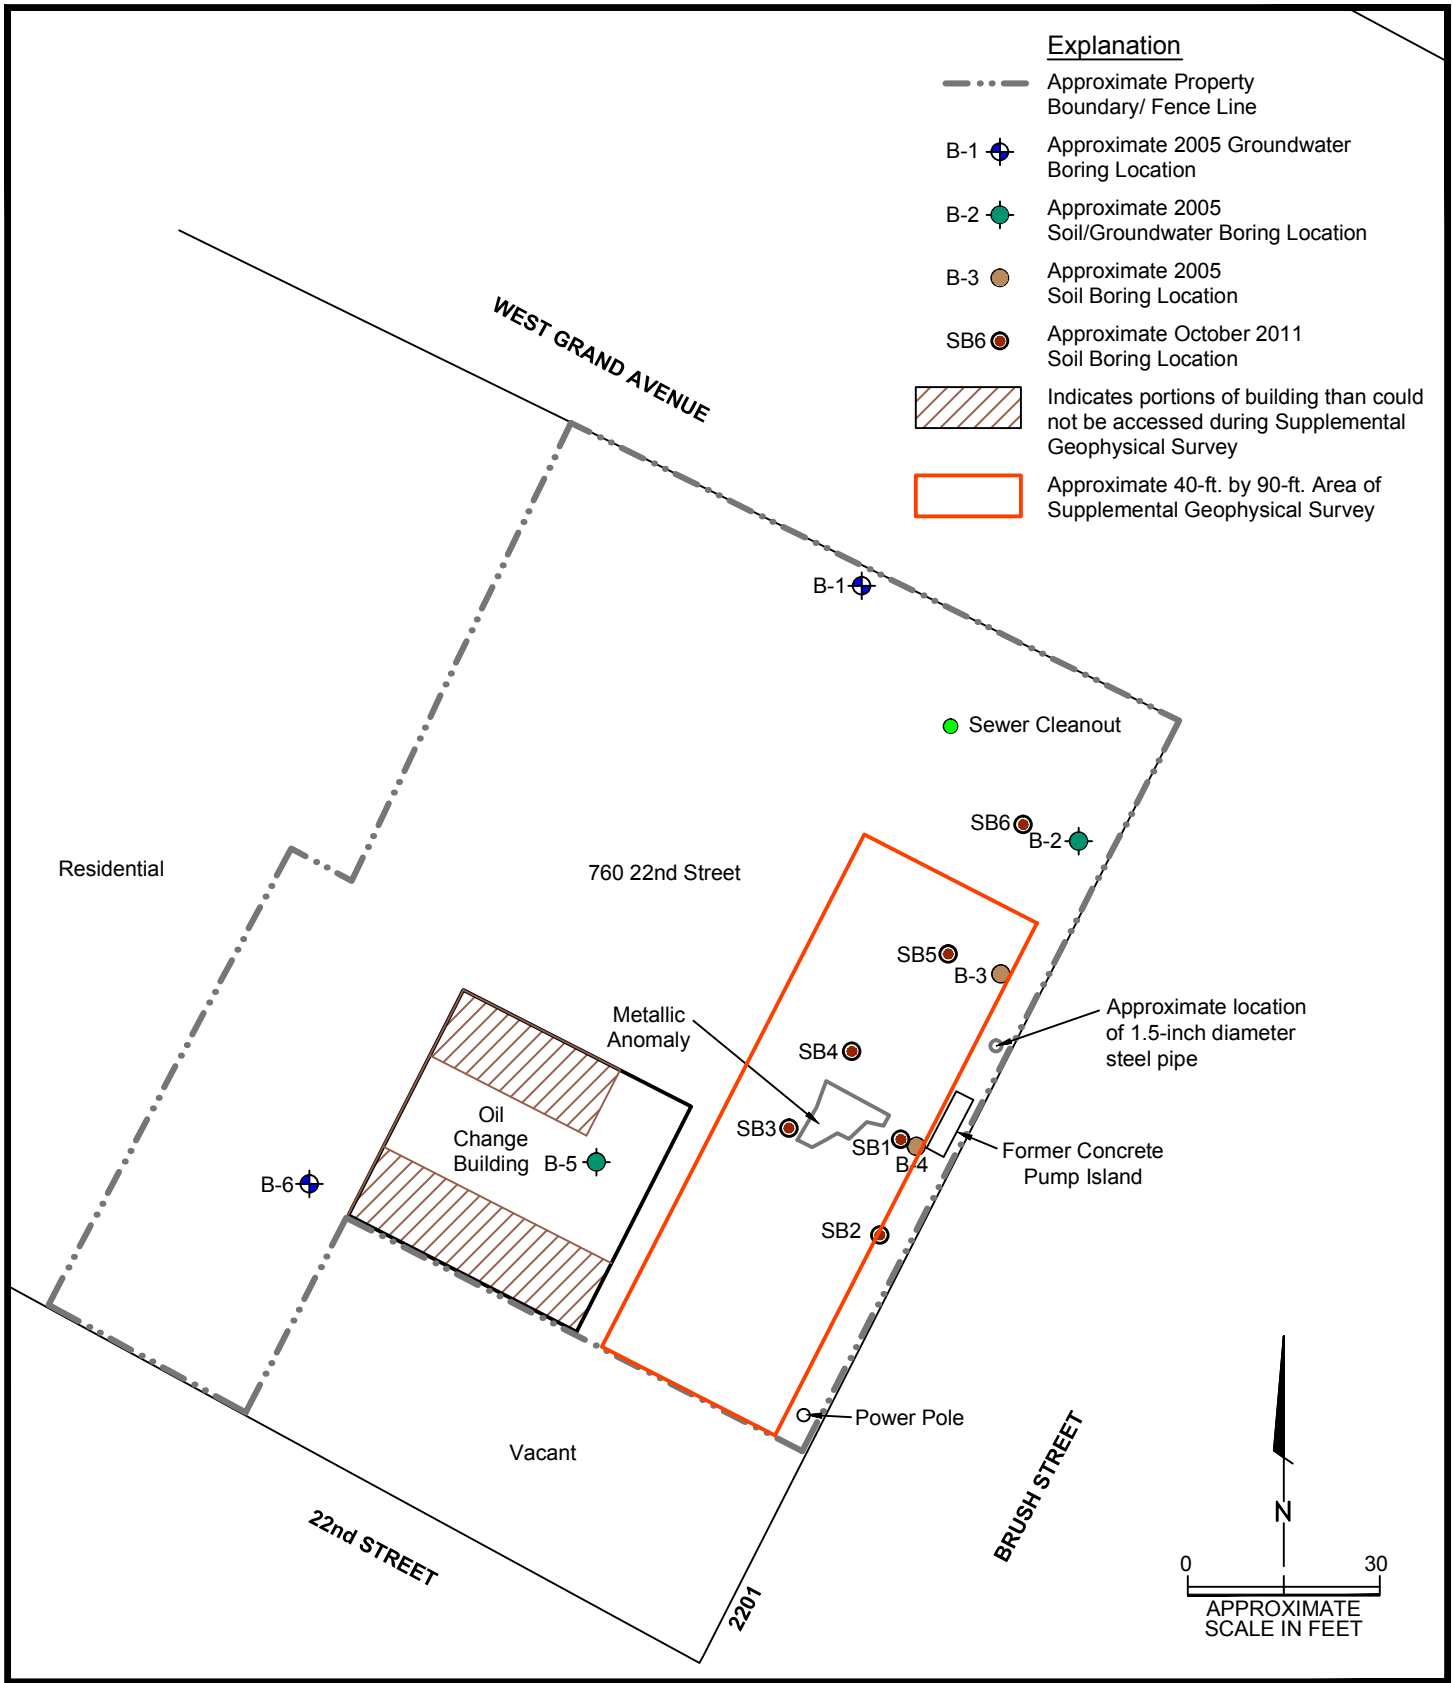
APPENDIX A

- An electric line that runs sub-parallel to Brush Street;
- Two tank vent pipes near the former fuel island; and
- A metallic anomaly located in the same location as the metallic anomaly found during the initial geophysical survey. As shown on the GPR images included in Appendix A, the metallic anomaly appears to be a near surface feature. JR Associates indicated that the metallic anomaly is very shallow and does not extend down vertically and does not appear to be a UST-related feature.

The results of the supplemental geophysical survey do not suggest that a UST(s) or similar metallic feature is present beneath or in the vicinity of the irregularly-shaped metallic anomaly found during both geophysical investigations. Based on the results of the supplemental geophysical survey, JR Associates indicated that the metallic anomaly is very shallow and does not extend vertically significantly beyond the ground surface. In addition, the results of this investigation do not suggest that a UST or similar metallic feature is present beneath the building. The two lines eastern side of the Oil Change Building, both of which extended

into it, were interpreted by JR Associates to be water and electrical lines. In addition no evidence such as vent pipes or other piping potentially associated with former US' was found within accessible portions of the building or in the vicinity of this building during the supplemental geophysical survey.

Based on the results of the supplemental geophysical survey, no addition work is recommended.
