## QUARTERLY STATUS AND GROUNDWATER-QUALITY MONITORING

MARCH 1, 2000 - MAY 31, 2000

208 Jackson Street, Oakland, California

Project No. 9401.114

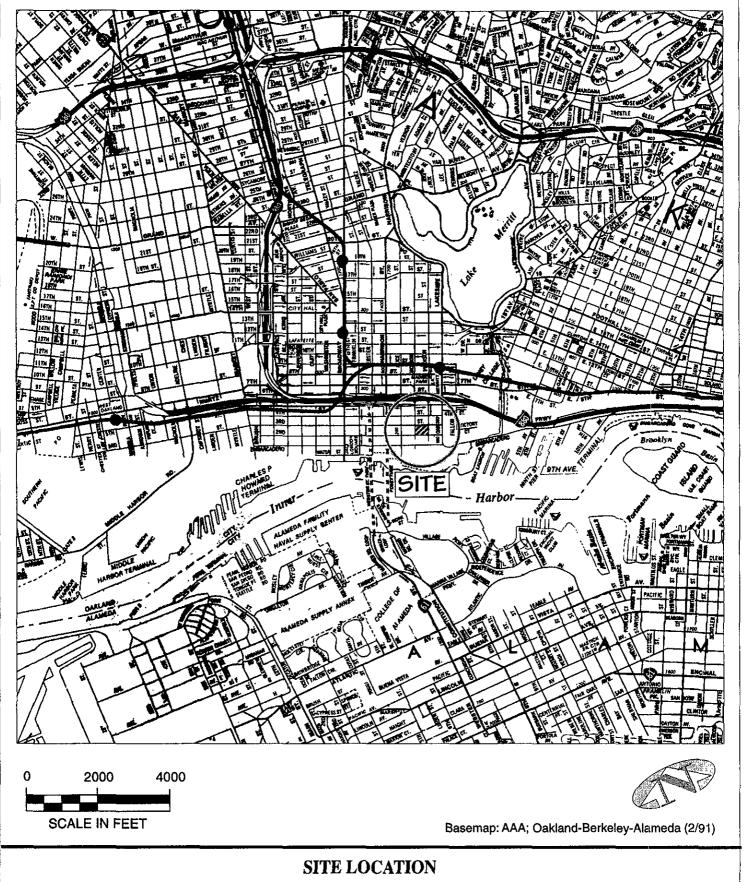
FIG 1 The San Joaquin Company Inc.

The subject property is situated at 208 Jackson Street, Oakland, California. That location is shown on Figure 1. Figure 2 is a site plan showing the location of groundwater-quality monitoring wells that have been installed on the site.
