Re: Second Quarter 2009 Groundwater Monitoring Report
Chevron Service Station 9-8139
16304 Foothill Boulevard
San Leandro, California
LOP Case #RO0000368

SECOND QUARTER 2009 GROUNDWATER MONITORING AND SAMPLING REPORT

RE: Second Quarter Event of May 4, 2009
Groundwater Monitoring & Sampling Report
Chevron Service Station #9-8139
16304 Foothill Boulevard
San Leandro, California

POTENTIOMETRIC MAP
Chevron Service Station #9-8139
16304 Foothill Boulevard
San Leandro, California

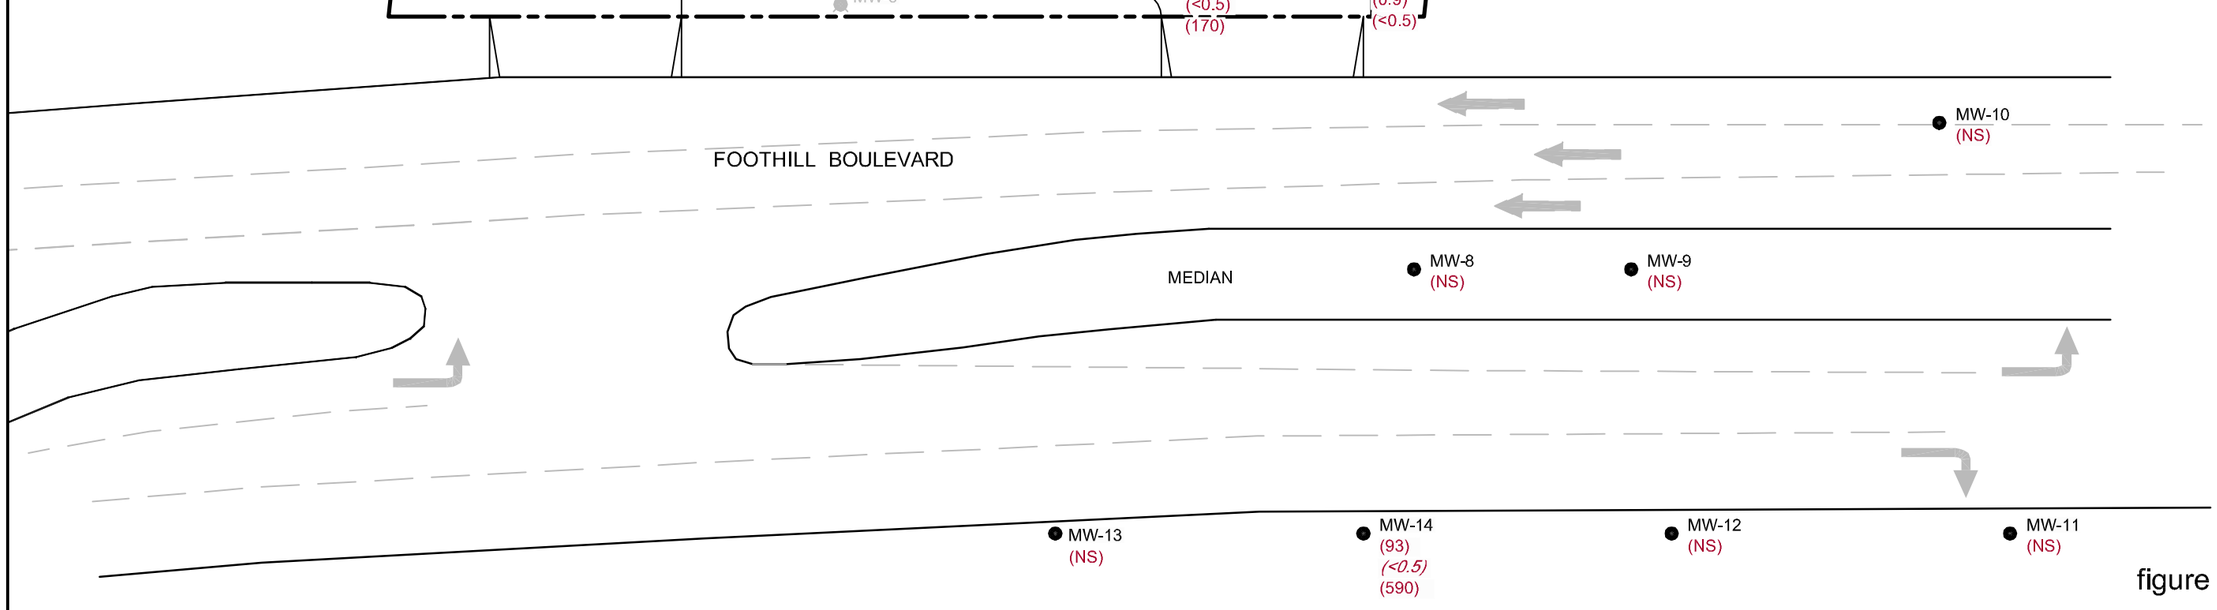
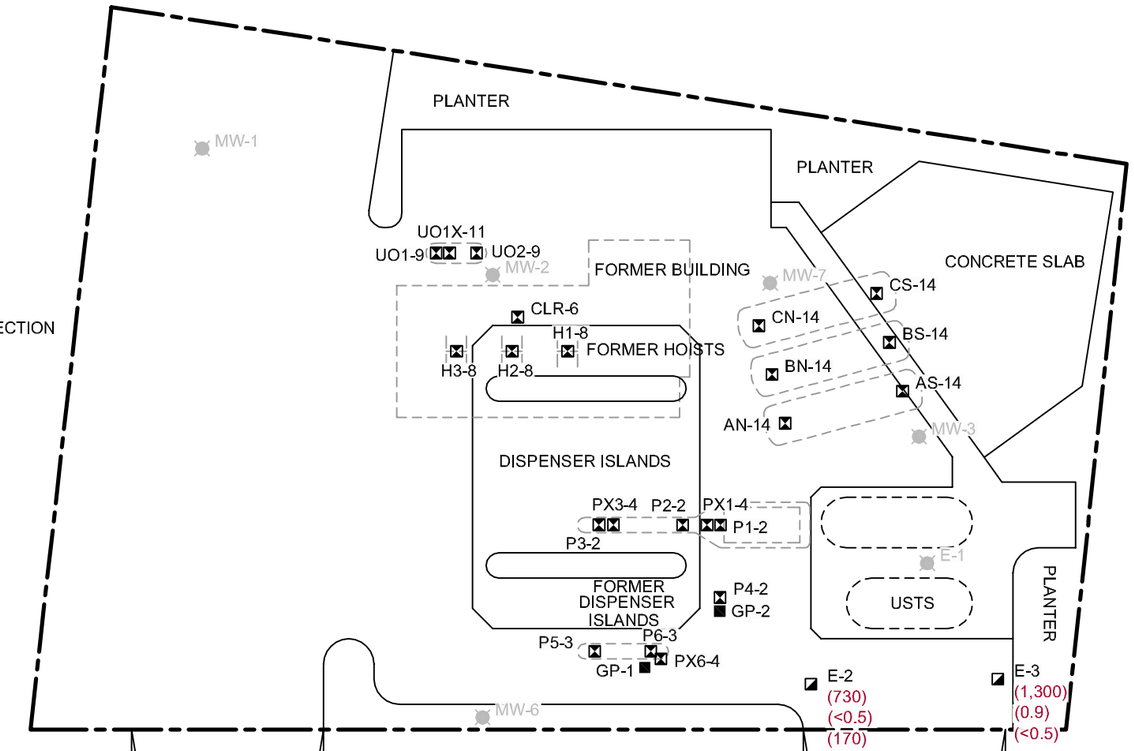
figure 2

CONCENTRATION MAP - MAY 4, 2009
CHEVRON SERVICE STATION 9-8139
16304 FOOTHILL BOULEVARD
San Leandro, California

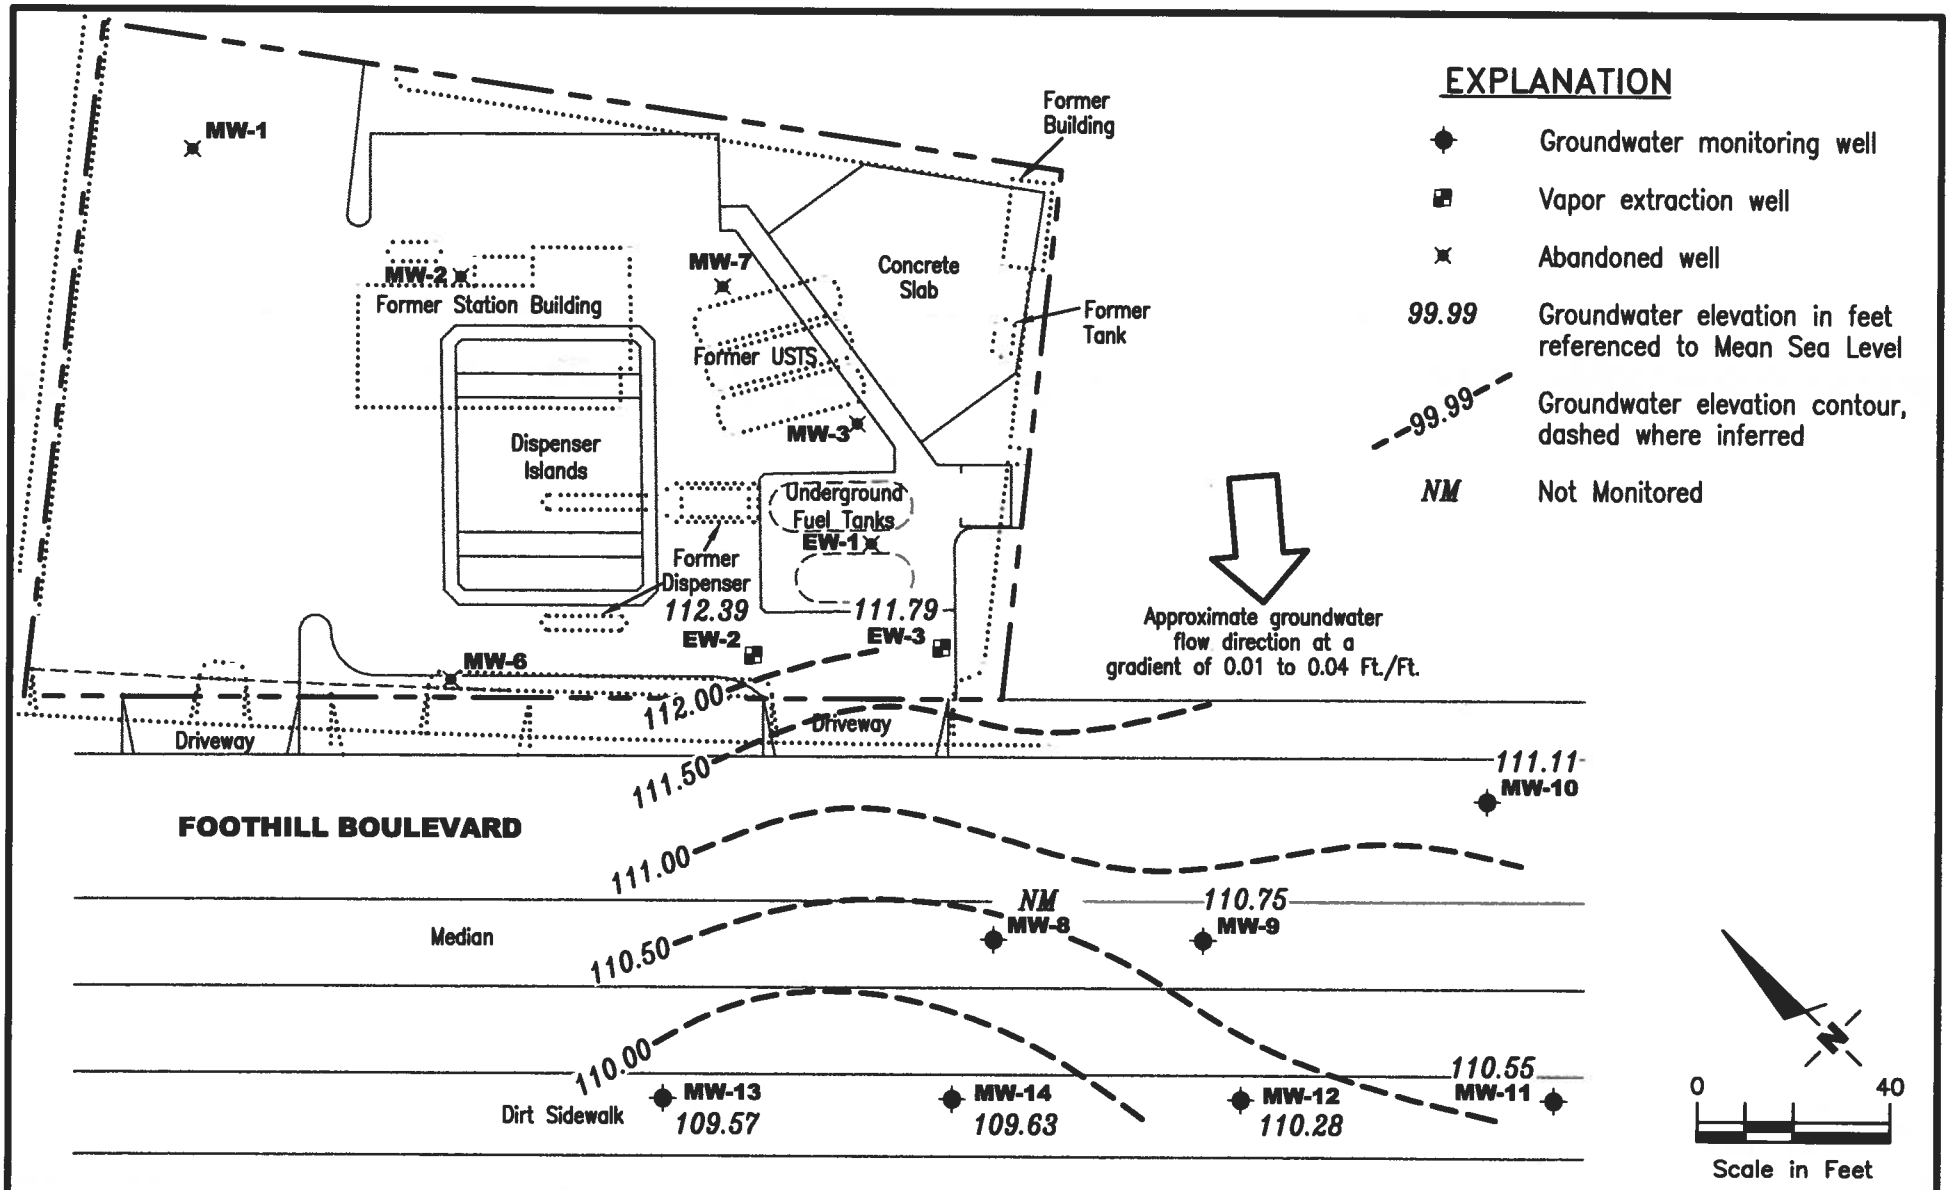
FIGURE
1

Static groundwater levels were measured and the wells were checked for the presence of separate-phase hydrocarbons. Static water level data, groundwater elevations and separate-phase hydrocarbon thickness (if any) are presented in the attached Table 1. A Potentiometric Map is included as Figure 1.
