Groundwater Monitoring Results
First Semi-Annual 2011 Monitoring Period
Cargill Salt – Alameda Facility
Alameda, California

RE: Groundwater Monitoring Results, First Semi-Annual 2011 Monitoring Period, Cargill Salt – Alameda Facility, Alameda, California, SLIC Case No. RO0002480

Project No. CS1605
May 11, 2011

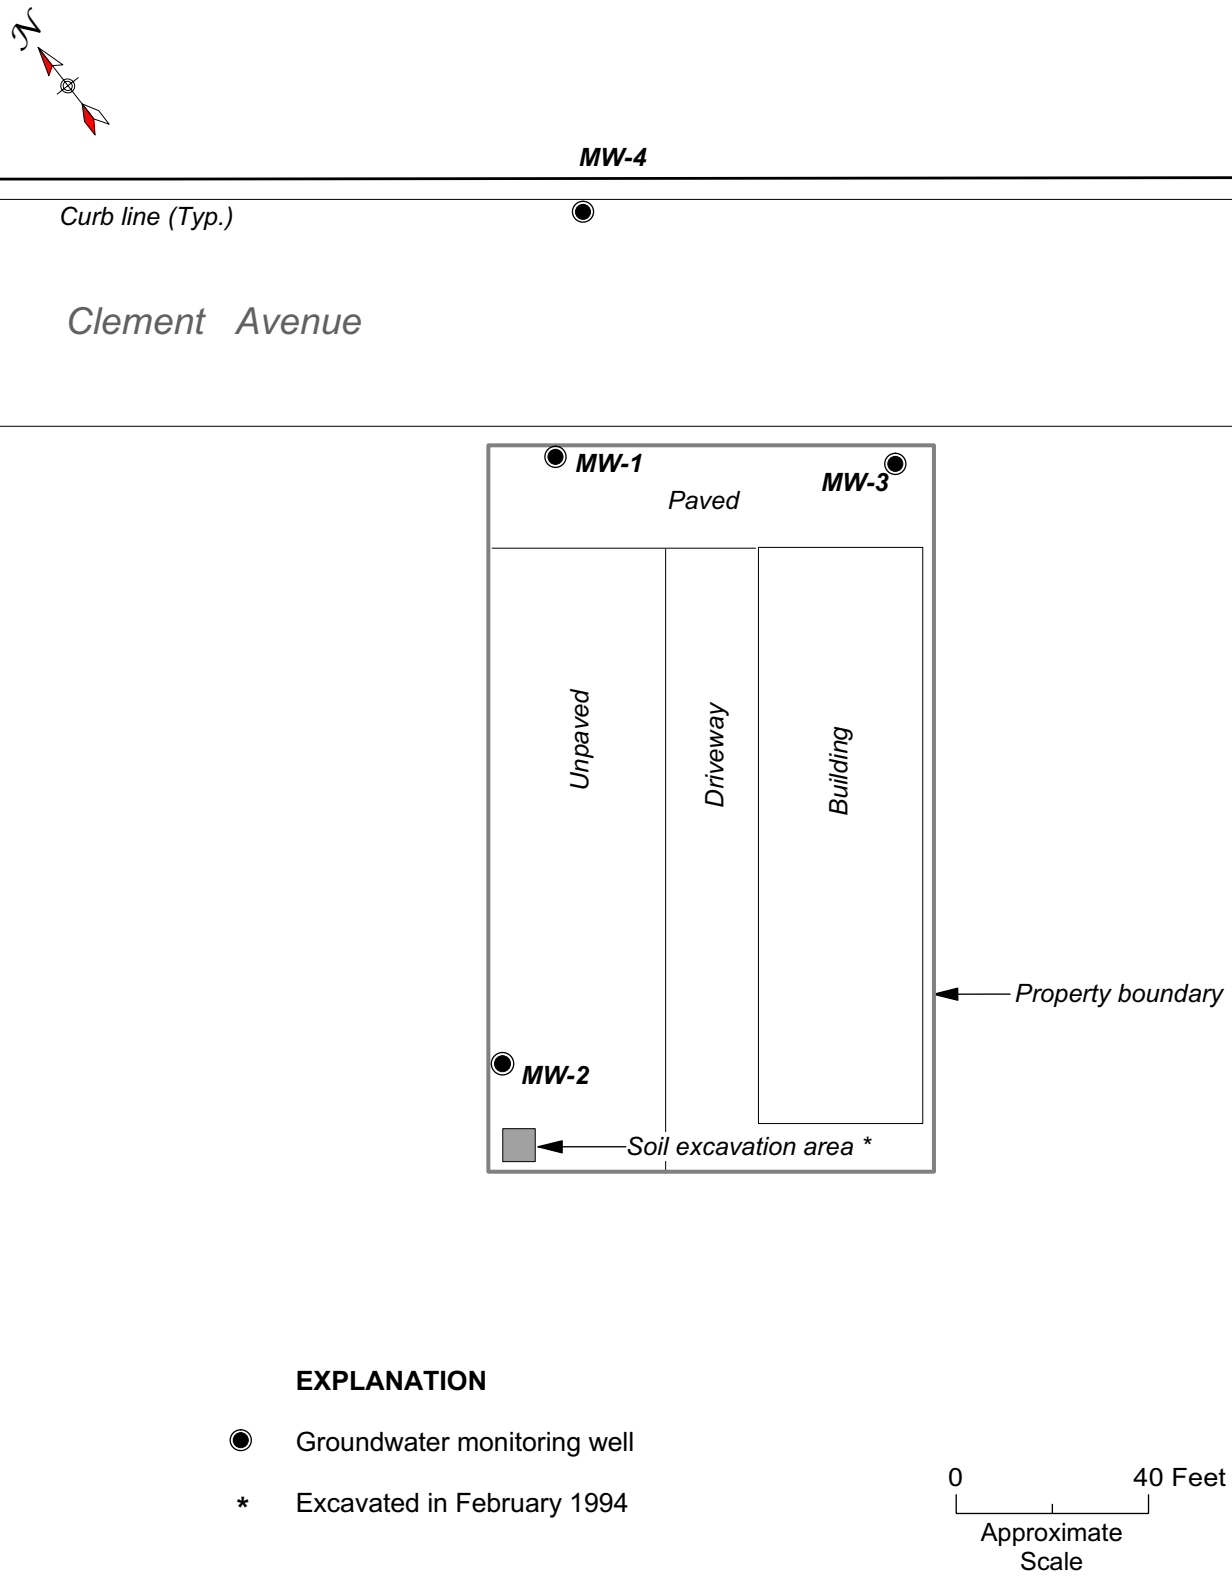
Project No. CS1605
Cargill Salt Dispensing Systems Division
2016 Clement Avenue, Alameda, California
Figure 2. Groundwater Monitoring Well Locations

After approval of the workplan by ACEHS, Cargill Salt conducted several phases of soil remediation and groundwater characterization. Surficial soils impacted by metals were excavated for disposal off site. Vadose-zone soils with the highest degree of impact by VOCs were also excavated for off-site disposal (see "Soil excavation area" on Figure 2).

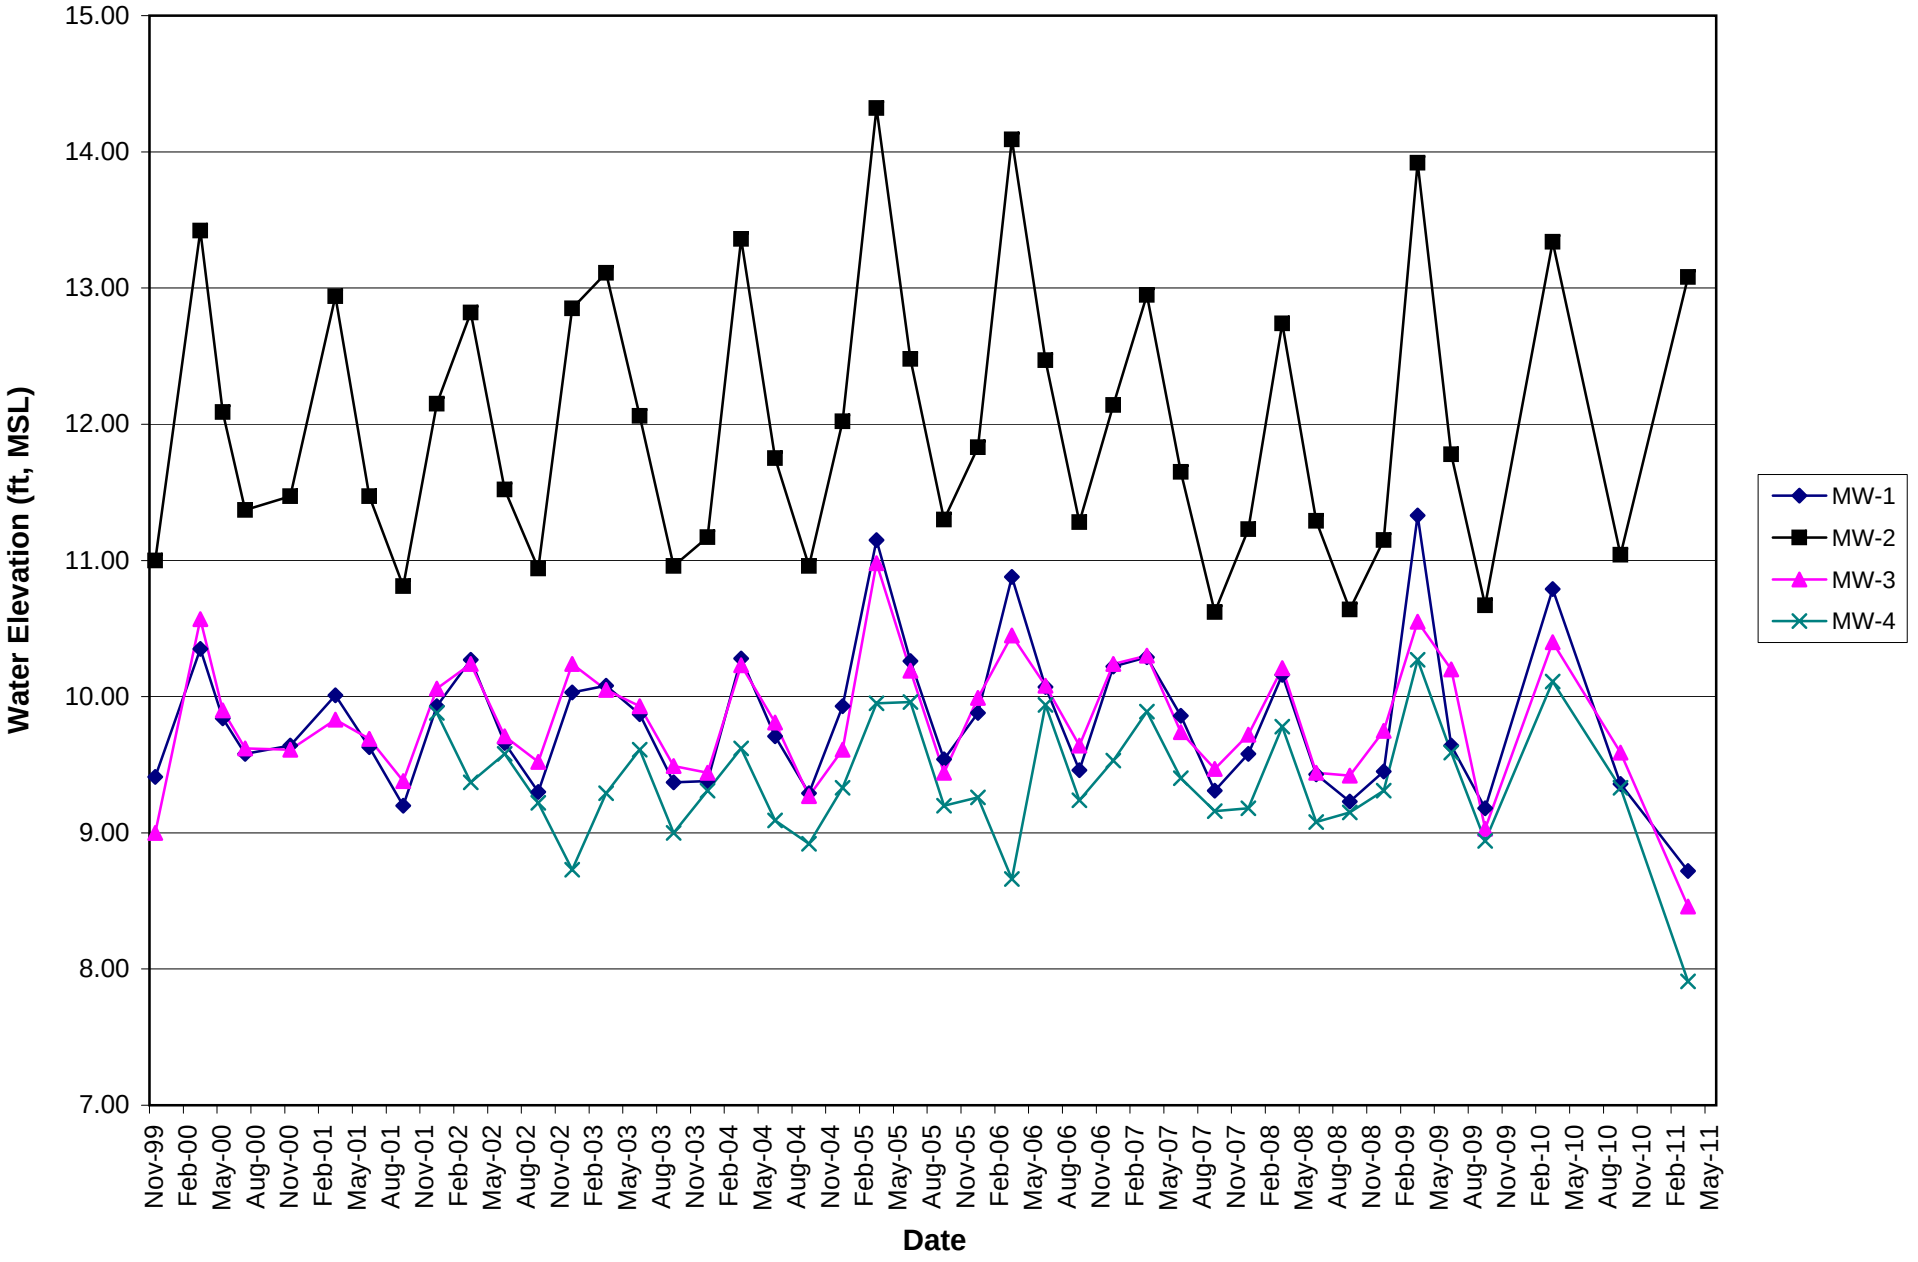
Figure 3. Graphical Summary of Groundwater Elevations

The water-level data through the first quarter of 2011 are shown on Table 1. The data in Table 1 include the date and time of measurement, the well casing elevation, the measured depth to groundwater, the groundwater elevation, and the change in elevation from the previous measurement. A plot of historical groundwater elevations is shown in Figure 3.

Groundwater levels in the on-site monitoring wells (MW-1, MW-2, and MW-3) and off-site well (MW-4) showed a different seasonal pattern in the first quarter of 2011 than the general pattern for the previous nine years (see Figure 3). Groundwater levels in all four wells generally exhibit similar seasonal fluctuations, and the first quarter groundwater elevations have typically exhibited effects of winter-season recharge. The groundwater elevation recorded in March 2011 for MW-2 was 2.0 feet higher than that recorded in September 2010, but the groundwater elevations recorded for MW-1, MW-3, and MW-4 were 0.6, 1.1, and 1.4 feet lower, respectively, in March 2011 than in September 2010. The March 2011 groundwater elevations recorded for these three wells were the lowest recorded to date. The reason for this atypical behavior is unknown and it is suspected that there was an artificial dewatering operation downgradient of the site that caused the lower than typical groundwater elevations recorded for wells MW-1, MW-3, and MW-4.

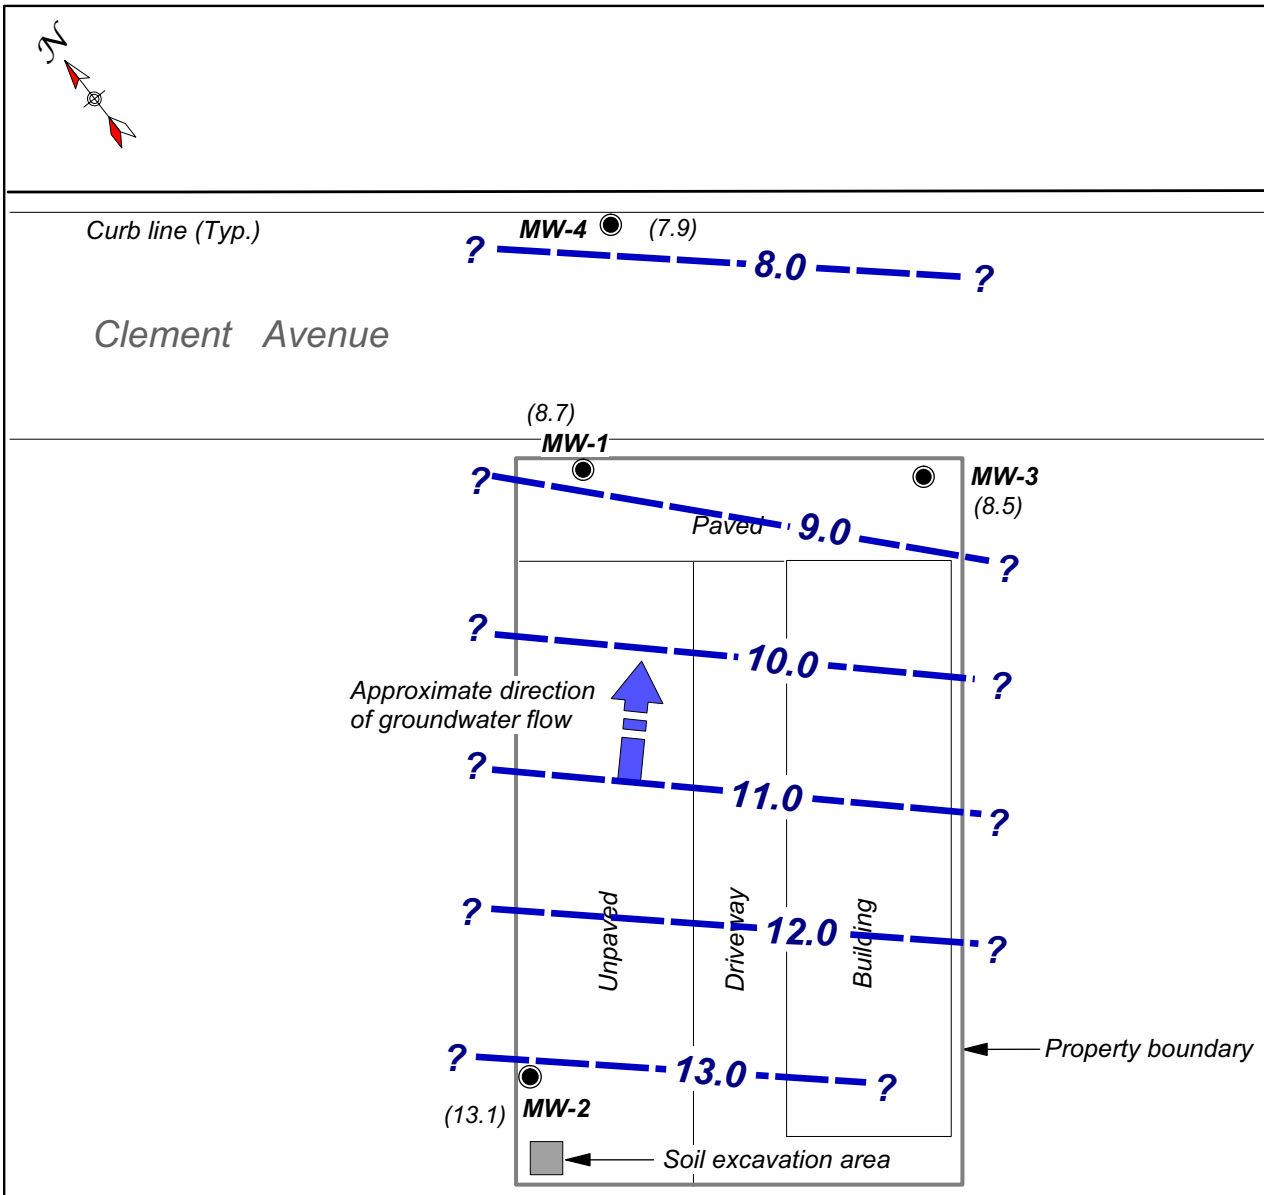
Project No. CS1605
Cargill Salt Dispensing Systems Division
2016 Clement Avenue, Alameda, California
Figure 4. Groundwater Elevation Contours - March 2011

A groundwater contour map based on the March 2011 water-level data is shown on Figure 4.

The groundwater flow direction determined for the first quarter of 2011 was to the northeast, consistent with the flow direction previously determined for the Site. The horizontal hydraulic gradient measured for the first quarter of 2011 was 0.035, the highest horizontal hydraulic gradient determined to date for the Site (highest previously recorded was 0.030). This is related to the atypically low groundwater elevations recorded for three of the wells at the Site, as discussed in Section 2.1 above.

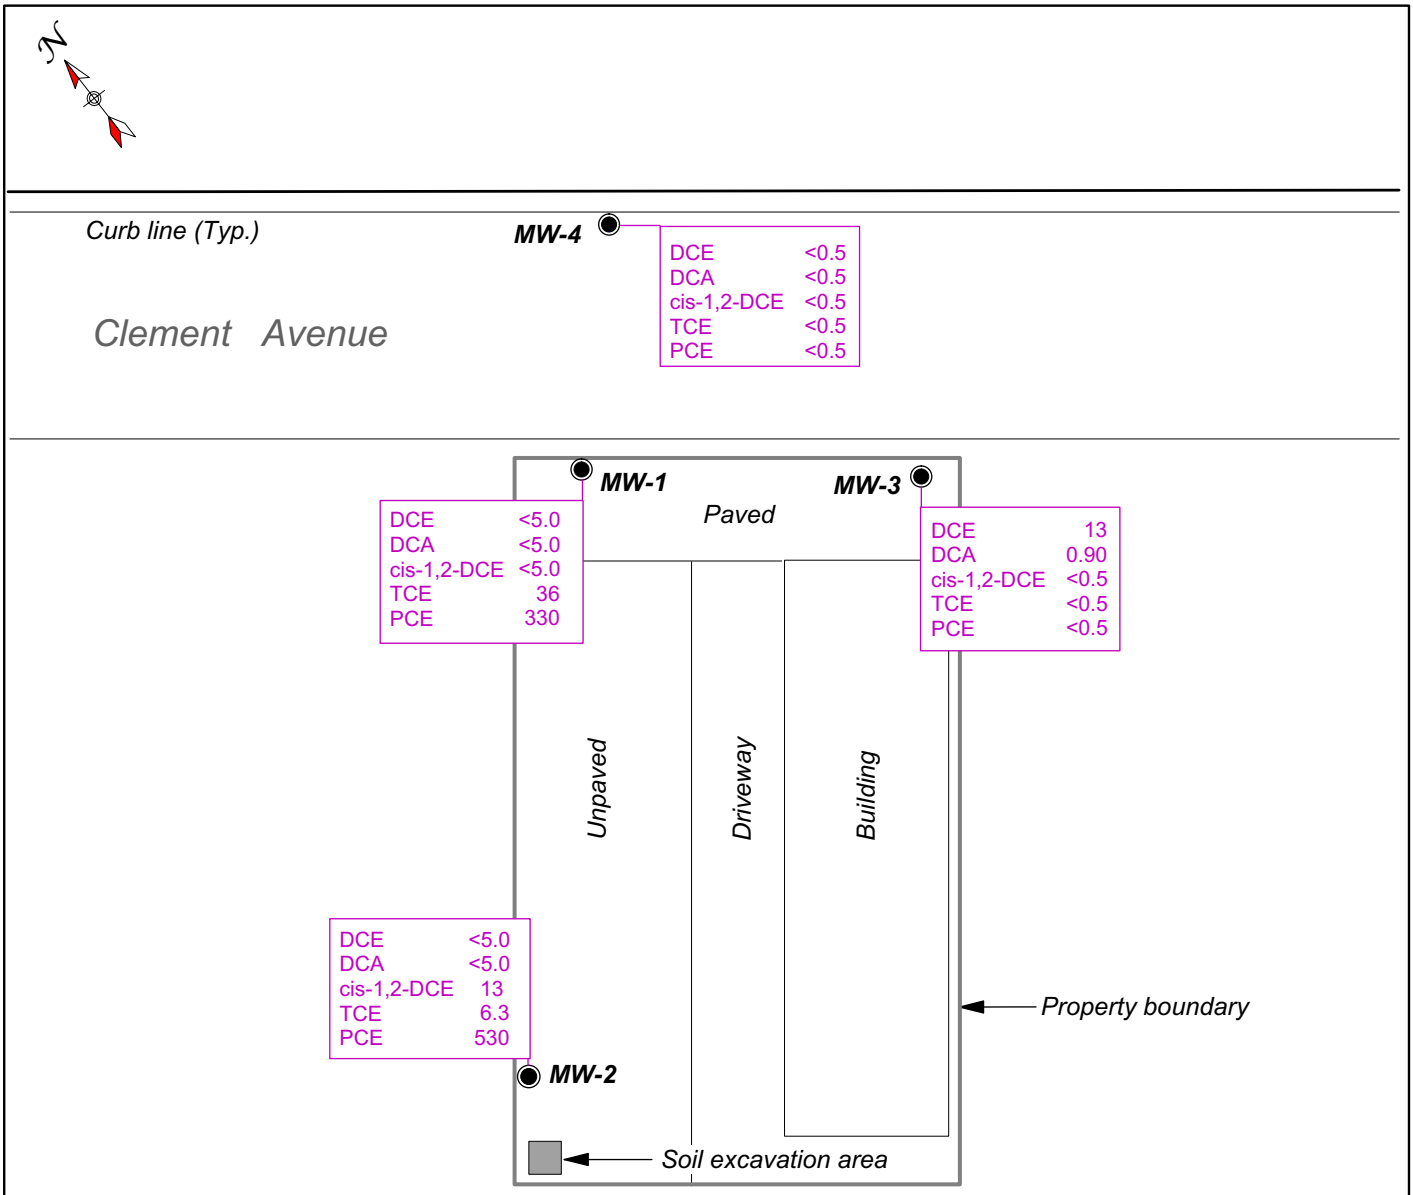
Project No. CS1605
Cargill Salt Dispensing Systems Division
2016 Clement Avenue, Alameda, California
Figure 5. VOC Concentrations in Groundwater – March 2011

The results for the first semi-annual 2011 monitoring event are shown on Table 3a and Figure 5. The results of historical VOC analyses for each quarter for 2000 through first quarter 2011 are summarized in Table 3b, which also shows the VOC results for the initial sampling event for monitoring wells MW-1, MW-2, and MW-3 in November 1999. Historical VOC results for all the wells are plotted on Figure 6.

For the first semi-annual 2011 event, the concentrations of PCE detected were:

- 330 micrograms per liter (μg/L) in monitoring well MW-1
- 530 μg/L in MW-2

- not detected in MW-3
- not detected in MW-4.

TCE was detected at 36 µg/L in monitoring well MW-1 and 6.3 µg/L in MW-2, but was not detected in MW-3 or MW-4.

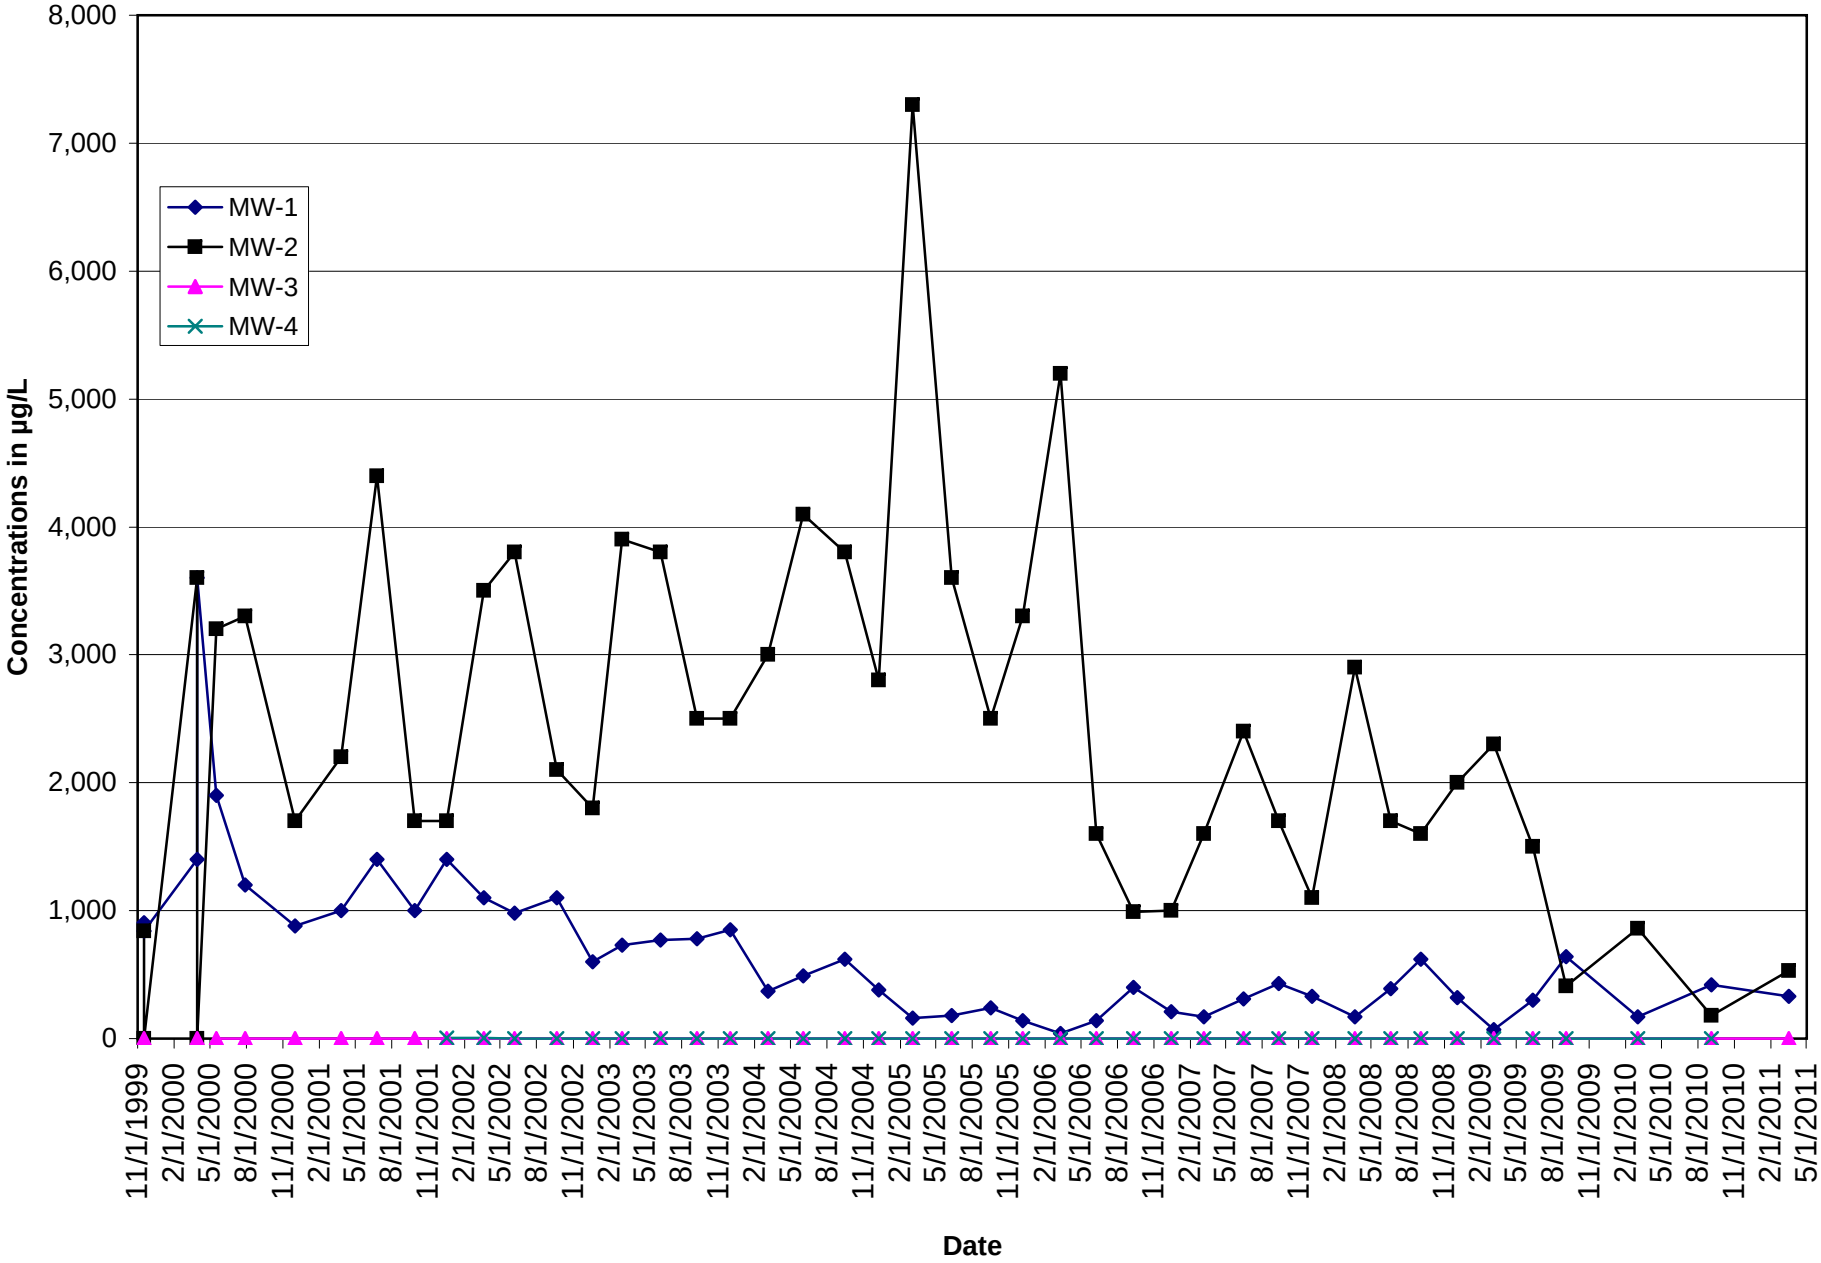
Figure 6. Graphical Summary of PCE Concentrations

The results for VOC concentrations reported for the first semi-annual 2011 quarterly monitoring event are generally similar to the results reported since the second quarter of 2006 (see Figure 6), with the following notable exceptions:

- The concentrations of PCE reported for well MW-2 during the last four events are the four lowest consecutive values ever reported for MW-2.

Continued monitoring will be required to assess the effectiveness of the phytoremediation project in further reducing the PCE concentrations in groundwater.

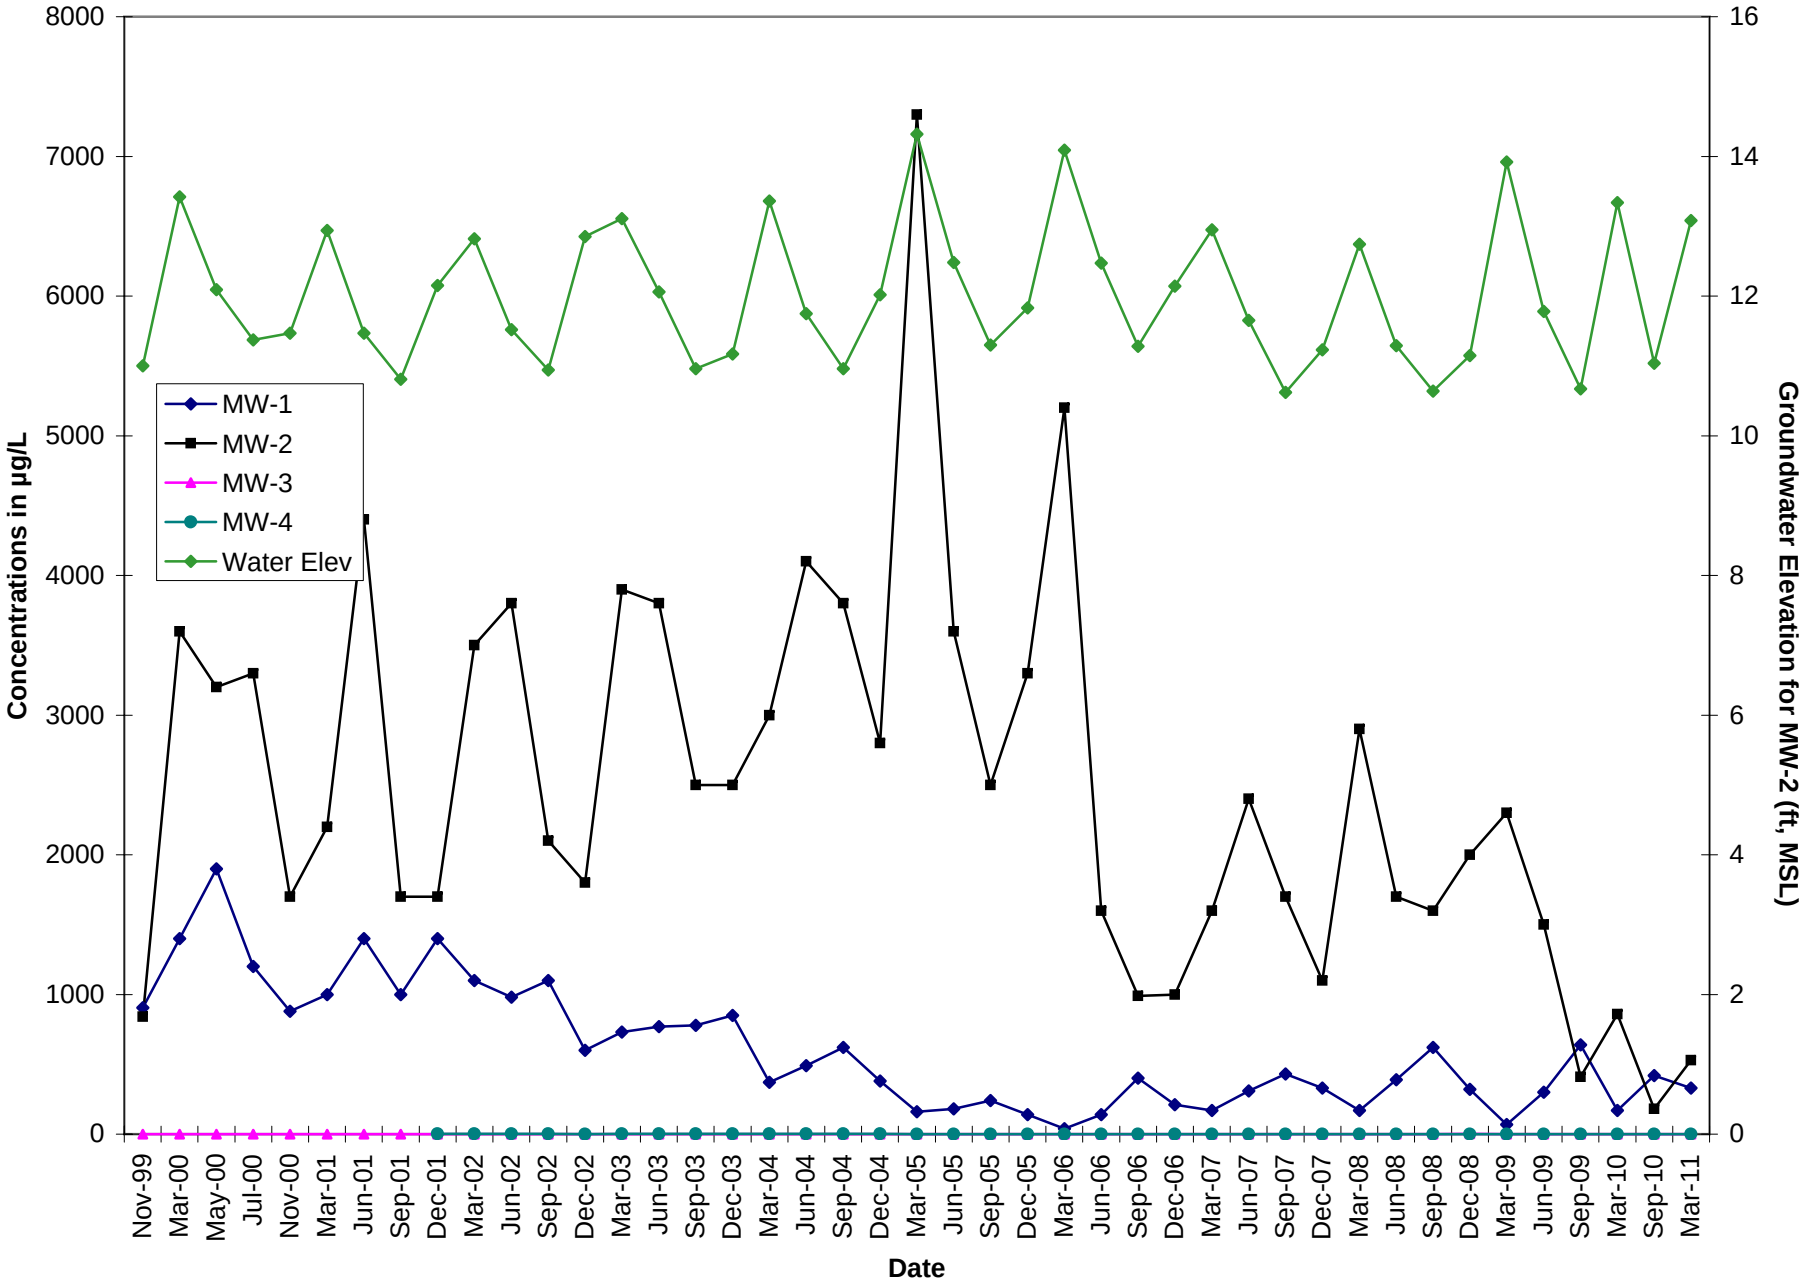
Figure 7. PCE Concentrations vs. Groundwater Elevation

Variations in VOC concentrations at monitoring well MW-2, the well with historically the highest reported PCE concentrations at the site, generally correlate with variations in groundwater elevations at the Site. An increase in VOC concentrations generally follows a rise in groundwater elevations, and a decrease in VOC concentration generally follows a fall in groundwater levels (see Figure 7). The variations in VOC concentrations sometimes lag one quarter behind the variations in groundwater elevation.
