FOLLOW-UP GROUND WATER TESTING  
CLARK'S HOME & GARDEN  
23040 CLAWITER ROAD  
HAYWARD, CALIFORNIA

PROJECT 4983

TERRATECH, INC.  
1365 Vander Way  
San Jose, California 95112

November 1991

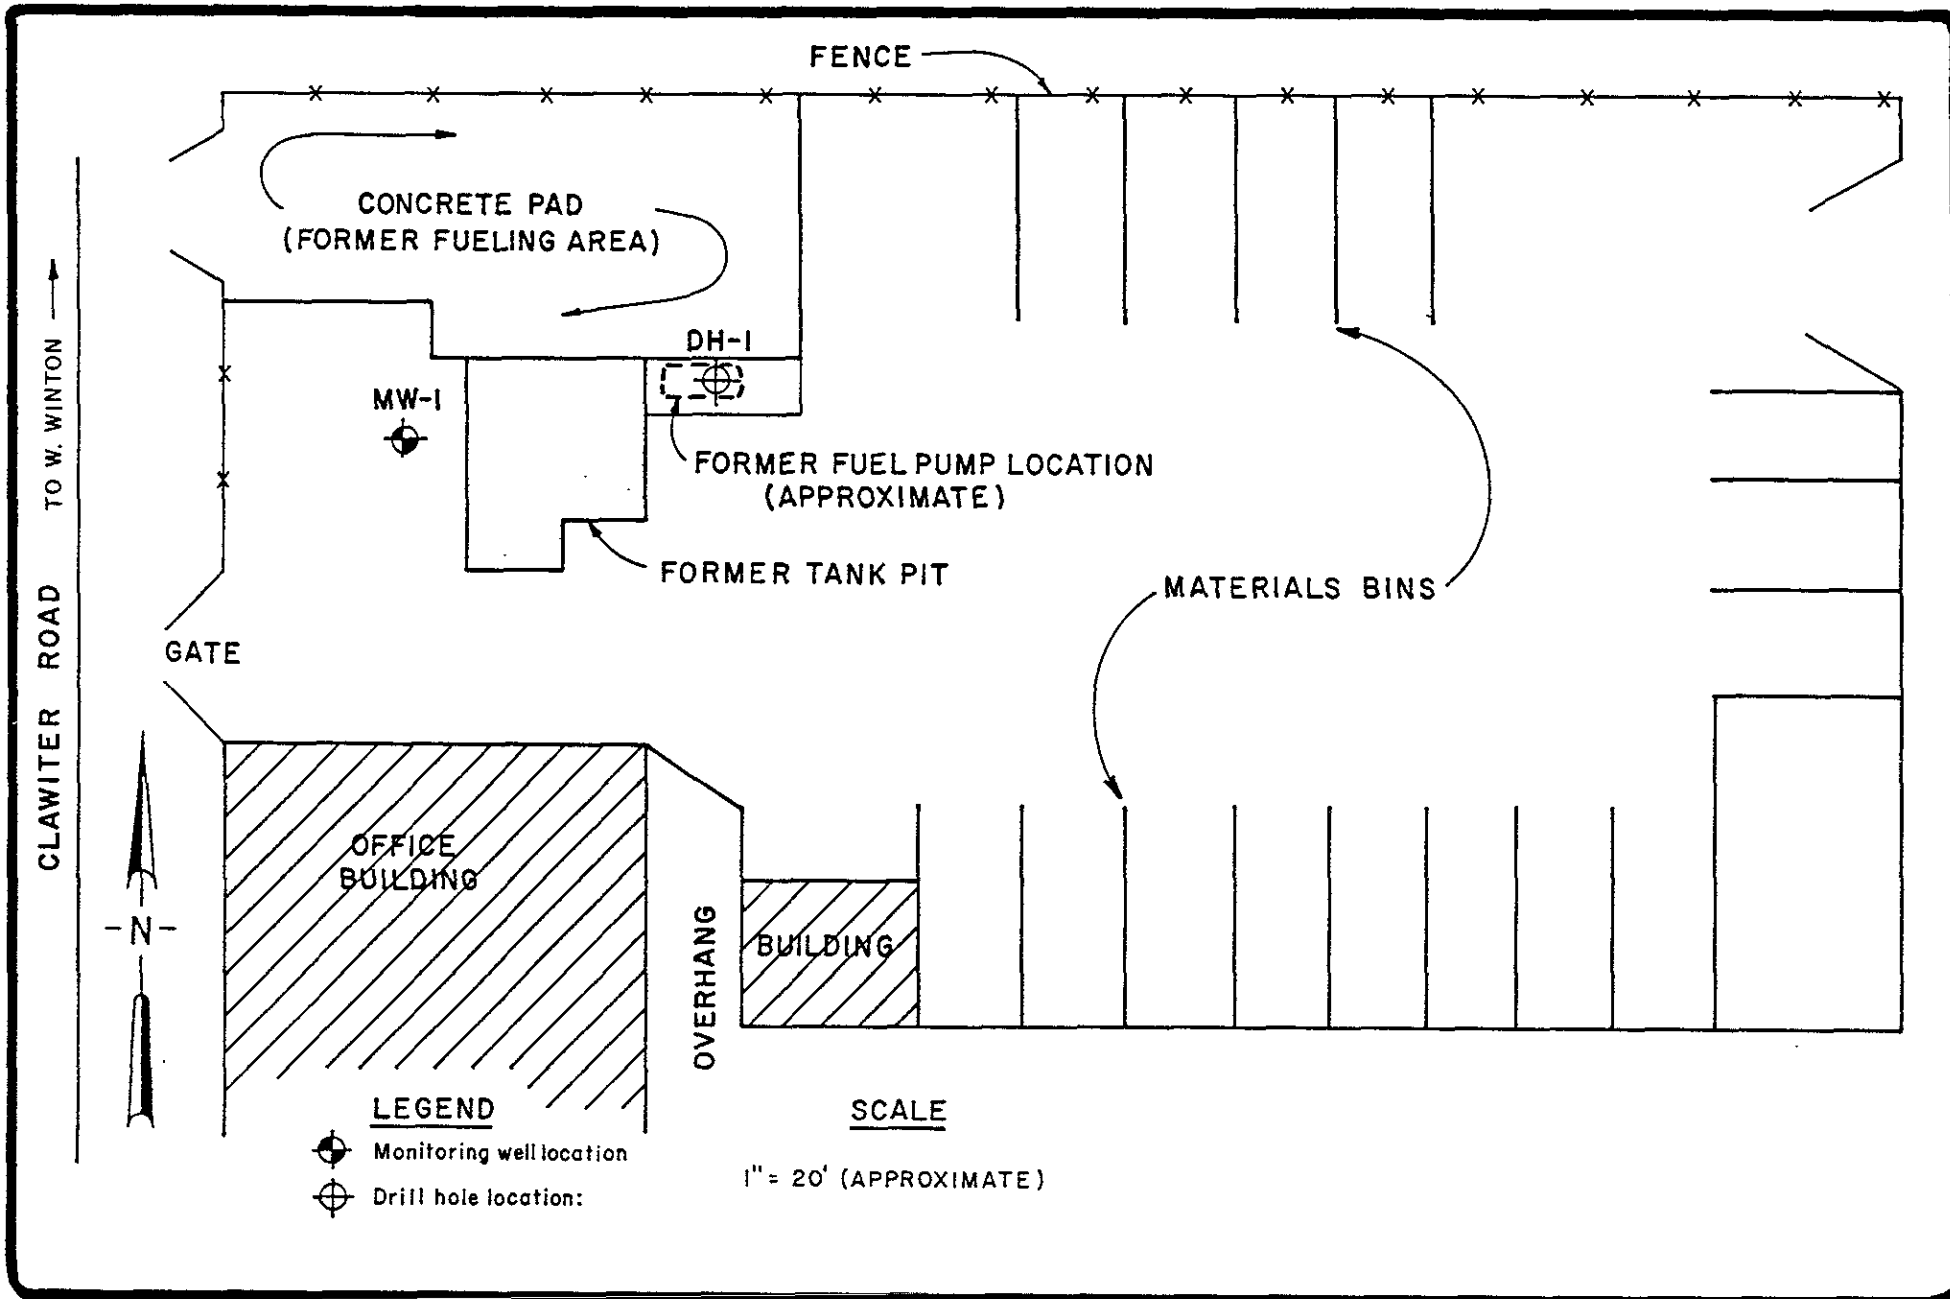
CLARK'S HOME AND GARDEN  
23040 CLAWITER ROAD  
HAYWARD, CALIFORNIA

This report describes the work performed and the findings from Terratech's recent testing of the shallow ground water at 23040 Clawiter Road in Hayward (see Figures 1 and 2). The work is being performed according to the requirements of the Alameda County Health Agency (ACHA) as follow-up to a fuel leak discovered when two underground storage tanks were removed from the site in 1988.
