Semiannual Groundwater Monitoring Report
Fall 2001

Kawahara Nursery
16550 Ashland Avenue
San Lorenzo, California
Site # 4403

January 11, 2002 BEI Job No. 94015

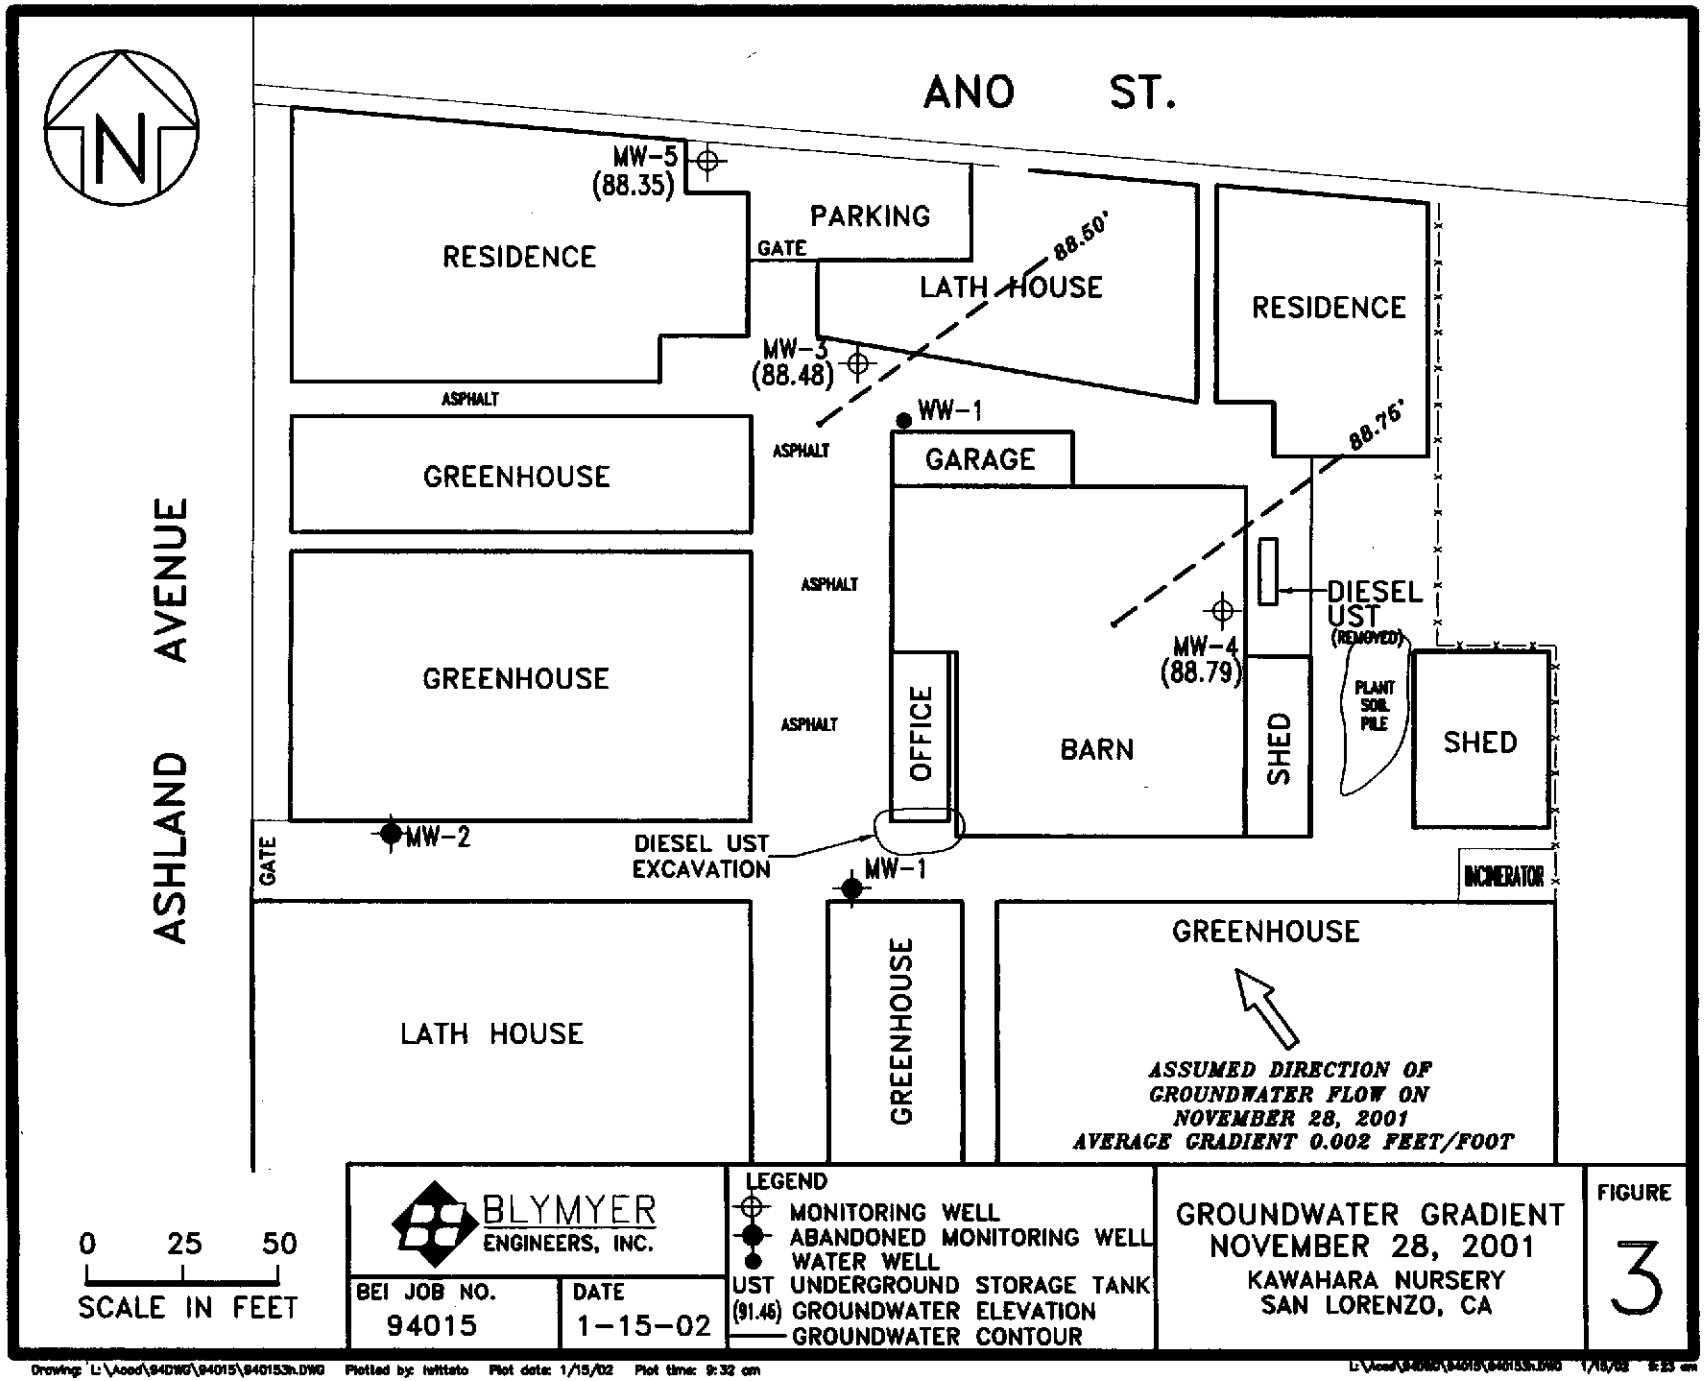
Table I and Figure 3 present groundwater gauging data collected on November 28, 2001. The depth to groundwater ranged from 9.79 feet below the top of casing (BTOC) in monitoring well MW-5 to 11.67 feet BTOC in MW-4. The depth to groundwater has increased an average of 1.45 feet since the previous monitoring event. The average groundwater gradient was 0.002 feet/foot. The direction of groundwater flow could not be conclusively determined based on the linear configuration of the wells. However, the gradient is likely to be directed toward the northwest based on the consistent historic flow direction documented at the site.

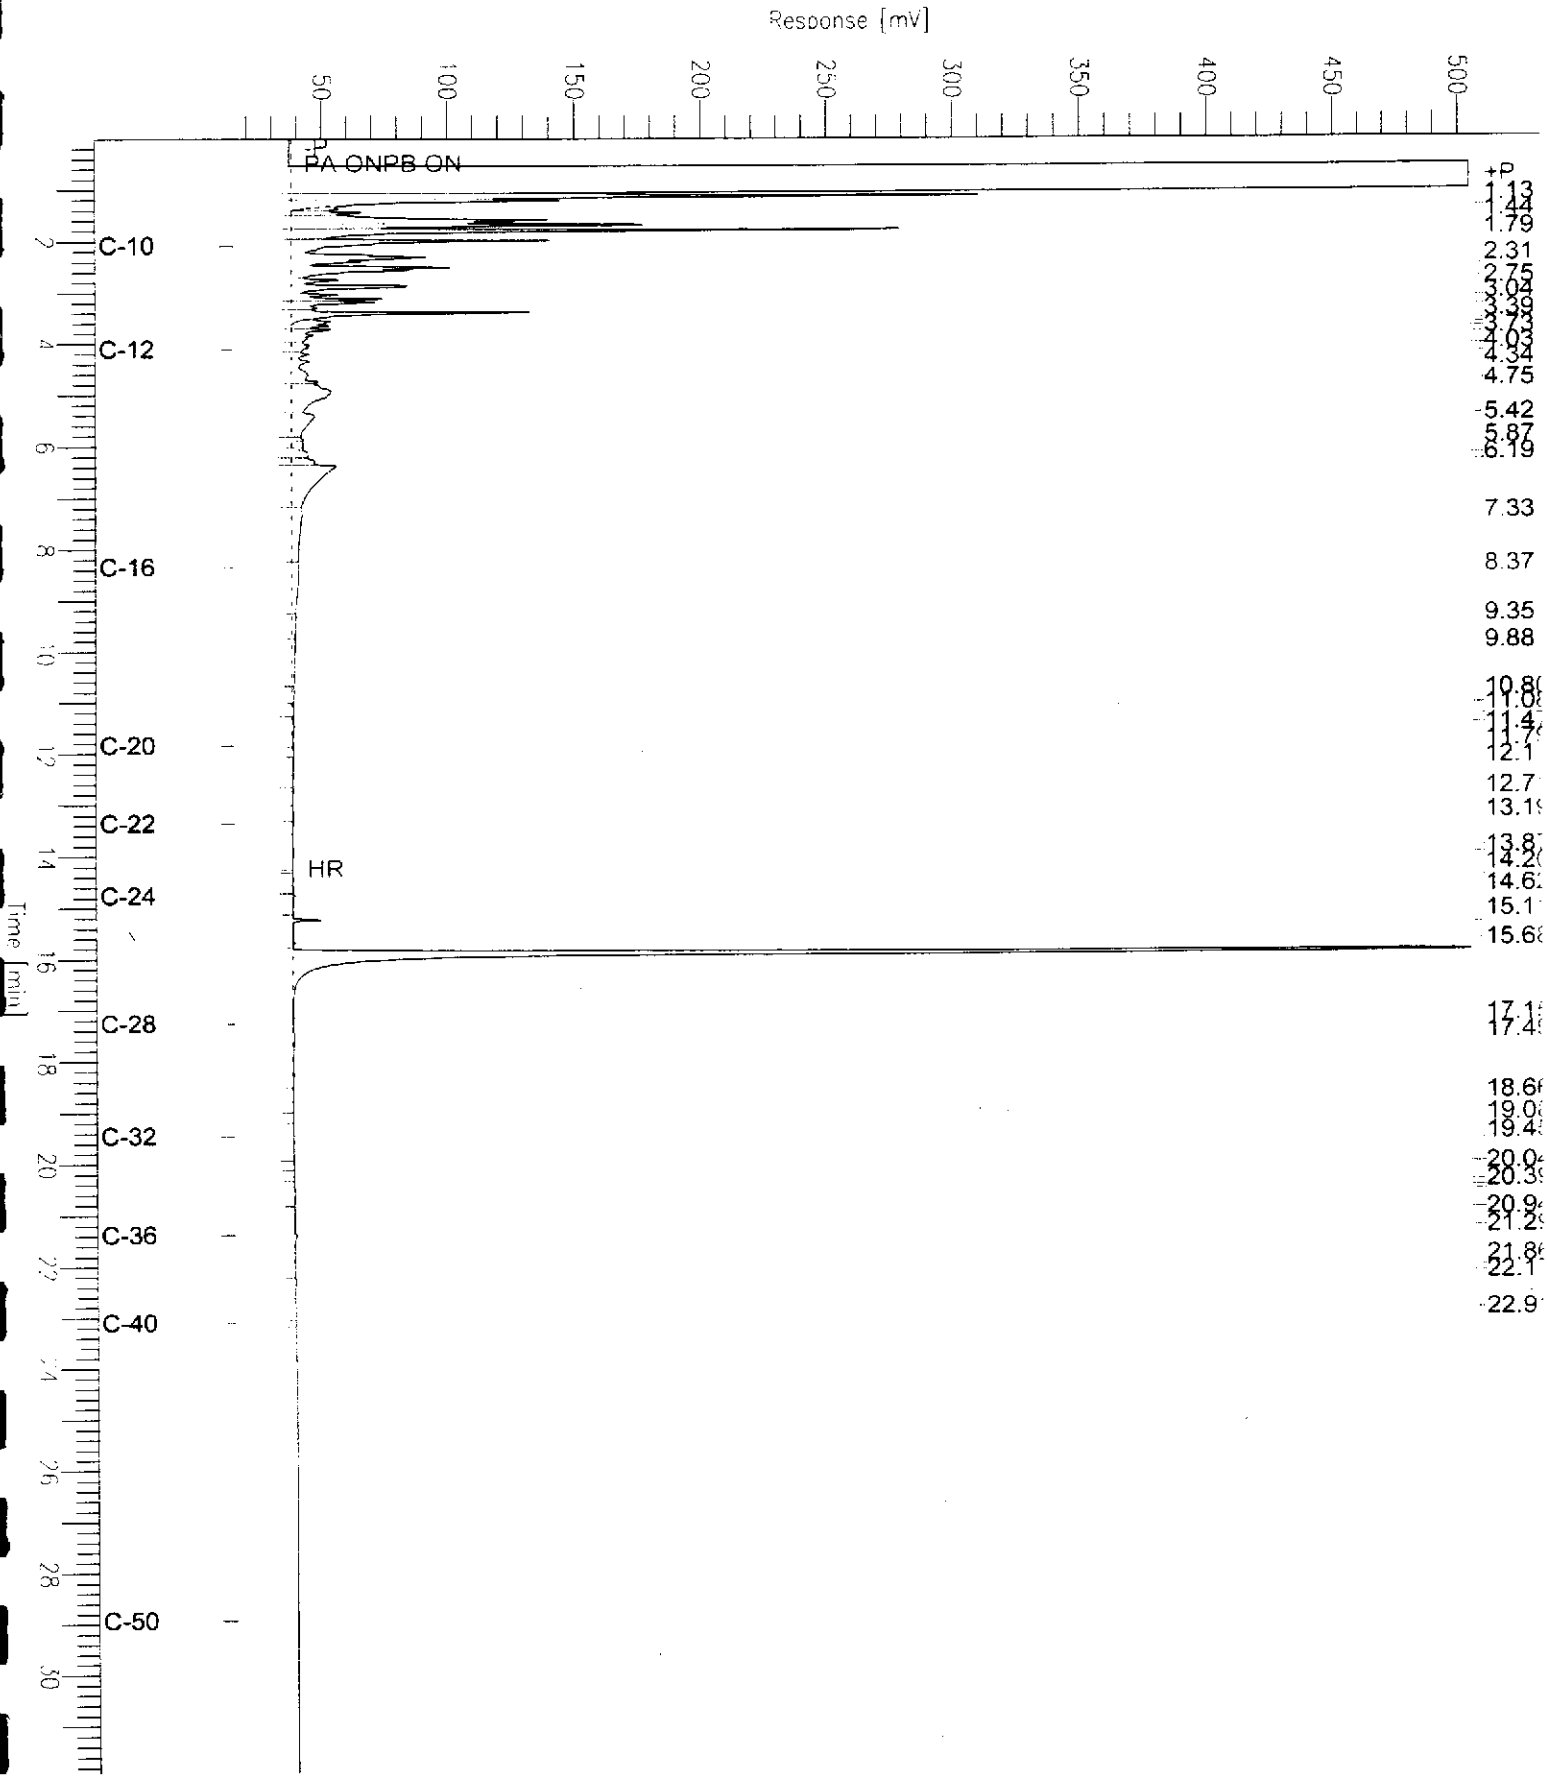
Chromatogram

The laboratory again included copies of the diesel and gasoline chromatograms for the TPH analysis for well MW-3. Notes contained in the report indicate that the chromatogram for TPH as diesel did not match the standard for diesel (included in the report) and that a lighter hydrocarbon contributed to the quantitation. No notes were included with the analysis for TPH as gasoline, documenting the laboratory opinion that the detected compound was composed predominantly of gasoline.

- The analytical laboratory has continued to strongly indicate with the use of chromatograms that TPH as diesel is not present in any of the groundwater samples. This has not varied in six consecutive monitoring events. Blymyer continues to recommend elimination of the laboratory analysis for TPH as diesel at the site.
