FOURTEENTH QUARTERLY GROUNDWATER MONITORING REPORT UNOCAL 76 SERVICE STATION 20405 AND 20629 REDWOOD ROAD CASTRO VALLEY, CALIFORNIA JANUARY 1994

January 31, 1994

BSK JOB P92057.3

Subject: Fourteenth Quarterly Groundwater Monitoring Report
Unocal 76 Service Station
20405 and 20629 Redwood Road
Castro Valley, California

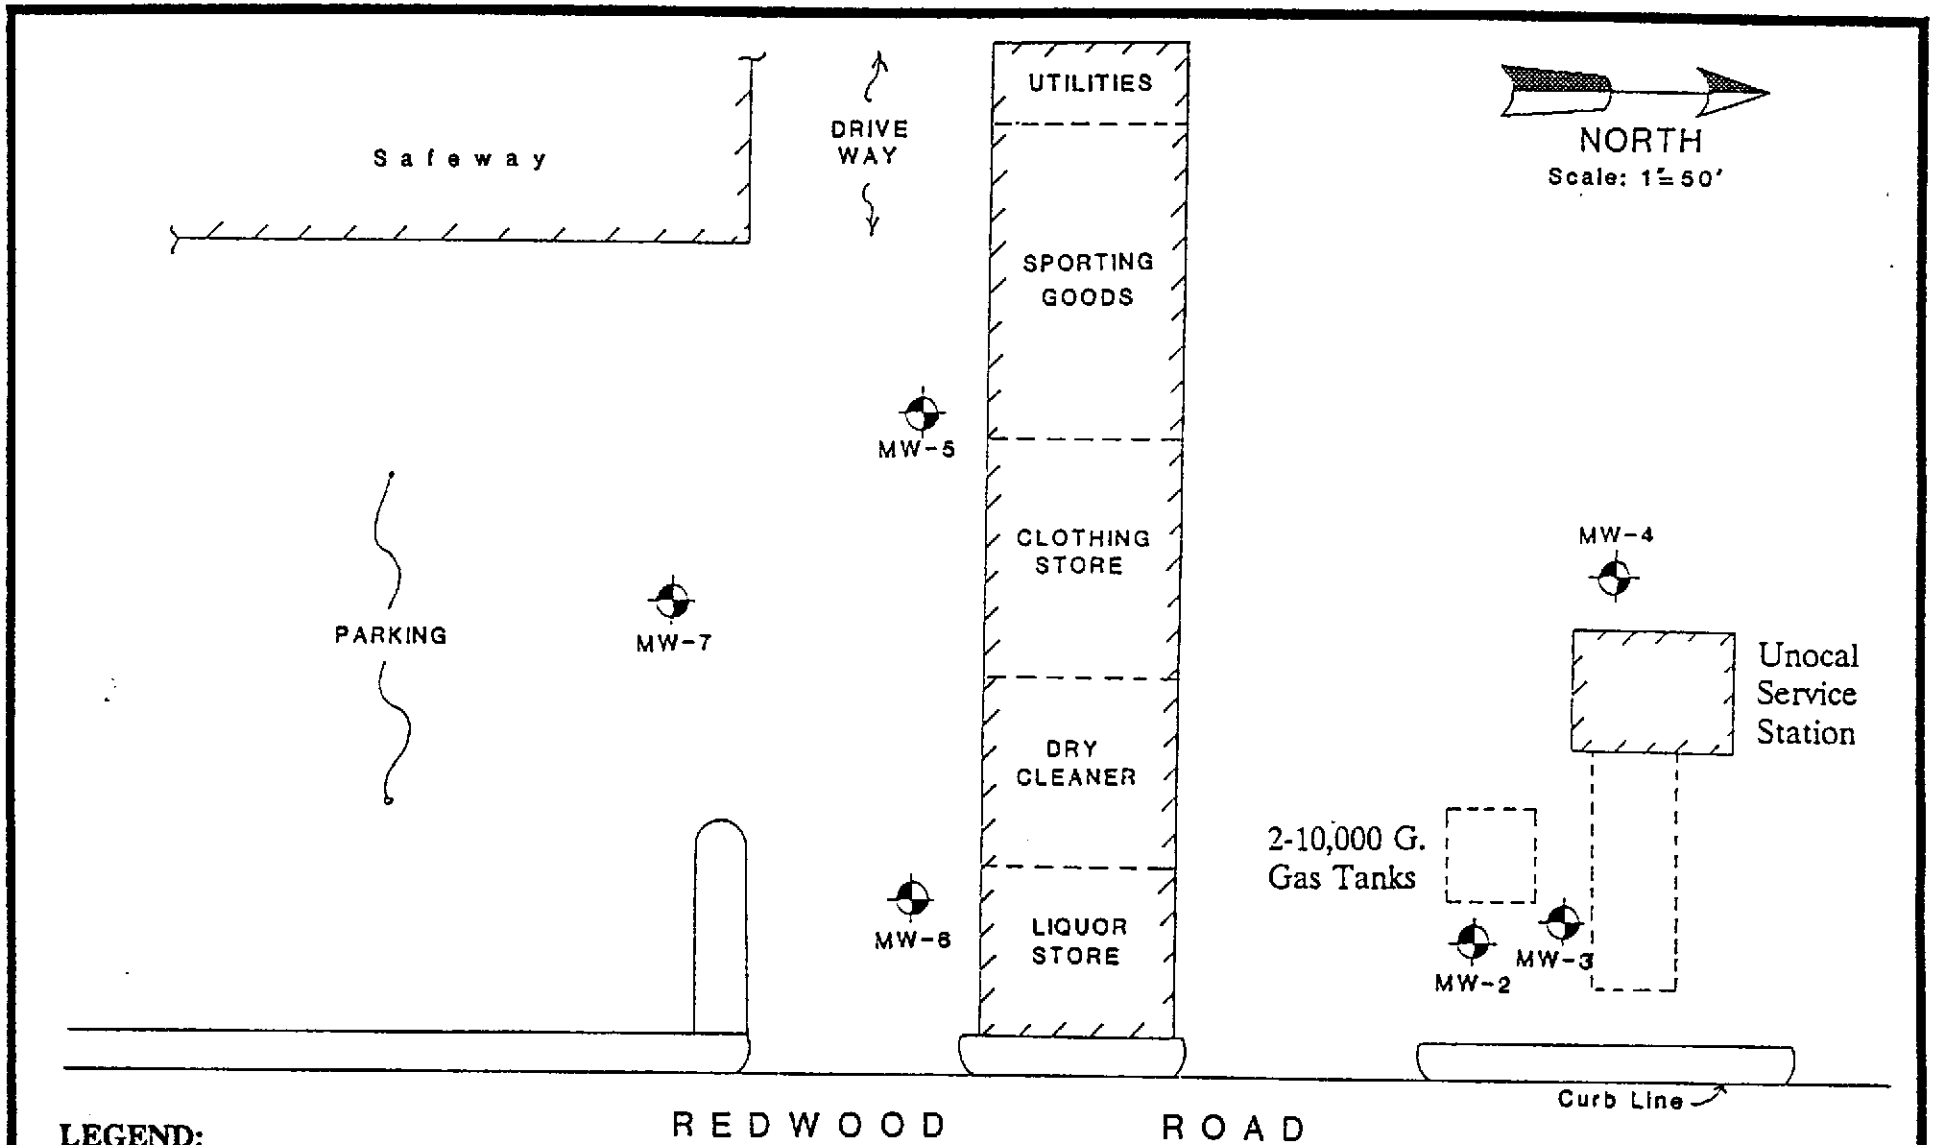
SITE PLAN

BSK & Associates installed three groundwater monitoring wells (MW-2, MW-3 and MW-4) in December 1989 at the Unocal 76 Service Station located at 20405 Redwood Road, Castro Valley, California. The service station location is shown on Figure 1, Vicinity Map. The monitoring facilities were installed in order to comply with the California UST Monitoring requirements of Alternative 6, Subchapter 16, Title 23, California Code of Regulations. The results of well installations, soil sampling and chemical testing of the soil and water samples were summarized in our Report P89134, dated February 5, 1990. The groundwater monitoring well locations are shown on Figure 2, Site Plan.

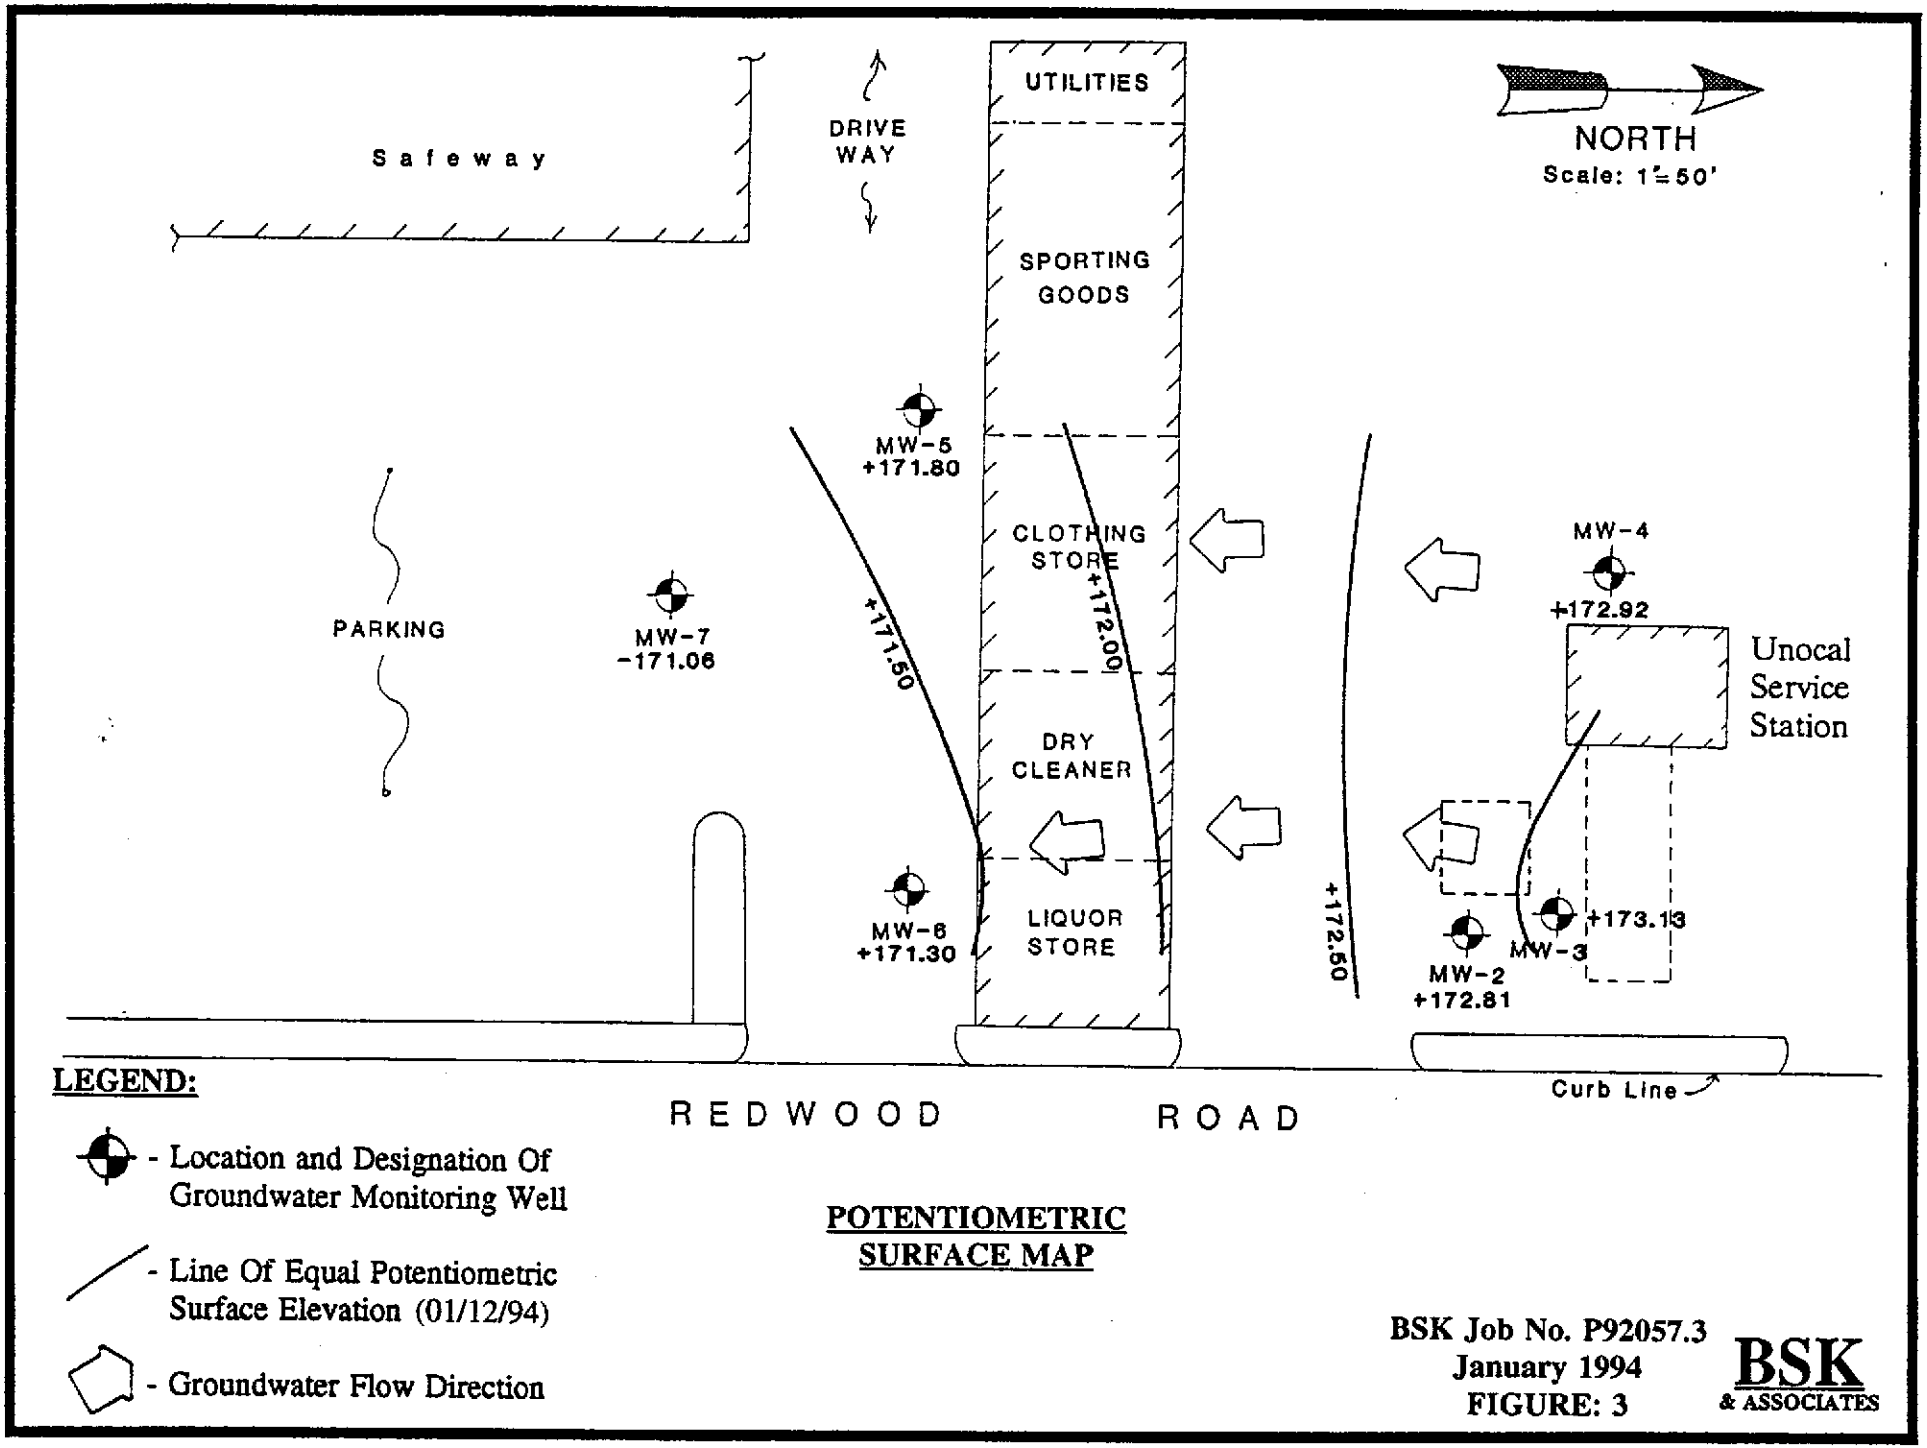
POTENTIOMETRIC SURFACE MAP

Groundwater measurements were made of the six existing wells on January 12, 1994 in order to assess the flow direction and gradient in the area. On that date, groundwater flow was generally south. The gradient was approximately 1.1 percent, an increase in gradient of 0.6 percent over the previous quarter. The flow direction is similar to the previous quarter. Groundwater levels have risen 0.14 to 0.23 feet since October 19, 1993. Groundwater flow direction and gradient are shown on Figure 3, Potentiometric Surface Map.
