TO WHOM IT MAY CONCERN

**REPORT - ADDITIONAL SOIL INVESTIGATION  
INCLUDING GEOLOGIC & SLOPE STABILITY ANALYSIS**

**PLANNED RESIDENTIAL DEVELOPMENT  
15900 SIMONI DRIVE  
SAN JOSE, SANTA CLARA COUNTY  
CALIFORNIA**

**111423B  
JULY 31, 2008**

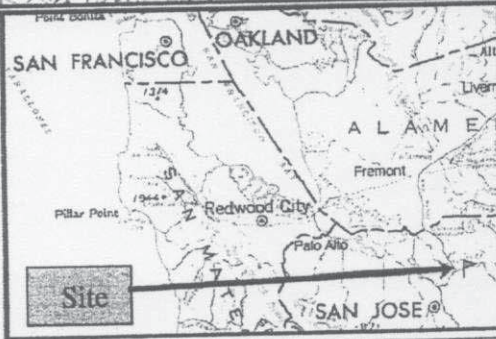
1

Site Vicinity Map

Planned Single-Family Residence  
East of 15880 Simoni Drive, San Jose, CA

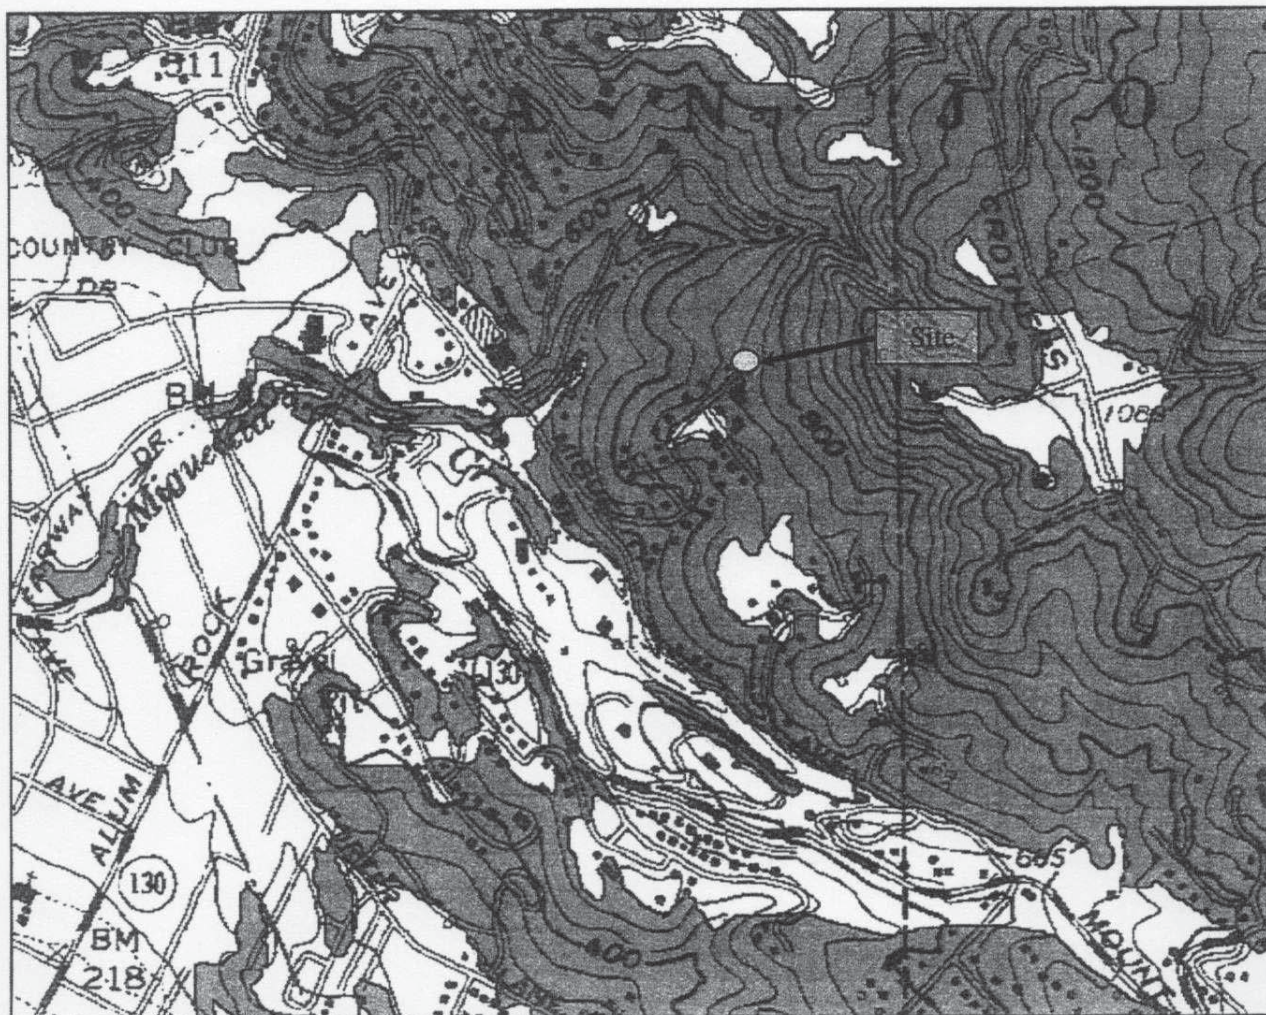
**3**

Base: California Geological Survey,  
 Seismic Hazard Map, Calaveras  
 Reservoir, Official Map  
 Released: October 17, 2001

■ Area of potential seismically  
 induced landslide movement

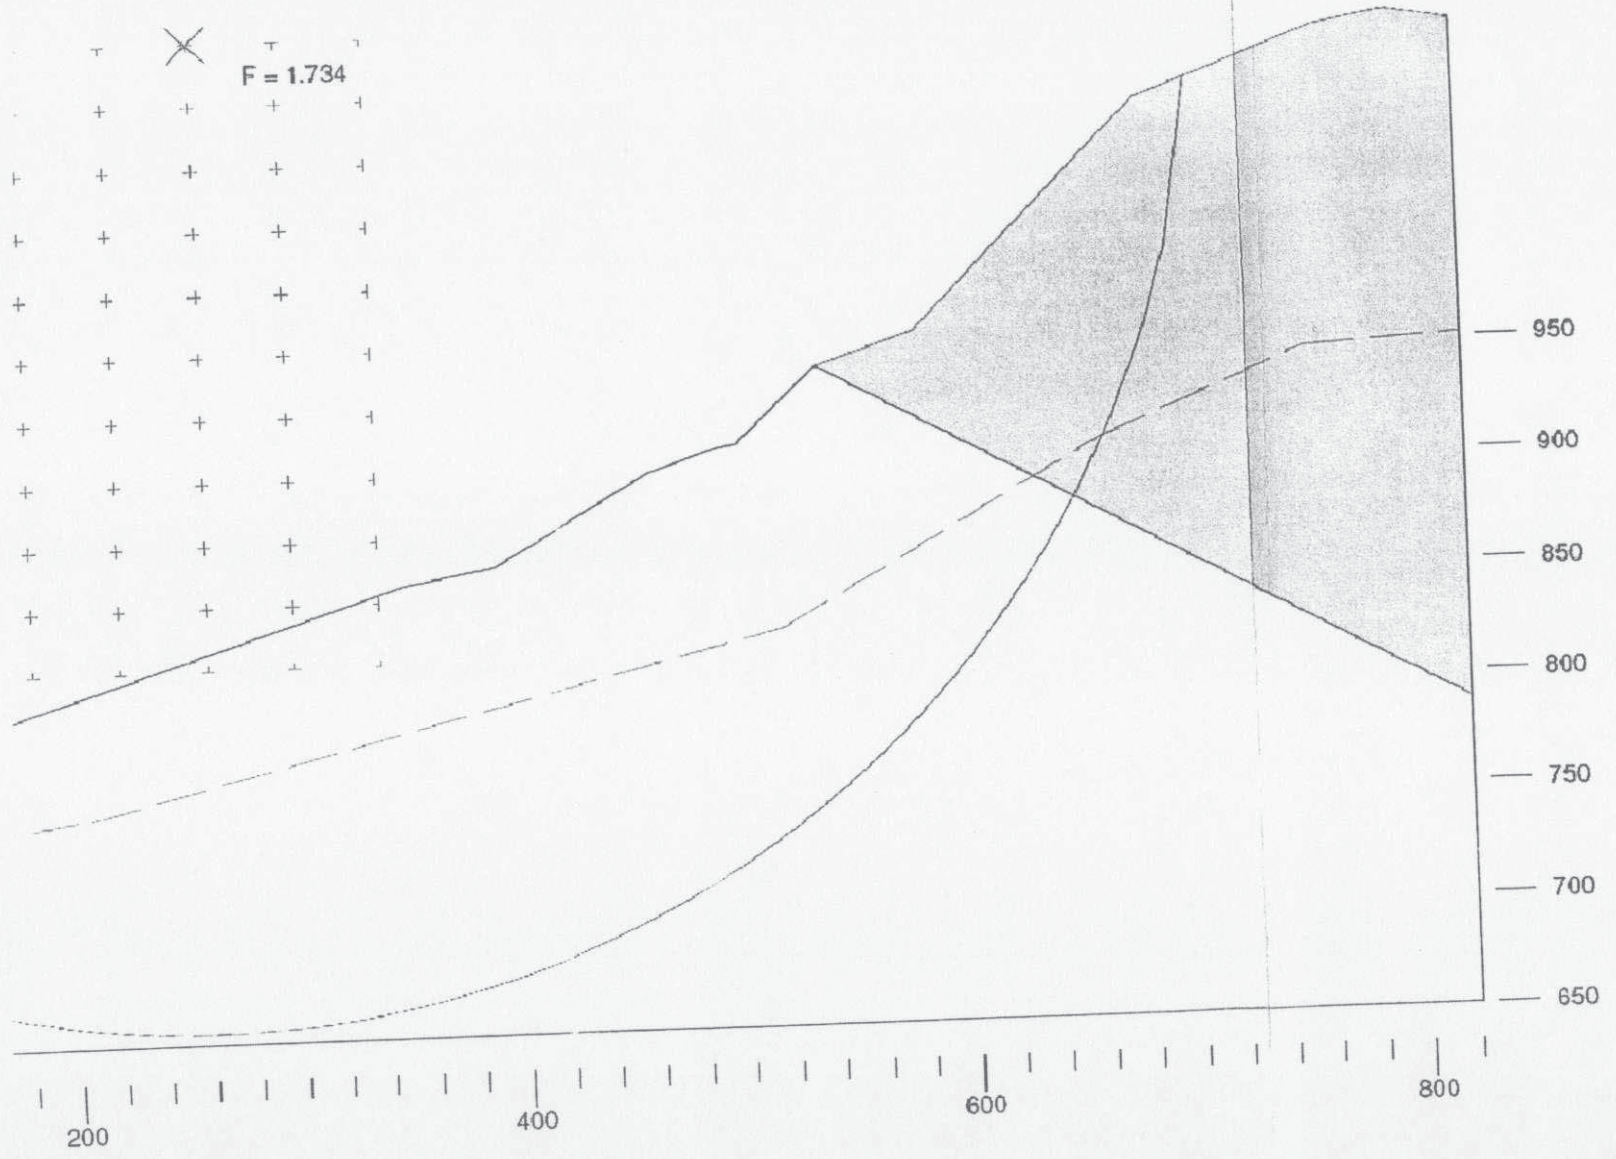
Tbc Berryessa conglo	130	1500	45	0
Tbs Berryessa shale	125	1300	39	0

Seismic coefficient = 0.34

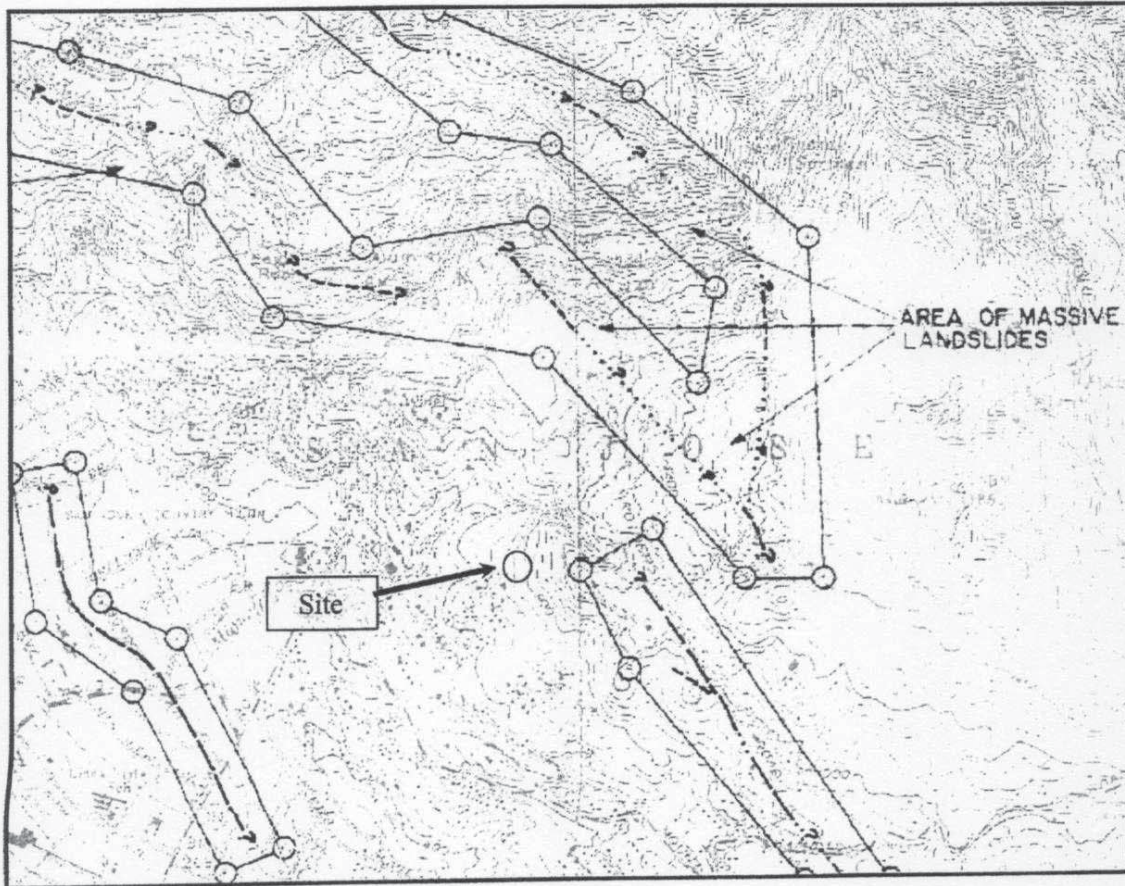
- Explanation**
- 1868 - Trace of 1868 earthquake
  - C - Area of observed creep
  - - Boundaries of Alquist-Priolo zone

Source: DMG Staff, 2000, Digital images of Official Maps of Alquist-Priolo Earthquake Fault Zones of California, central coast region: California Division of Mines and Geology, CD 2000-004, Calaveras Reservoir, Official Map Released: January 1, 1982, scale 1:24000.

The site is not within an Alquist-Priolo Earthquake Fault Zone (Earthquake Fault Zone Map, Plate 10) and, based upon the reviewed geologic and seismologic reports and maps, no known active or potentially active faults cross or project toward the site. Additionally, during our site reconnaissance no evidence of active faulting was observed on or projecting toward the site. Therefore, it is our professional opinion that the potential for fault-related surface rupture at the site is very low.

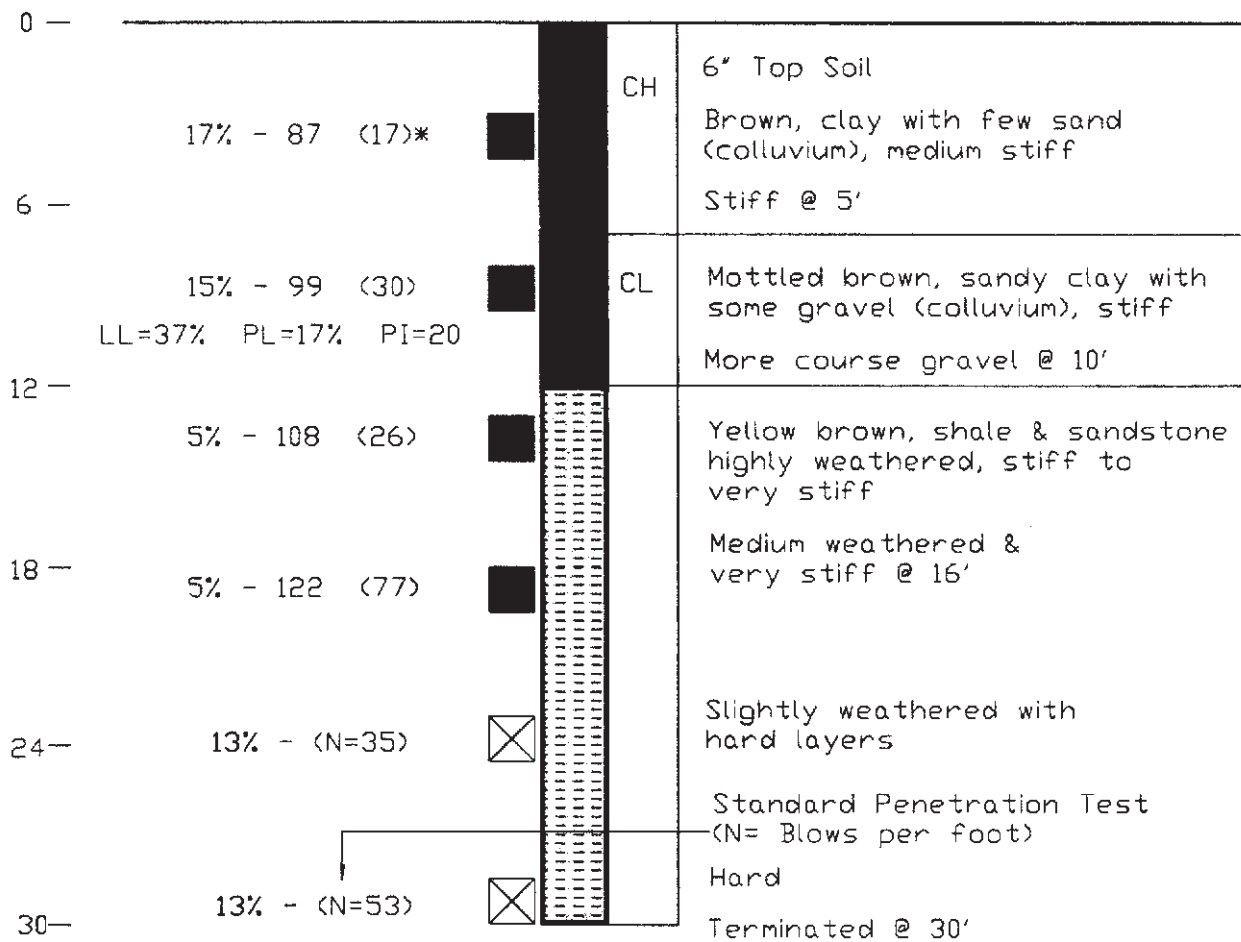
\*140-lbs. weight falling 30-ins.

Note: Free ground water not encountered

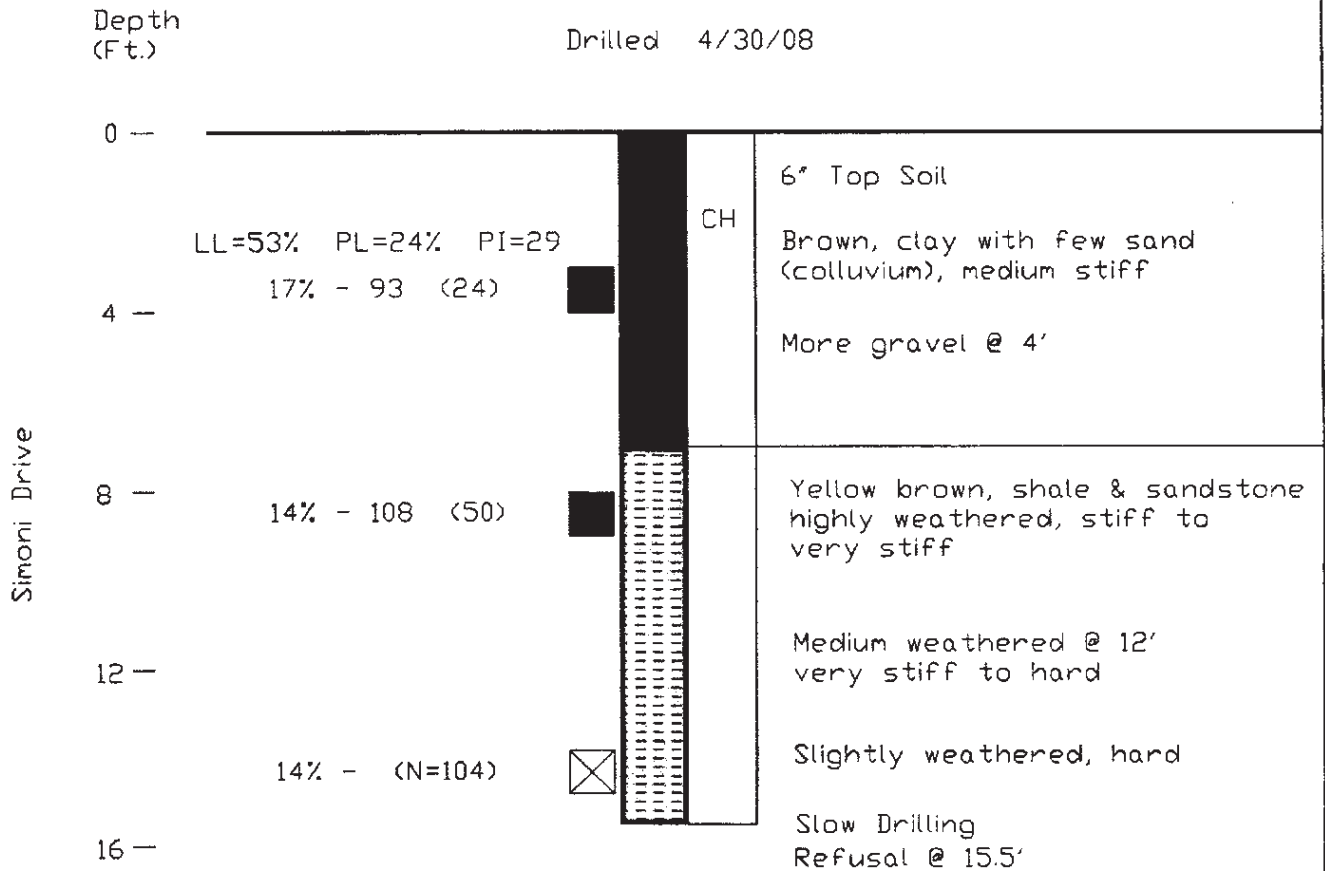
Note: Free ground water not encountered

## LOG OF BORING

1" Diameter Percussion Hole

Drilled 4/30/08

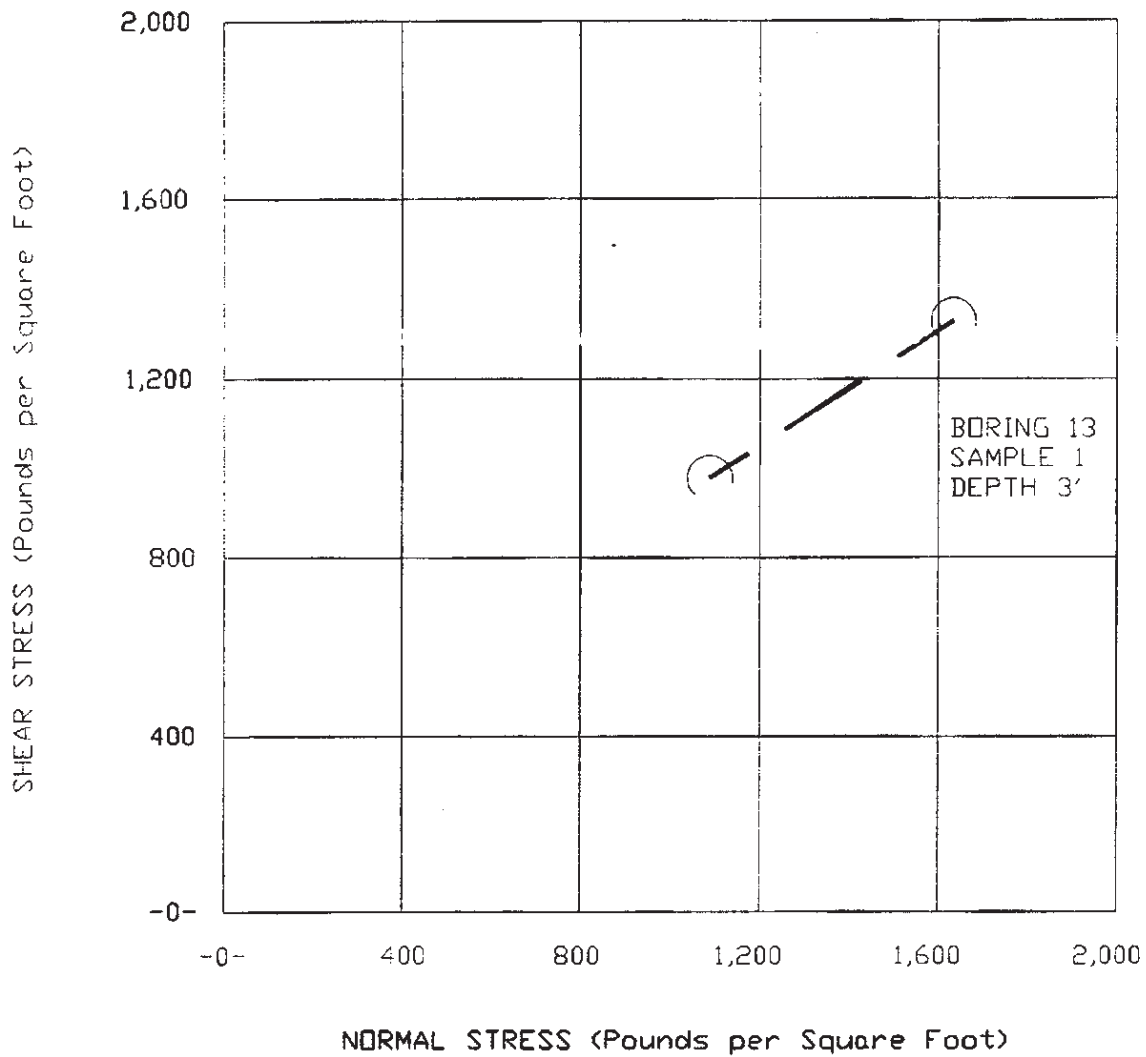
## WET SHEAR TEST DATA

(Saturated Direct Shear)

The moisture-density results and Atterberg limits (Liquid Limit = LL, Plastic Limit = PL, Plasticity Index = PI) are presented on plates 11 through 13. The direct shear test data are summarized on plate 14. The results of the compaction test are presented on plate 15.

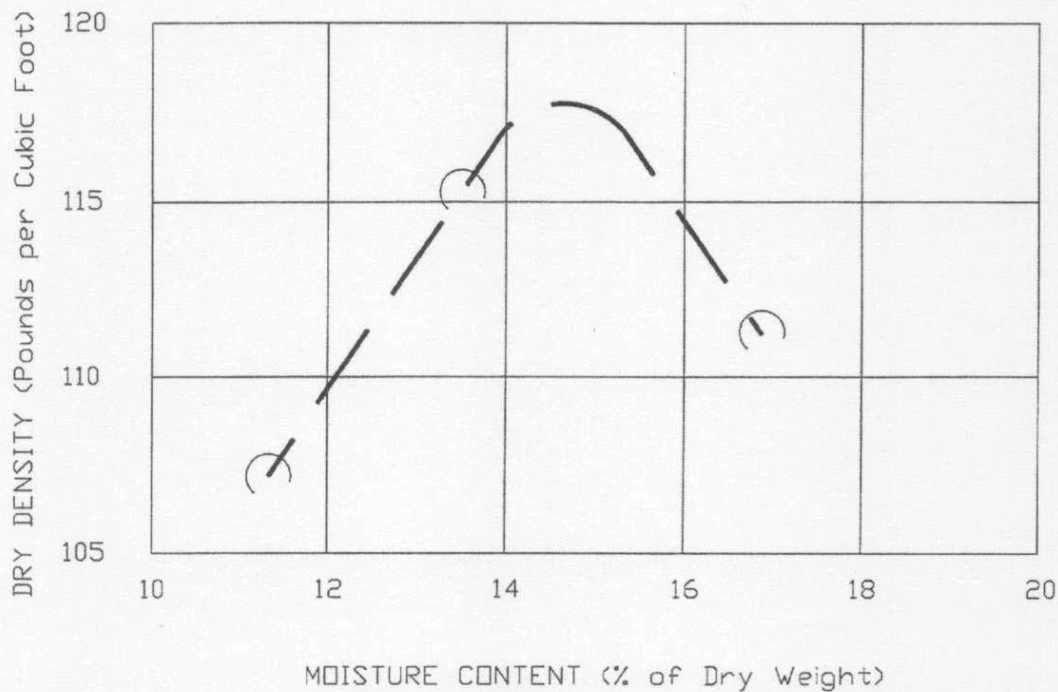
PLATE 15

AMERICAN SOCIETY FOR TESTING & MATERIALS DESIGNATION: D:1557-78

(Modified Proctor Compaction Method)

## COMPACTION TEST DATA
