A Report Prepared for

Texaco Refining and Marketing Inc.
10 Universal City Plaza
Universal City, California 91608

QUARTERLY TECHNICAL REPORT
FIRST QUARTER 1992
FORMER TEXACO SERVICE STATION
2200 EAST 12TH STREET
OAKLAND, CALIFORNIA

HLA Job No. 2251,175.03
May 26, 1992
1992 Report No. 1

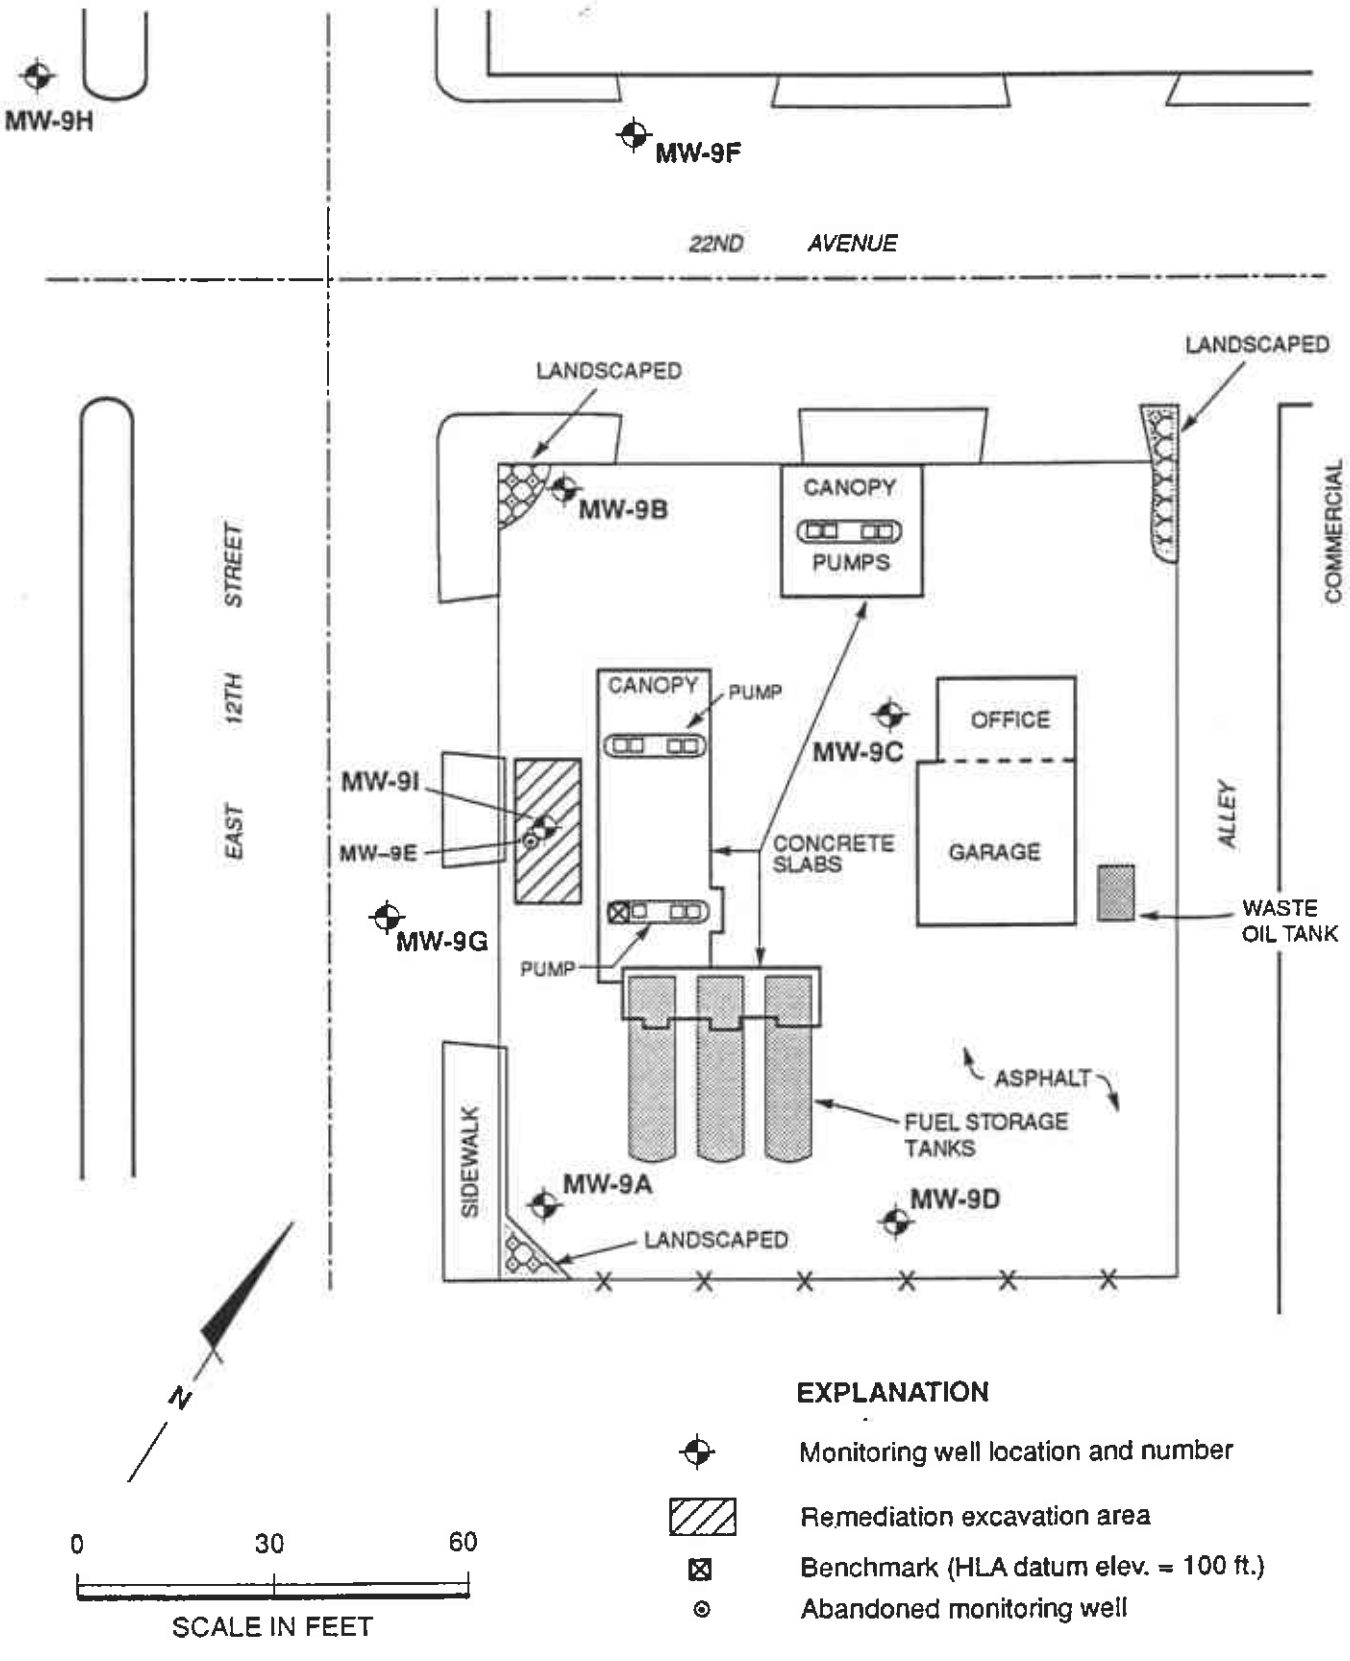
PLATE **3**

At the station, unleaded gasoline is currently dispensed, and automotive repair services are provided. Leaded gas was dispensed prior to January 1992. Structures include a building, three fuel pump islands, one underground waste oil tank, and three underground fuel storage tanks (Plate 3).

- Abandoned MW-9E (located inside the remediation excavation boundaries) and installed a new monitoring well (MW-9I) in approximately the same location after backfilling the excavation (Plate 3).

Site Plan
Former Texaco Service Station
2200 East 12th Street
Oakland, California

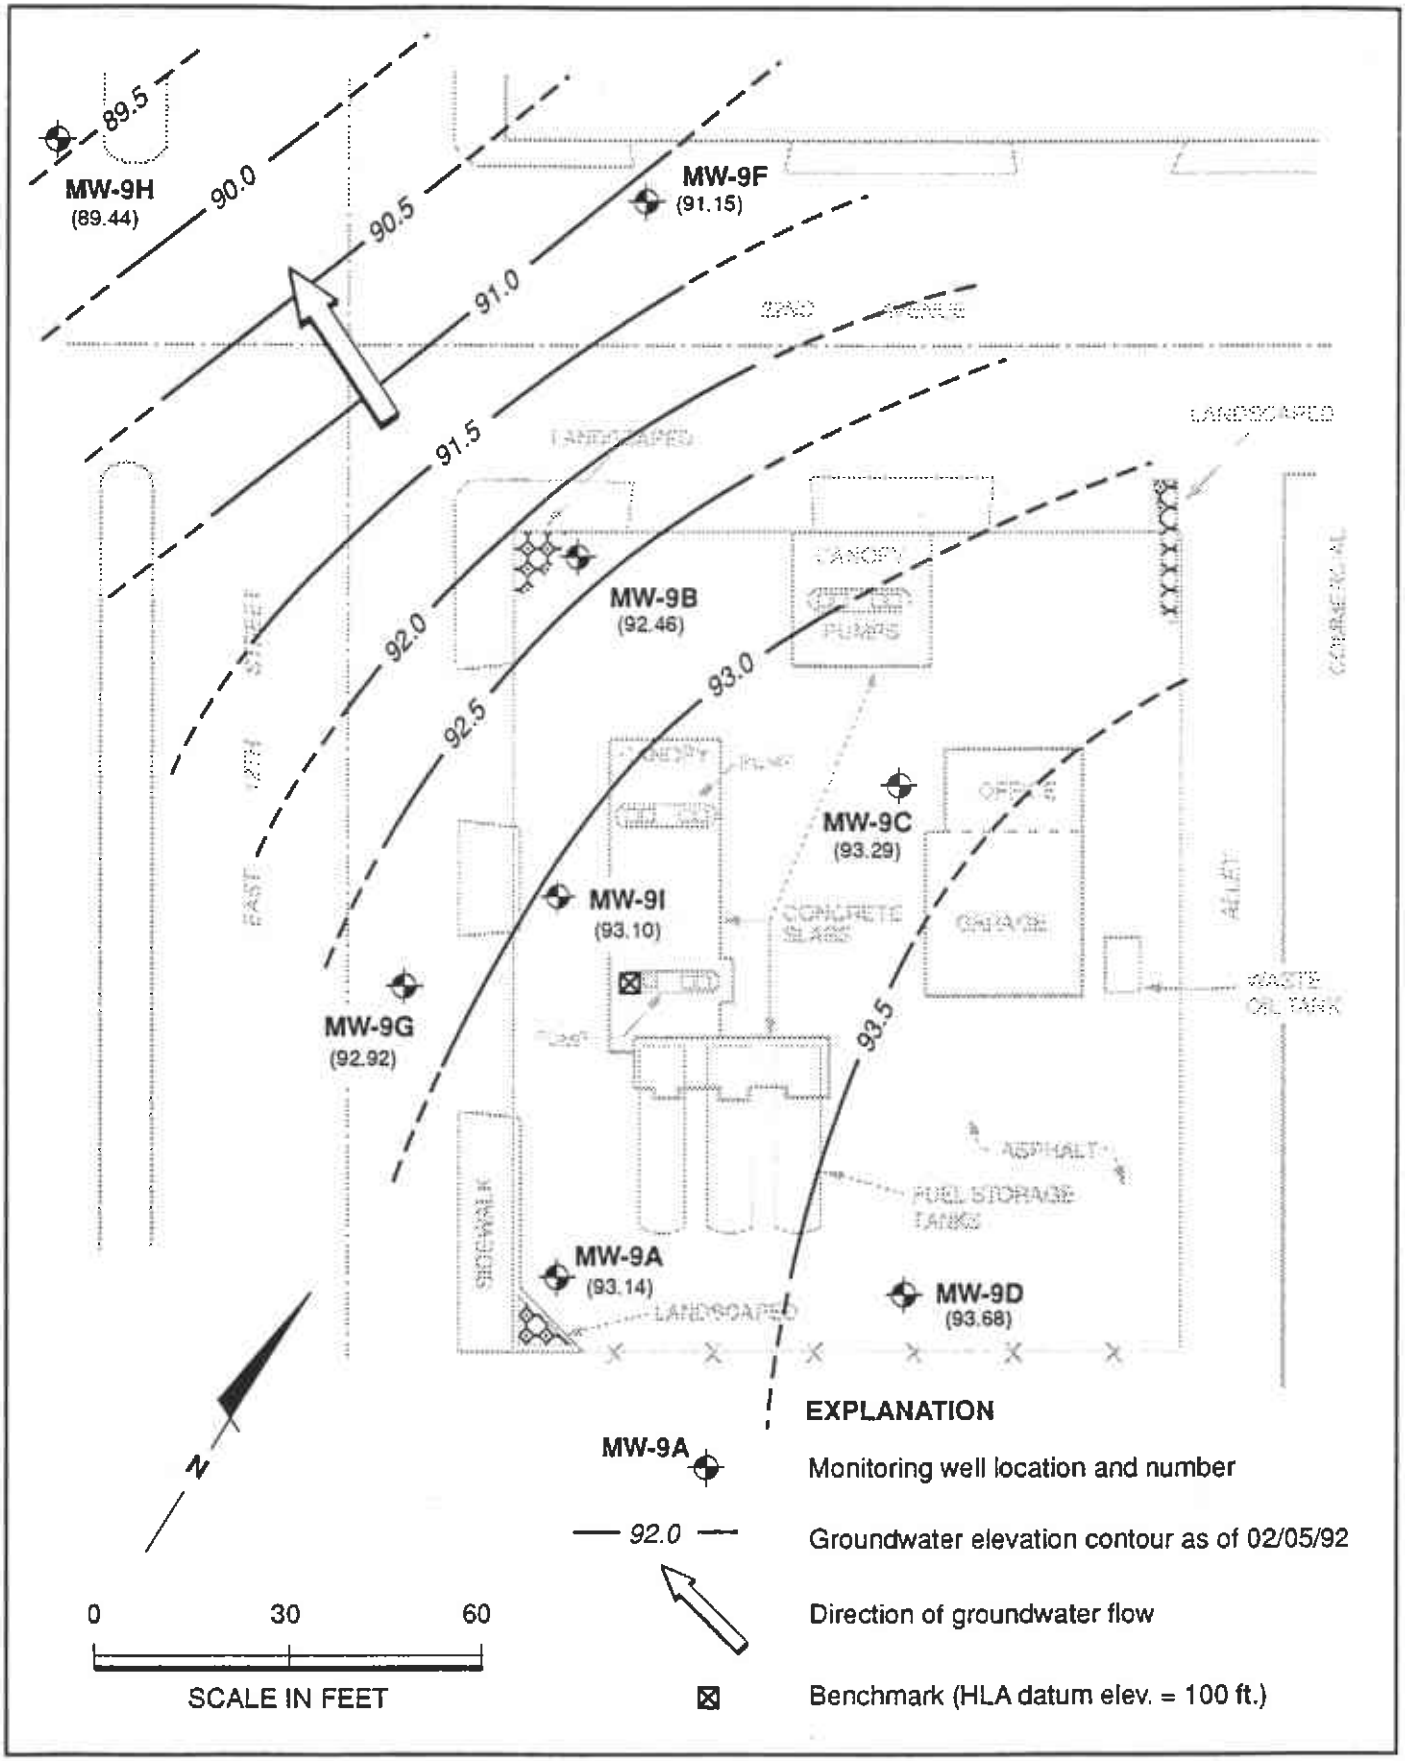
PLATE
4

Groundwater Surface Map
Former Texaco Service Station
2200 East 12th Street
Oakland, California

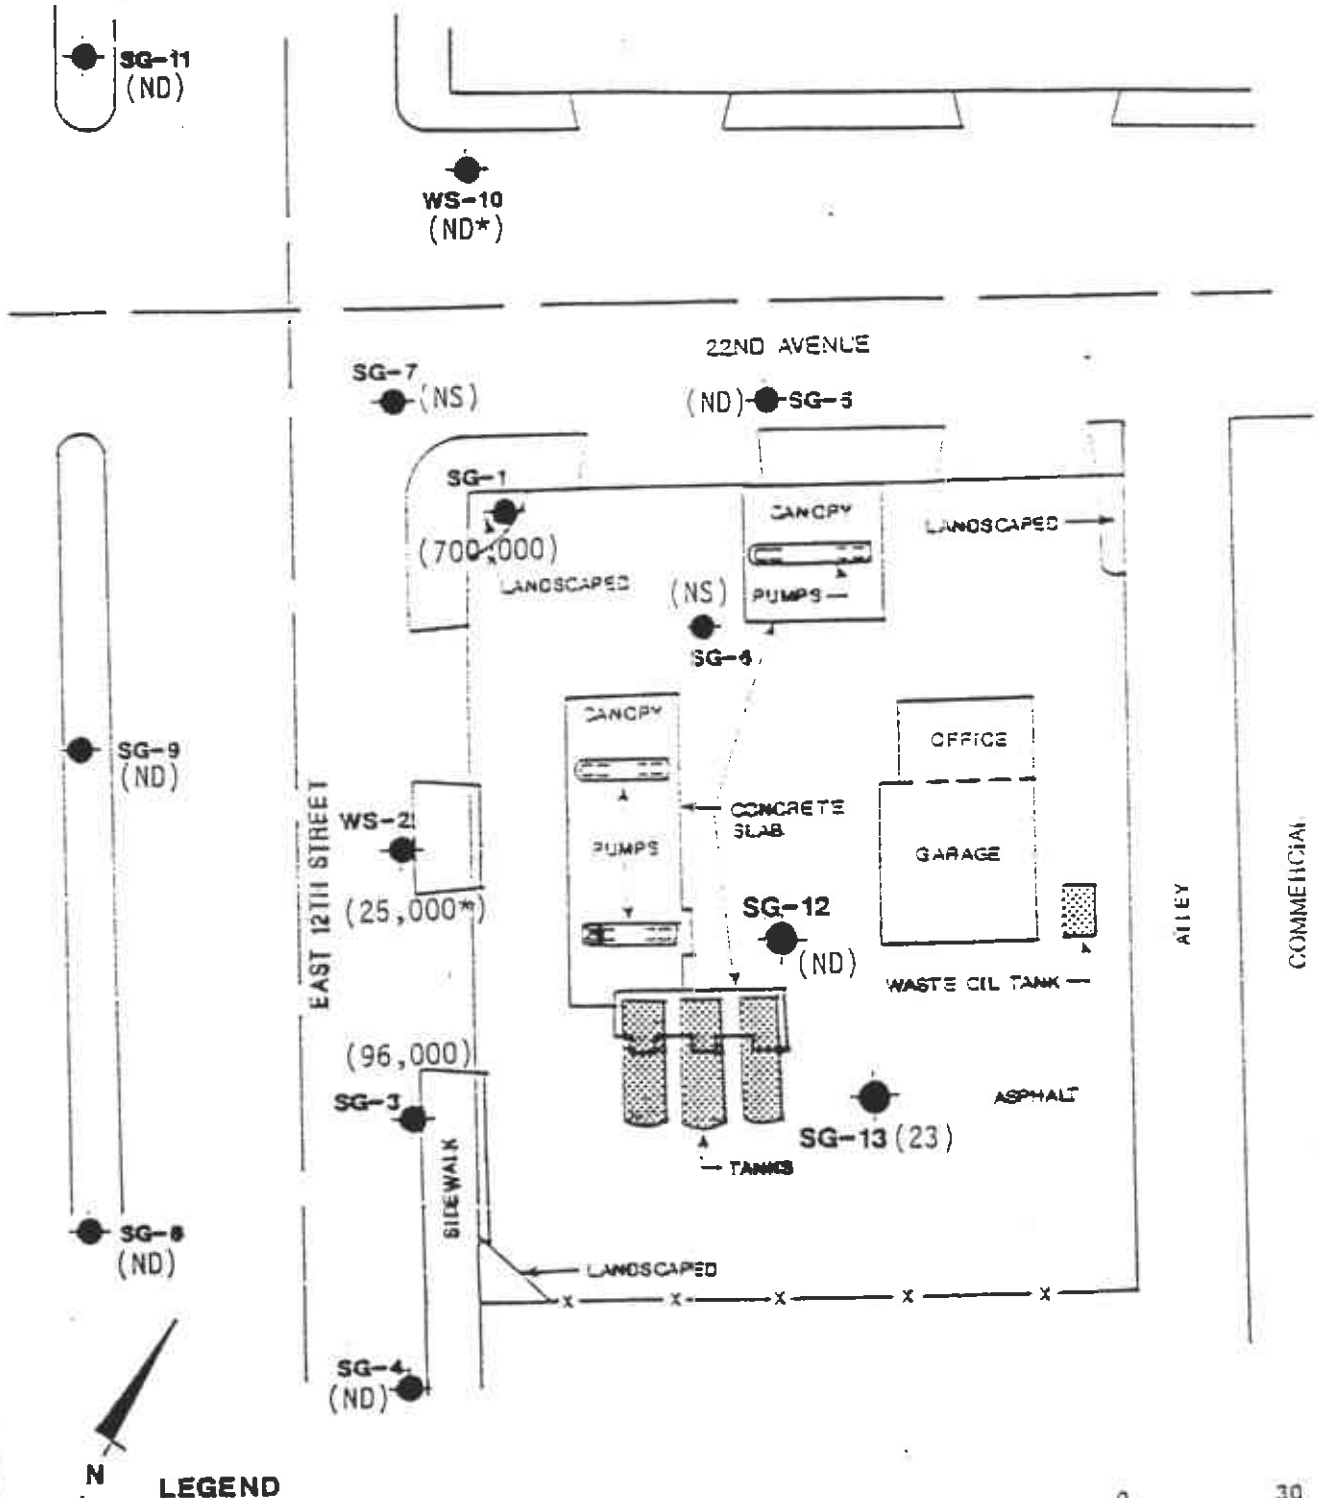
PLATE
5

- Conducted a soil-gas survey on site and in city streets near the site. Probe locations are shown on Plate 5 and soil-gas survey results are presented in Table 2.

Soil-gas Probe Locations
Former Texaco Service Station
2200 East 12th Street
Oakland, California

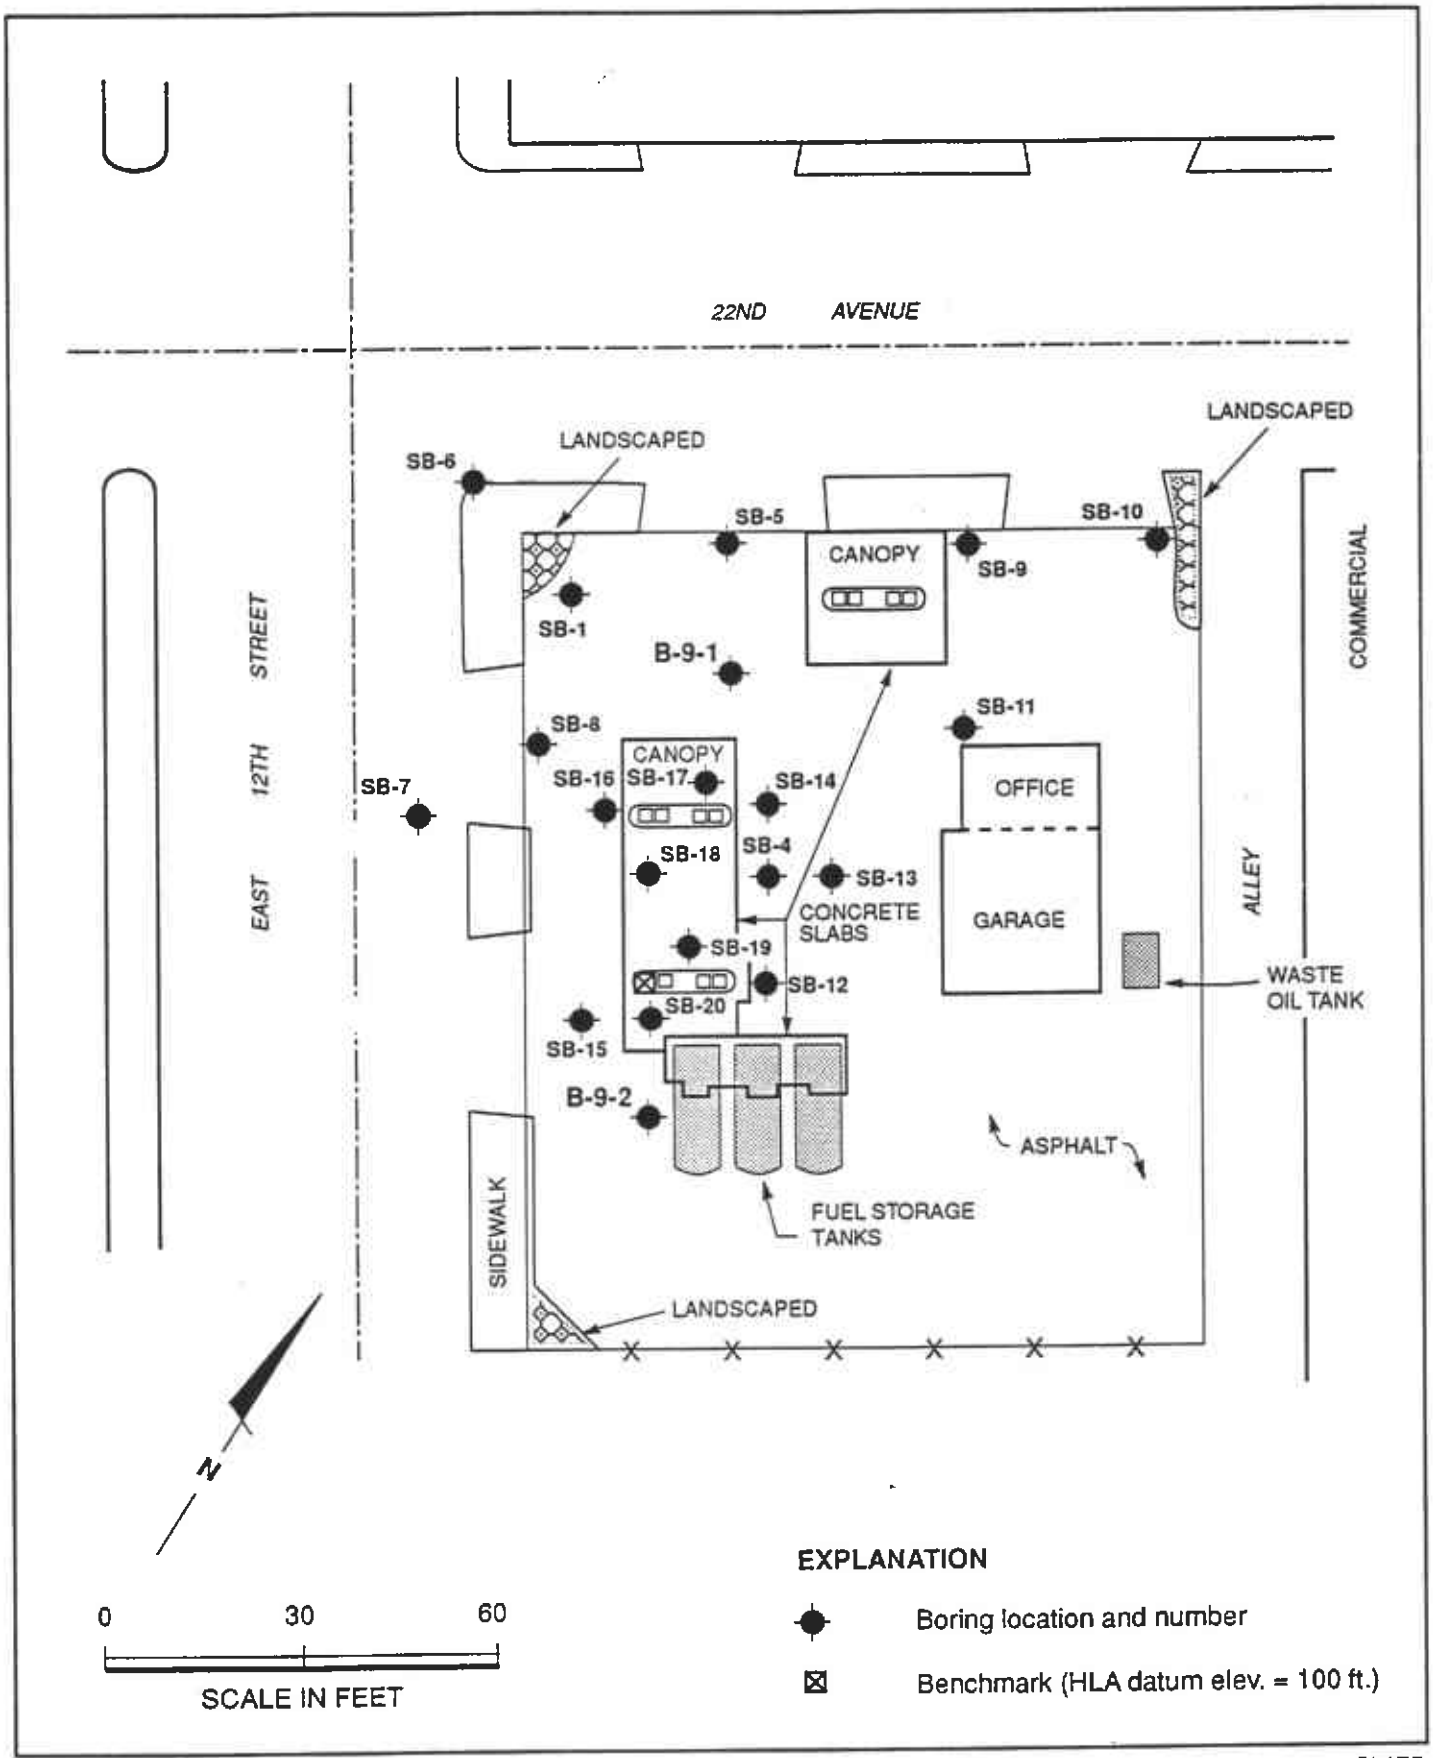
PLATE
6

- Drilled and sampled 20 shallow soil borings (SB-1 through SB-20); locations are shown on Plate 6.
- Drilled, constructed, developed, and sampled five on-site monitoring wells (MW-9A through MW-9E) and three off-site wells (MW-9F through MW-9H); locations are shown on Plate 3.

Soil Boring Locations
Former Texaco Service Station
2200 East 12th Street
Oakland, California
