GEOTECHNICAL INVESTIGATION EMERYVILLE SENIOR HOUSING PROJECT 4300-4328 SAN PABLO AVENUE EMERYVILLE, CALIFORNIA SCI 537.002

This report presents results of our geotechnical investigation for the proposed Emeryville Senior Housing Project in Emeryville, California. The project is located at 4300-4328 San Pablo Avenue, as shown on the Site Plan, Plate 1.

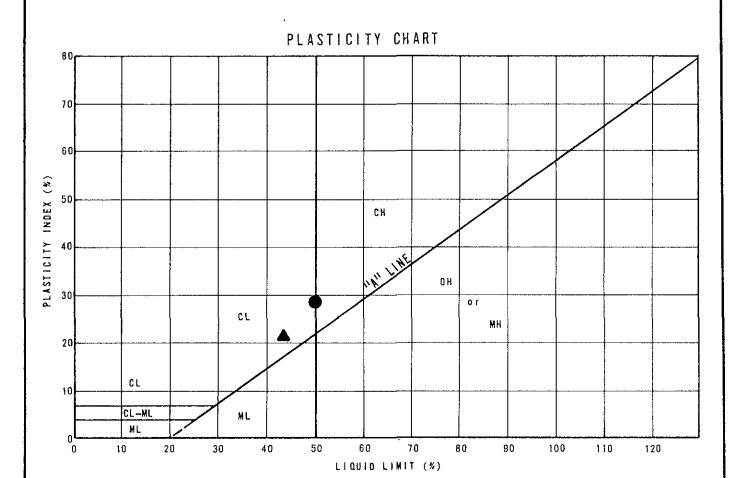
PLASTICITY DATA

XEY SYMBOL	BORING Number	DEPTH (ft)	NATURAL WATER CONTENT W (%)	PLASTIC LIMIT (%)	LIQUID LIMIT (%)	PLASTICITY INDEX (%)	LIQUIDITY INDEX (W-PL)	UNIFIED SOIL CLASSIFICATION SYMBOL
•	1	2	22.1	22	50	28	0.00	CL
A	6	2	21.3	21	43	22	0.02	CL
				•
