Re: Chevron Service Station # 206127

RE: Chevron #206127
2301-2337 Blanding Avenue
Alameda, California
(Former Signal Oil Marine Terminal)

RE: Third Quarter Event of July 15, 2005
Groundwater Monitoring & Sampling Report
Chevron #206127 (Former Signal Oil Marine Terminal)
2301-2337 Blanding Avenue
Alameda, California

GROUNDWATER ELEVATION MAP
Chevron #206127 (Former Signal Oil Marine Terminal)
2301-2337 Blanding Avenue
Alameda, California

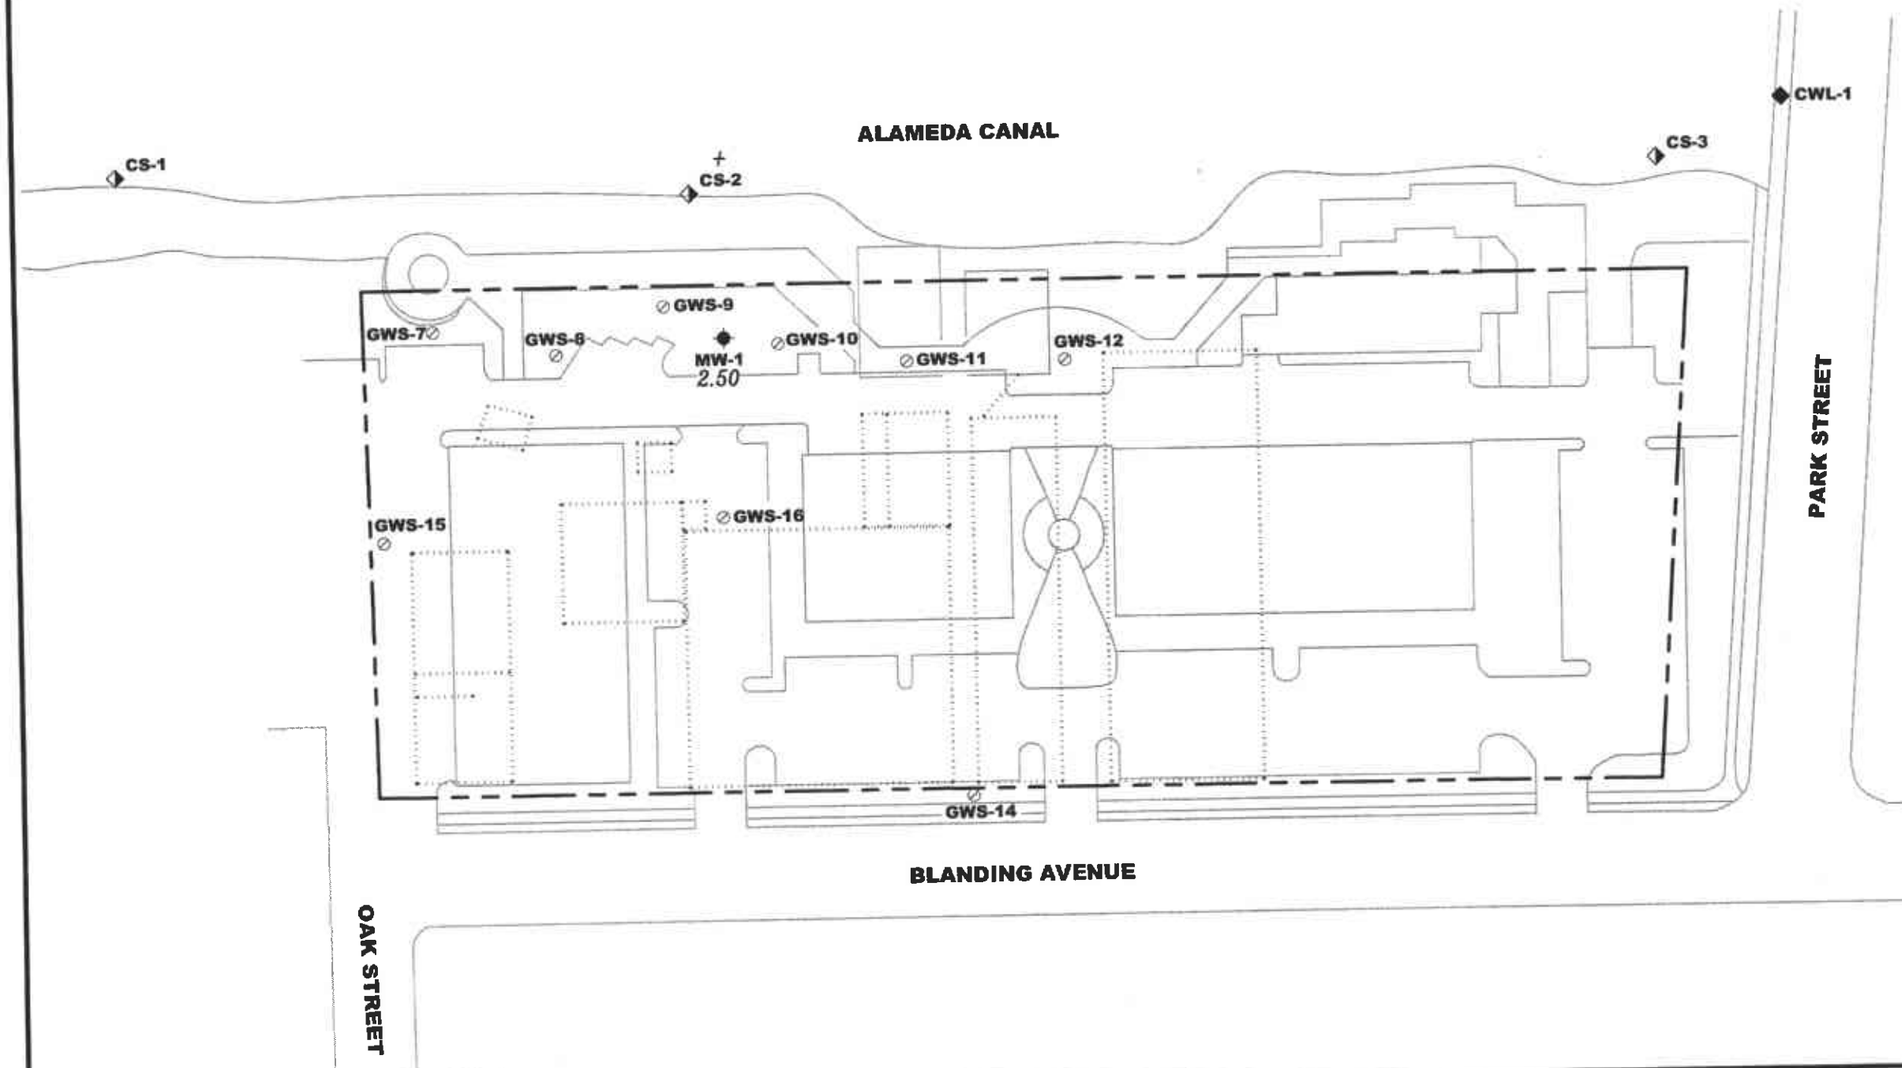
FIGURE 1

Static groundwater level was measured and the well was checked for the presence of separate-phase hydrocarbons. Static water level data, groundwater elevation, and separate-phase hydrocarbon thickness (if any) are presented in the attached Table 1. A Groundwater Elevation Map is included as Figure 1.
