TECHNICAL SUMMARY REPORT

**See the Doctor Transmission
16611 East 14th Street
San Leandro, California
ERAS Project Number 03088A**

**ERAS Environmental
September 16, 2003**

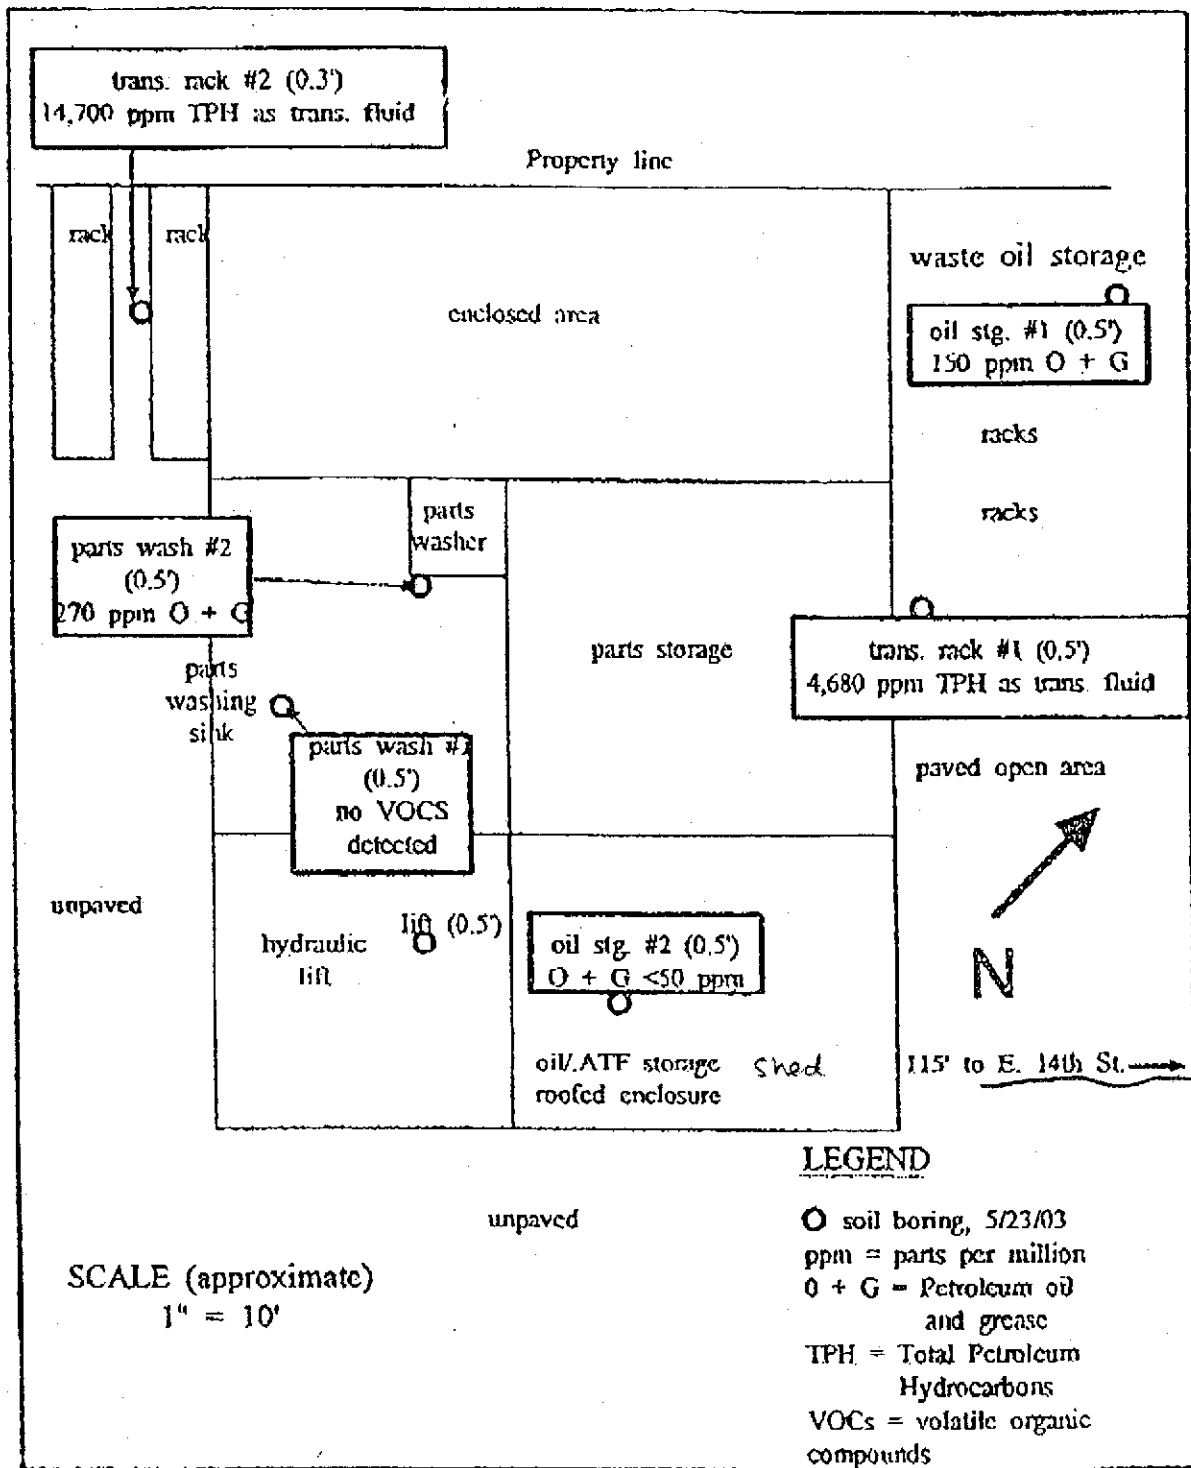
FIGURE 2
PROPERTY SITE PLAN

16611 EAST 14th STREET
SAN LEANDRO, CALIFORNIA

The soils encountered generally consisted of two or three inches of sand, silt, and gravel base material (fill) beneath the paved surface, which was underlain by dark brown clayey silt. No obvious evidence of contamination or odors was observed in these borings, except at the transmission racks in the unpaved area, where visible oil and grease was observed on the surface of the soil. No fill material was present at this location, which is entirely unpaved. The locations of the borings are shown on Figure 2.

The analytical results are summarized on Table 1 and Figure 2. Copies of the laboratory analyses and the Chain of Custody documentation are attached to this report.
