KAPREALIAN ENGINEERING
INCORPORATED

KEI-P89-0111.QR15
May 25, 1993

RE: Quarterly Report
Unocal Service Station #5487
28250 Hesperian Boulevard
Hayward, California

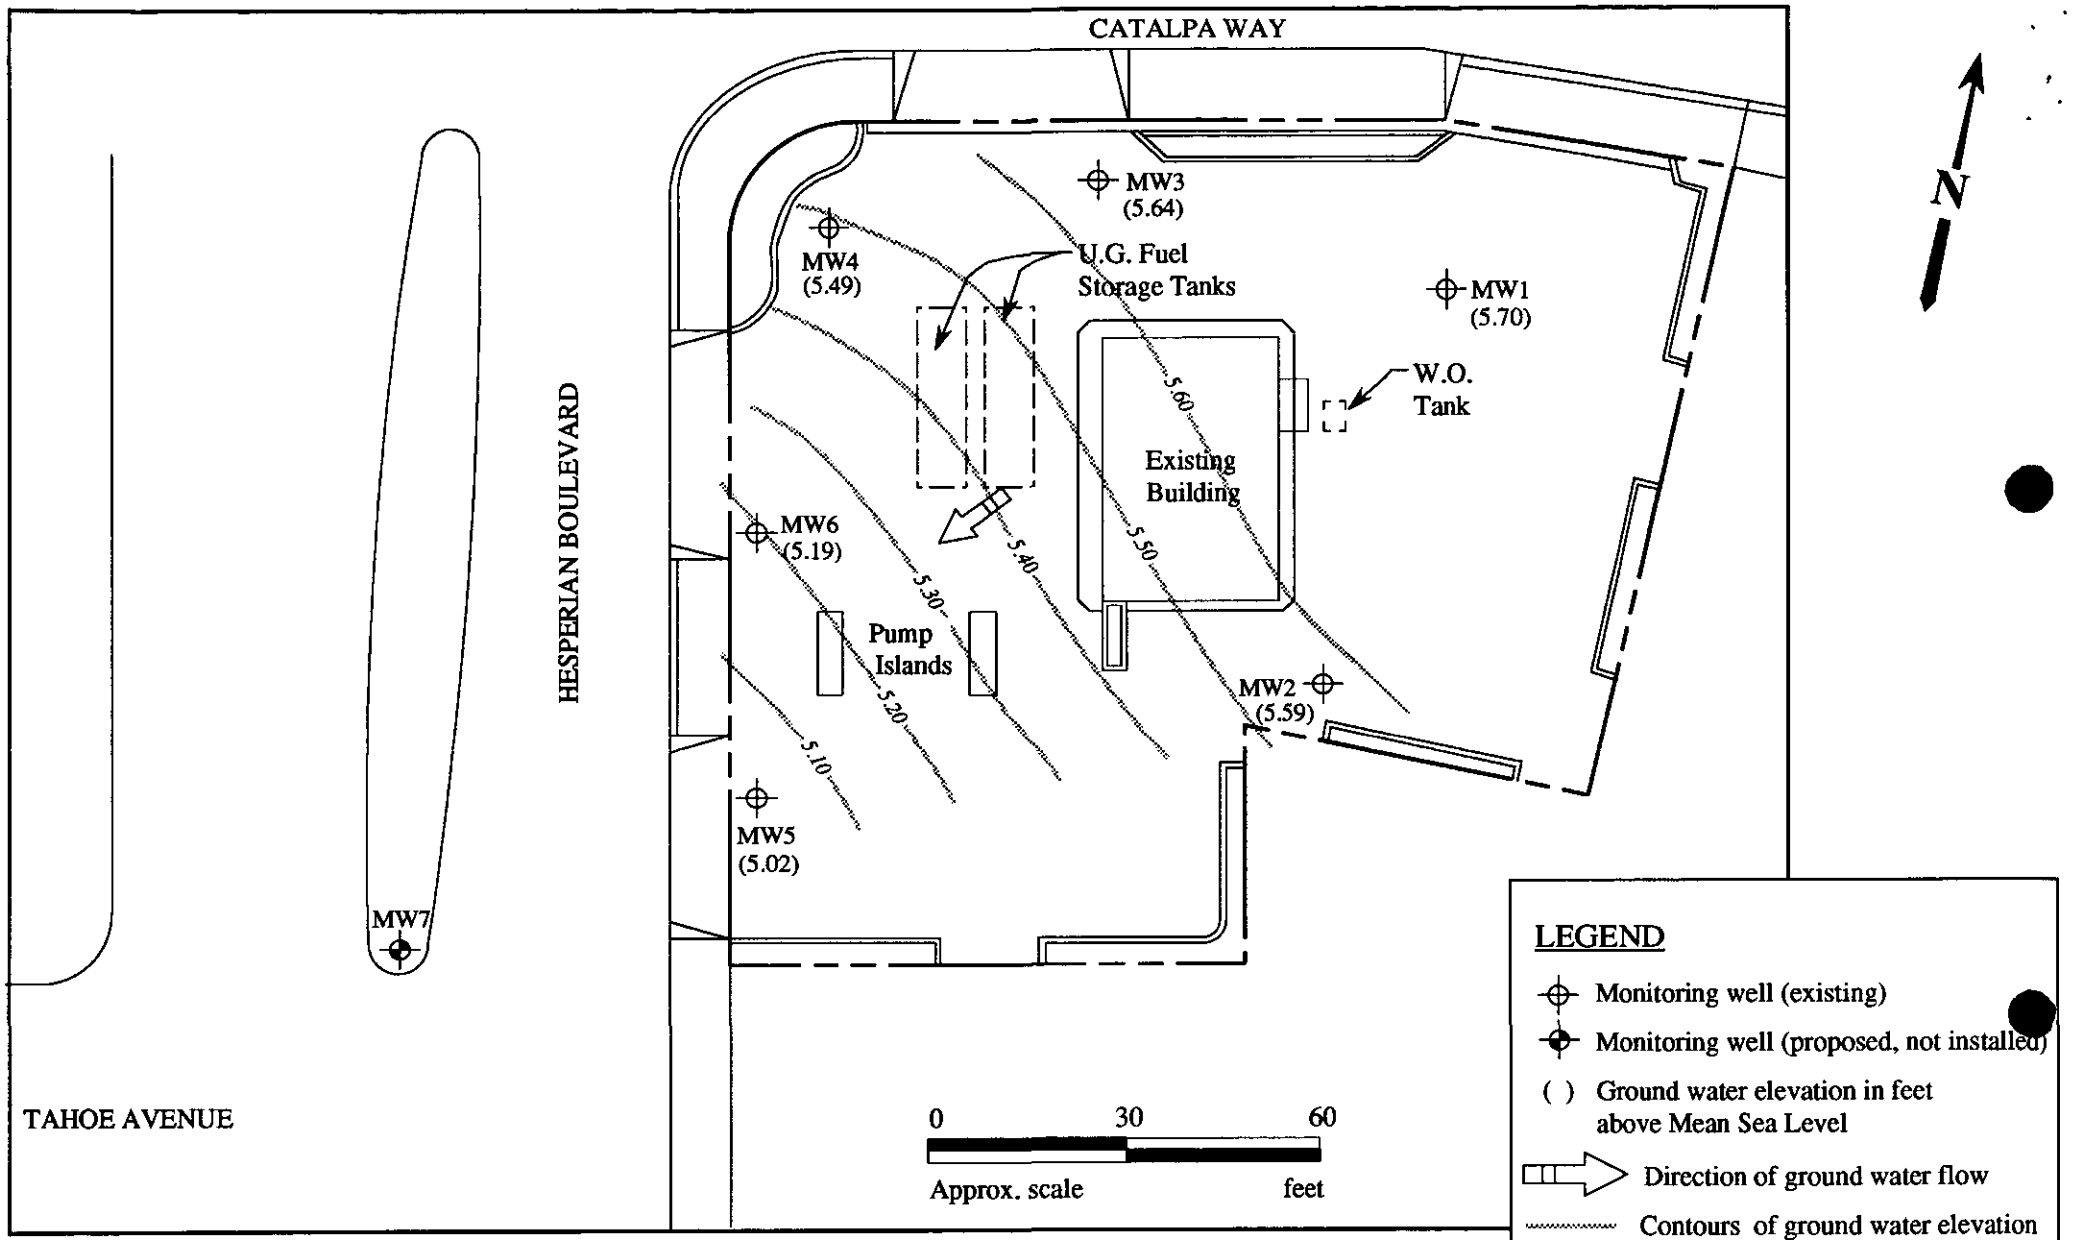
FIGURE
1

The measured depth to ground water at the site on May 3, 1993, ranged between 6.16 and 7.30 feet below grade. The water levels in all of the wells have shown net decreases ranging from 1.23 to 1.44 feet since February 2, 1993. Based on the water level data gathered on May 3, 1993, the ground water flow direction appeared to be to the southwest, as shown on the attached Potentiometric Surface Map, Figure 1. The ground water flow direction has been to the southwest since July of 1991 (eight consecutive quarters). The average hydraulic gradient across the site on May 3, 1993, was approximately 0.006.

POTENTIOMETRIC SURFACE MAP FOR THE MAY 3, 1993 MONITORING EVENT

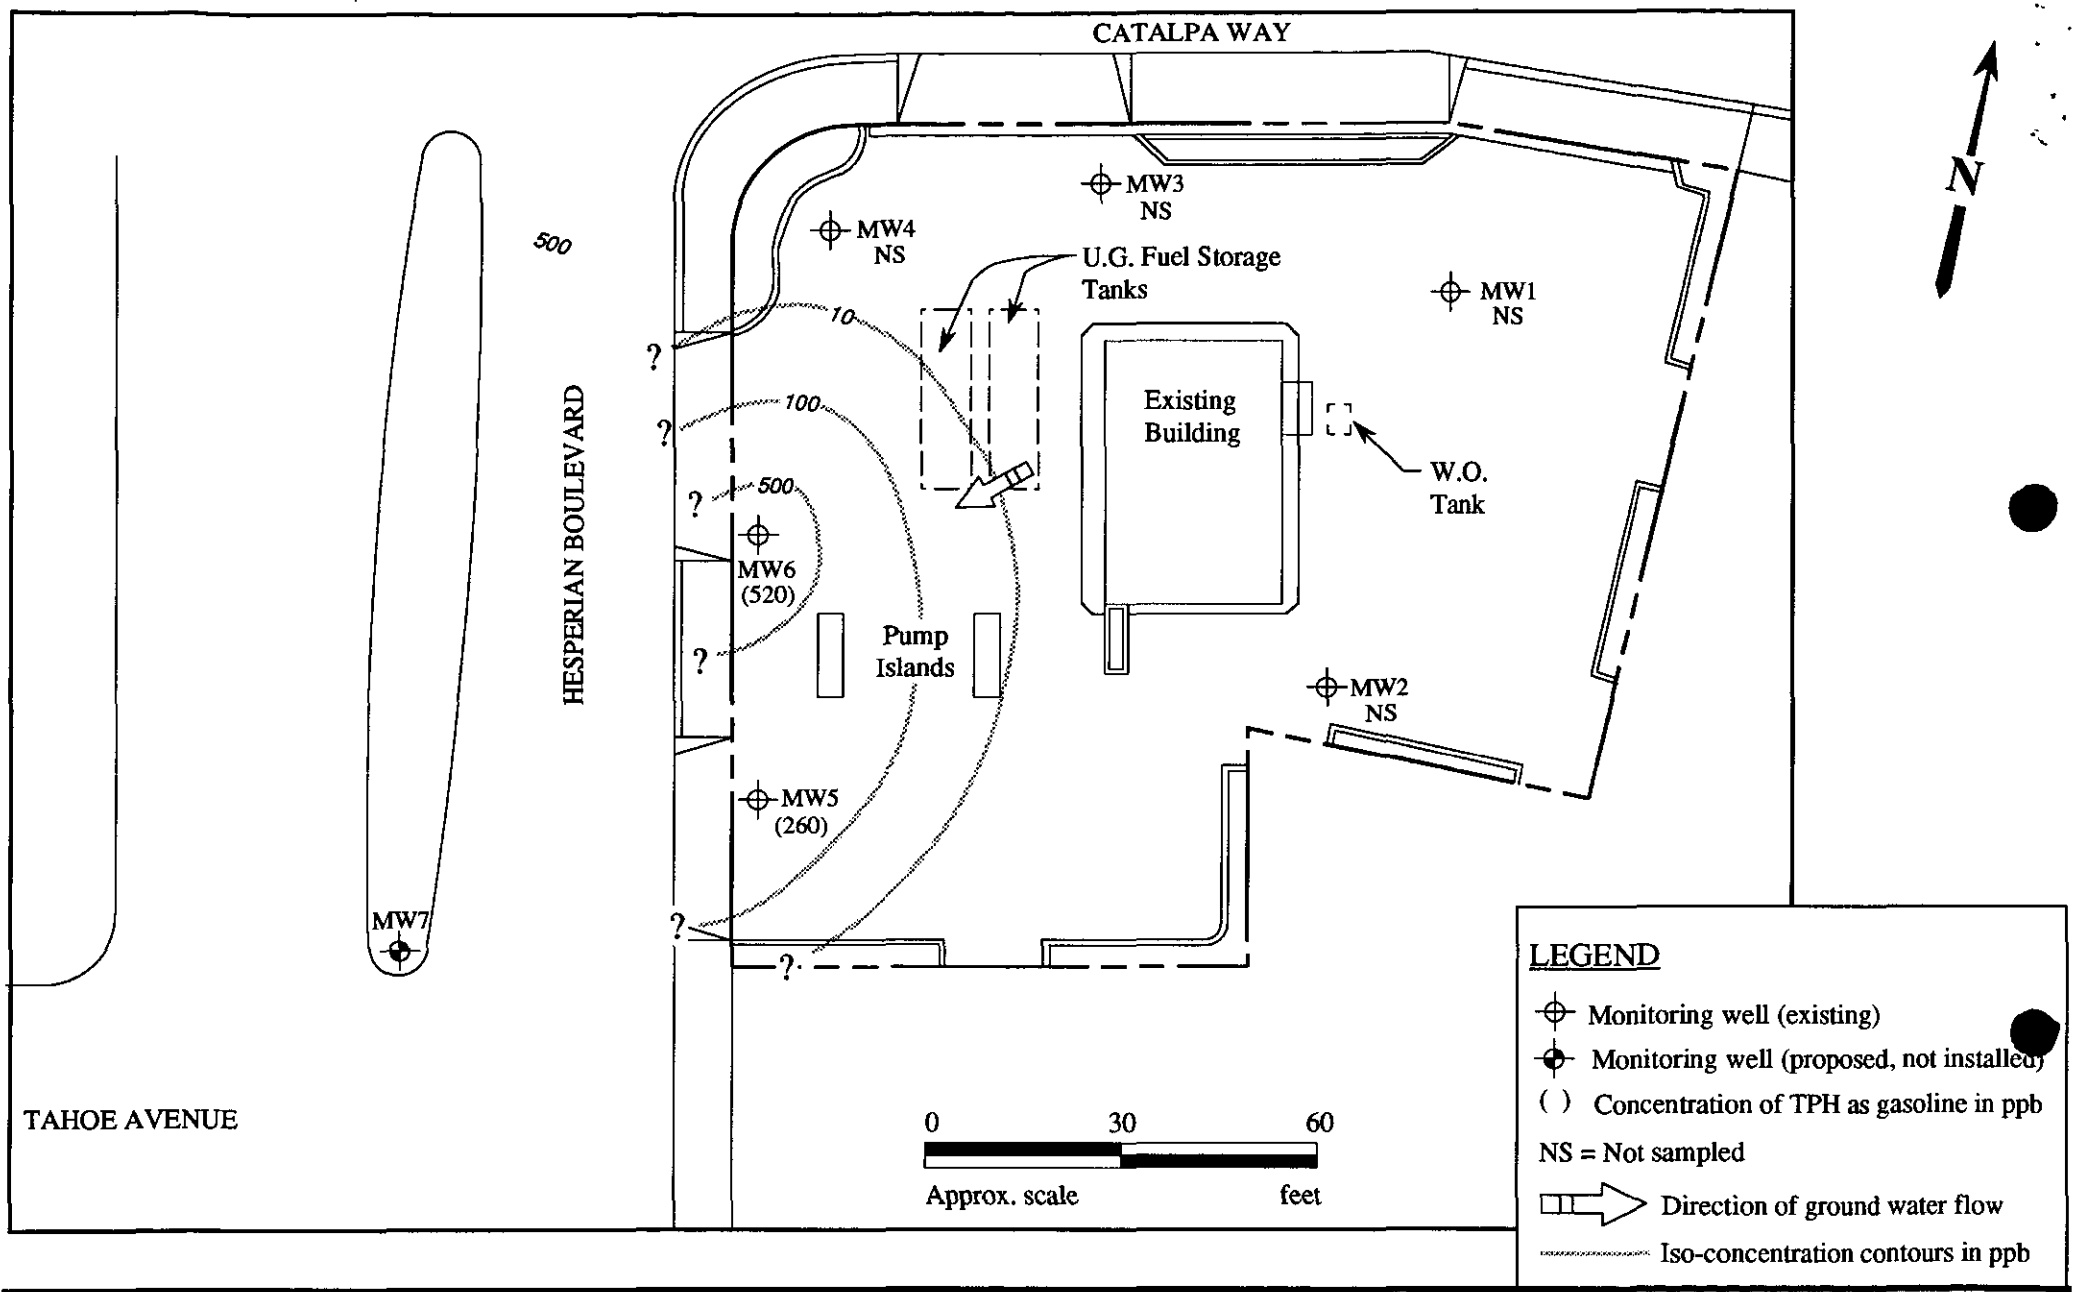
FIGURE
2

The analytical results of all of the ground water samples collected from the monitoring wells to date are summarized in Table 2. The concentrations of TPH as gasoline and benzene detected in the ground water samples collected this quarter are shown on the attached Figures 2 and 3, respectively. Copies of the laboratory analytical results and the Chain of Custody documentation are attached to this report.

TPH AS GASOLINE CONCENTRATIONS IN GROUND WATER ON MAY 3, 1993

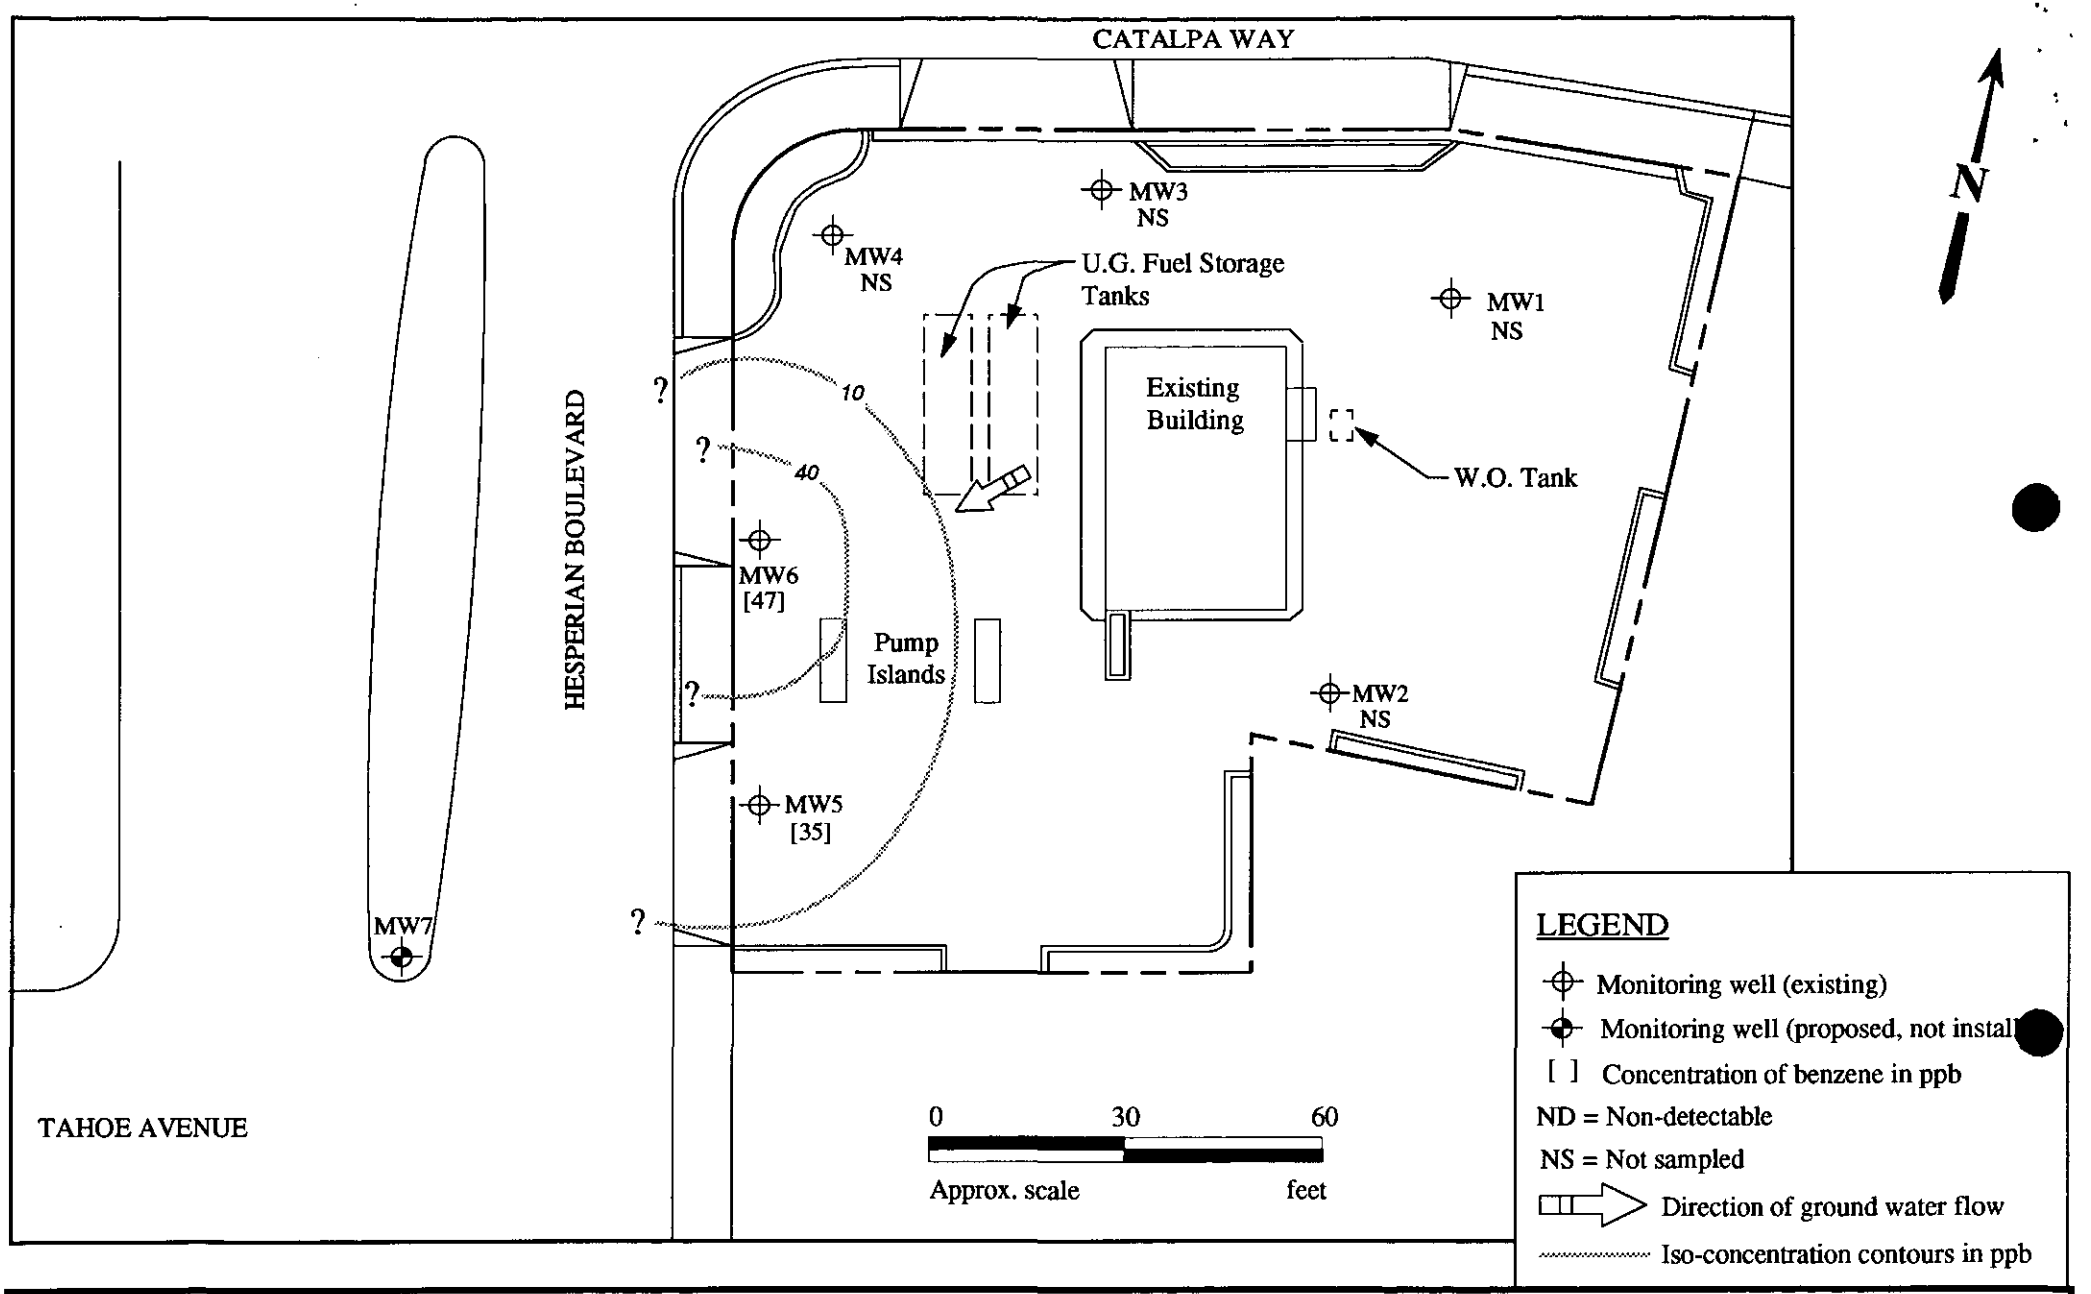
FIGURE
3

BENZENE CONCENTRATIONS IN GROUND WATER ON MAY 3, 1993
