**ALTREA, LLC.**

March 6, 2007

**RE: Revised Work Plan for Subsurface Investigation of Below-Ground Hydraulic Elevator Unit, 7200 Johnson Drive, Pleasanton, CA**

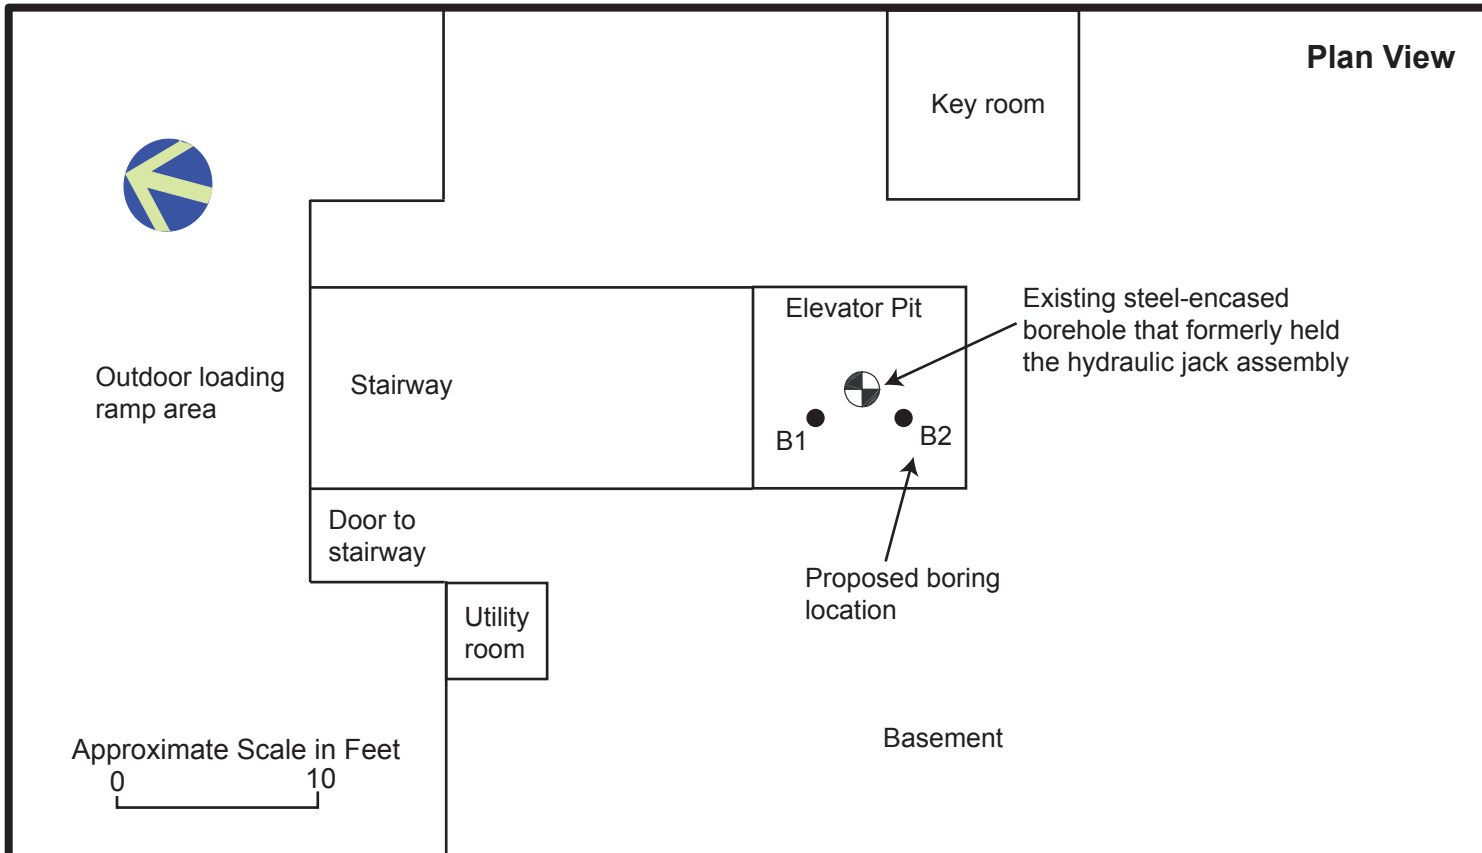
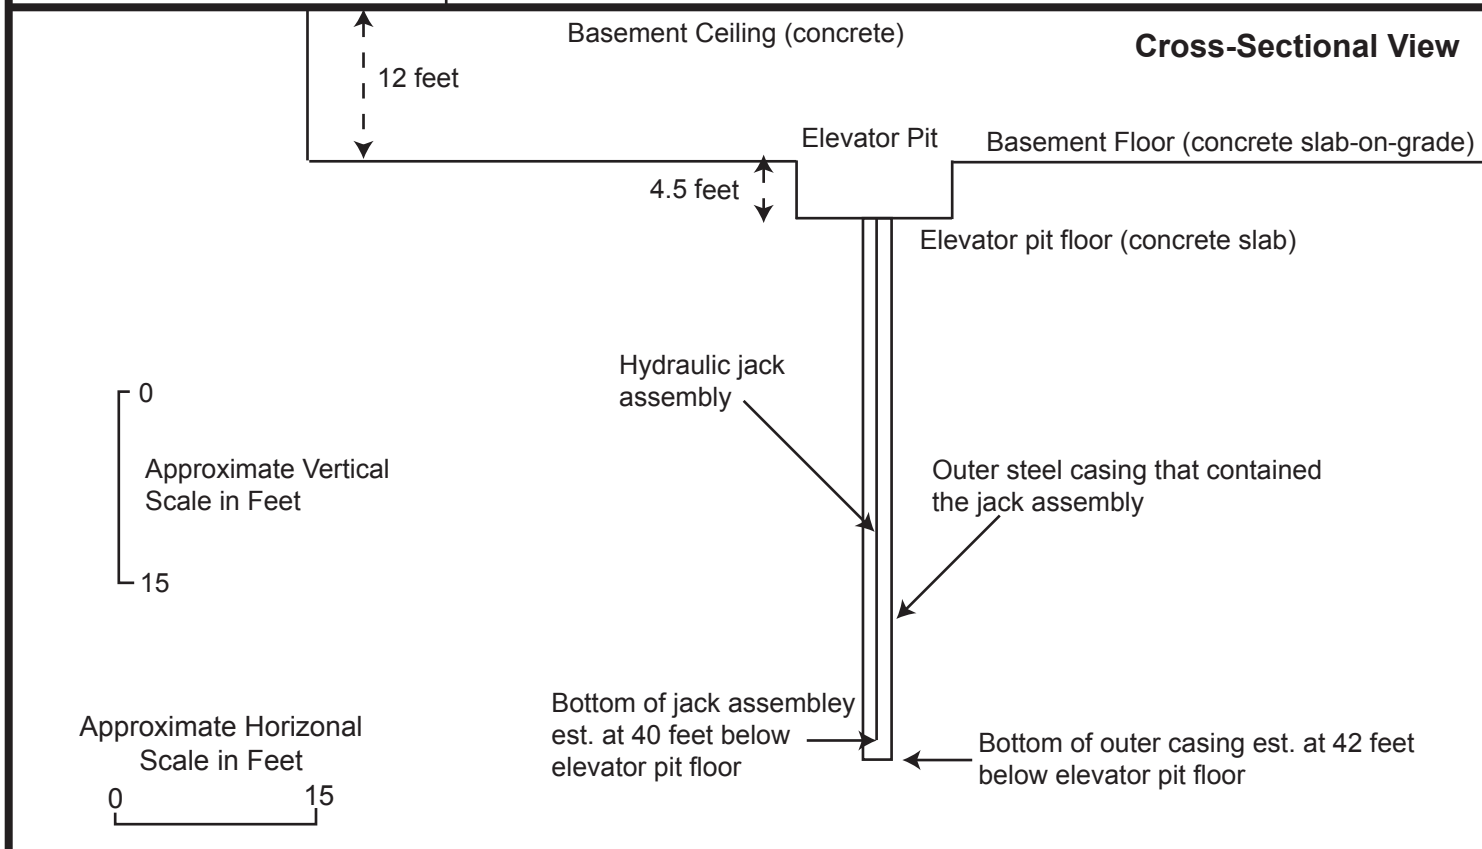
<p>ALTREA LLC P. O. Box 255251 Sacramento, CA 95865</p>	<p>Clorox Services Facility 7200 Johnson Drive Pleasanton, CA</p>	<p><b>Figure 2:</b> <b>Plan View and Cross-Sectional View of</b> <b>Elevator Pit Area in Basement</b> <b>Building No. 3</b></p>
	<p>February 2007</p>

Based on inspection and discussions with Clorox and McRae, the elevator system was comprised of a subsurface closed loop system consisting of a jack assembly (piston and cylinder) installed in an outer steel casing. The jack assembly extended to approximately forty (40) feet below the elevator pit floor. The bottom of the outer steel casing terminated at approximately 42 feet below the elevator pit floor. The elevator pit floor is approximately 4.5 feet below the basement floor. The attached **Figure 2** is a plan view and cross-section of the elevator pit in the basement of Building No. 3.

The hydraulic oil storage tank for the below-ground jack assembly was located at floor level in a utility room in the basement, approximately twenty (20) feet northwest of the elevator pit (**Figure 2**). The hydraulic piping extended above-ground along walls and the basement ceiling from the storage tank to the jack assembly in the elevator pit.

**Figure 2** is a plan view and cross-sectional view of the elevator pit area in the basement of Building No. 3. The figure presents a preliminary schematic of the jack assembly and outer steel casing, as requested in your letter of February 13, 2007. **Figure 2** also presents the proposed boring locations.

- 
- Altreia proposes to drill two (2) boring locations in the elevator pit (**Figure 2**). These borings (B1 and B2) will be drilled in the cored holes described above for access to the subsurface soil materials. These borings will be drilled utilizing portable, continuous-flight hollow-stem auger equipment to be installed in the elevator pit. The diameter of the borings will be approximately 6.5 inches in diameter. An attempt will be made to advance each boring to maximum depth of approximately forty-two (42) feet below the elevator pit floor. A soil sampler consisting of a hollow steel cylinder approximately two (2) feet long and 1.5-inch diameter will be used to retrieve soil samples. The sampler will be loaded with retractable steel sleeves that will contain the soil samples. After advancing the auger flight to the desired sampling depth, the soil sampler will be driven by percussion approximately two (2) feet into the undisturbed soil at the base of the auger flight. The sampler will be retrieved and the geologist will inspect the soil sleeve samples using the Unified Soil Classification System. The soil will be field screened with a portable photo-ionization detector (PID). A selection of soil samples will be collected from each boring for submittal for laboratory analyses. The soil sampler will be cleaned and decontaminated, and loaded with a new set of inner sleeves for the next sampling interval. The borehole will be advanced to the next sampling depth and the soil sampling process repeated. Starting at the base of the elevator pit slab, Altreia plans to collect soil samples at approximately four (4) feet depth intervals for purposes of field inspection and screening. However, Altreia will attempt to perform continuous soil sampling in the 26 to 30 feet depth interval, around the 28-foot depth where the alleged oil leak in the jack assembly occurred.
