FIRST SEMIANNUAL 2016 GROUNDWATER MONITORING AND PRODUCT EXTRACTION REPORT

BRIDGEWATER APARTMENTS PHASE I PARKING GARAGE
6400 CHRISTIE AVENUE
EMERYVILLE, CALIFORNIA

STELLAR
ENVIRONMENTAL SOLUTIONS, INC.
GEOSCIENCE & ENGINEERING CONSULTING

Project No. 2007-65

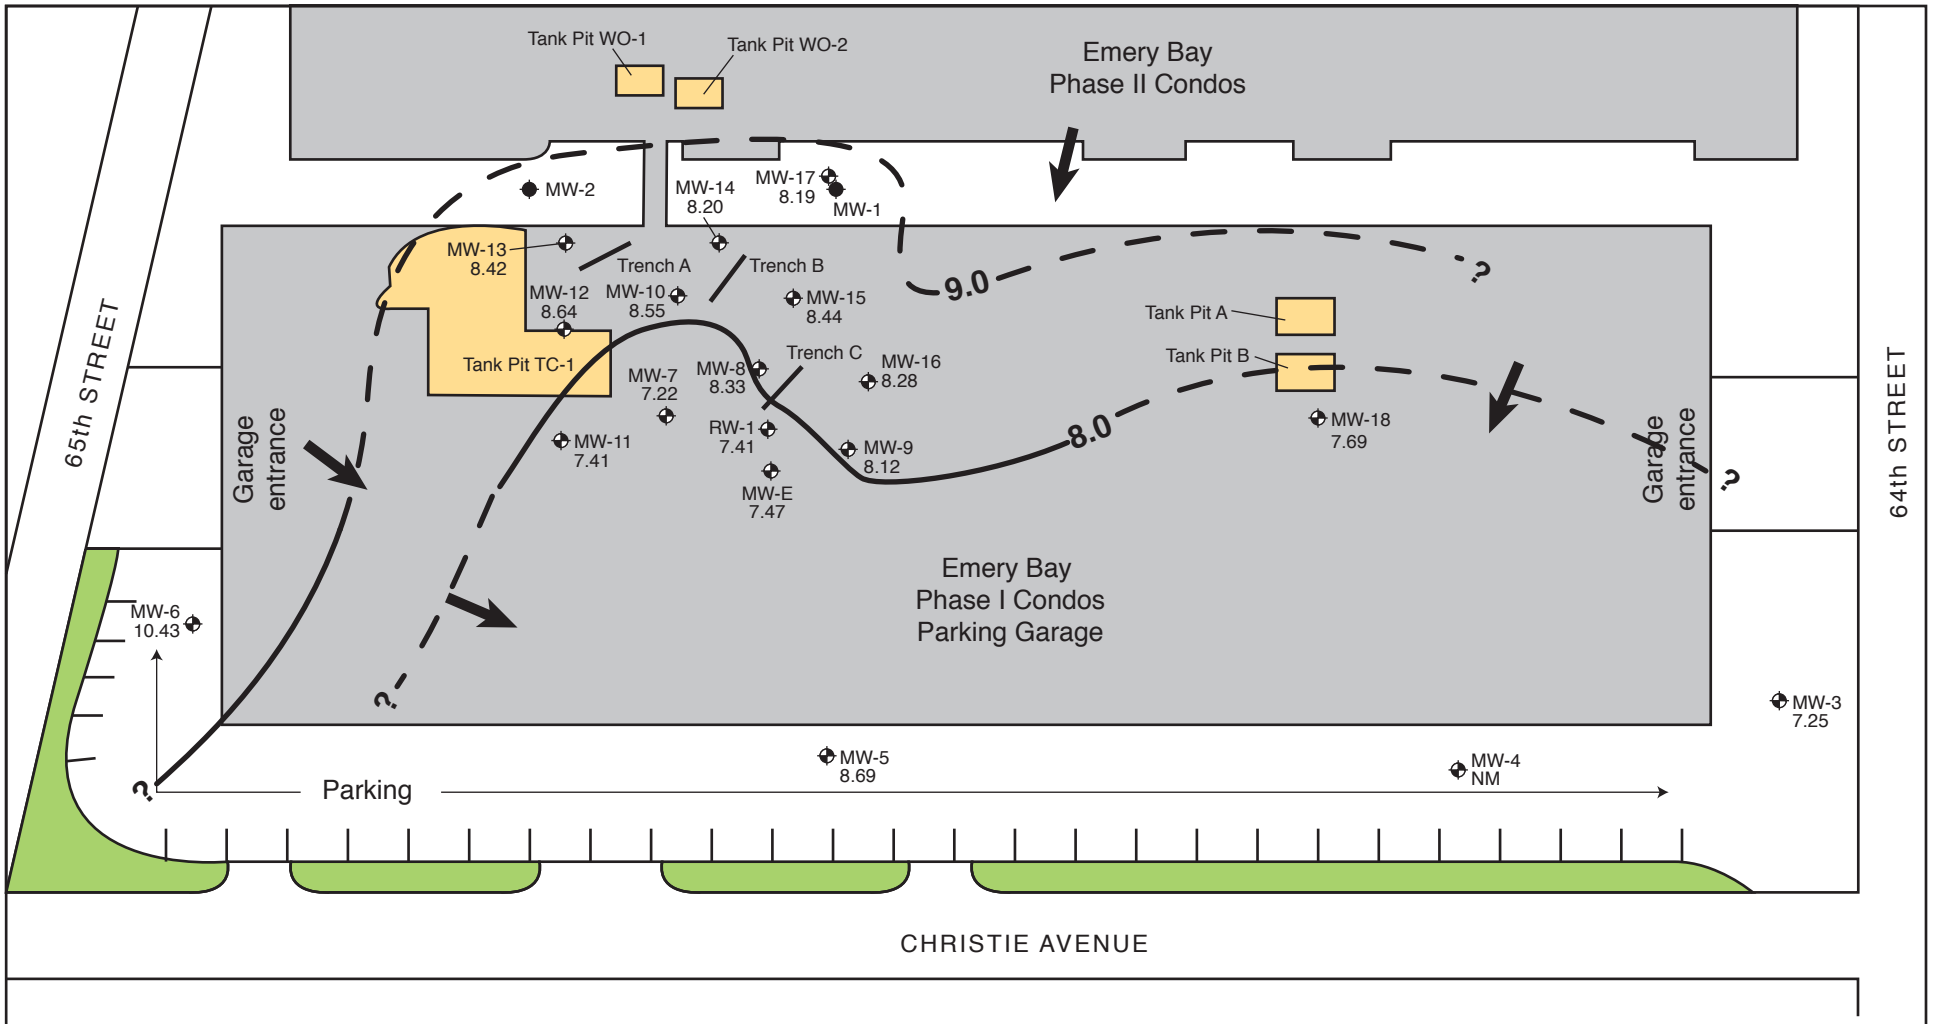
The groundwater flow direction measured during the March 2016 monitoring event was generally towards the west. The localized, approximately southerly direction to groundwater flow in the area of MW-3 noted in the 2013 monitoring events, thought to be the result of construction dewatering that had been occurring during 2013 at the re-development site across 64th Street, appears to have dissipated for the current event, since that de-watering has been discontinued since February of 2014. According to current and historical water level data obtained from onsite monitoring wells, depth to groundwater beneath the site ranges from approximately 7.5 to 10.5 feet below ground surface (bgs). Groundwater elevations recorded during the previous spring monitoring event in March 2015, ranged from 7.03 feet (RW-1) to 9.19 feet (MW-6) above mean sea level. For this Spring monitoring event of March 2016, groundwater elevations ranged from 7.22 feet (MW-7) to 10.43 feet (MW-6) above mean sea level, with the average groundwater gradient for the current monitoring event being 0.007 foot/foot.

Figure 4 is a groundwater elevation map from the recent groundwater-monitoring event (activities discussed in Section 4.0).

- The groundwater flow direction calculated during this monitoring event was found to be generally to the west. Some mounding is evident in the area of MW-4 which is likely due to water accumulating from landscape irrigation leaks (MW-4 well box often full of water).

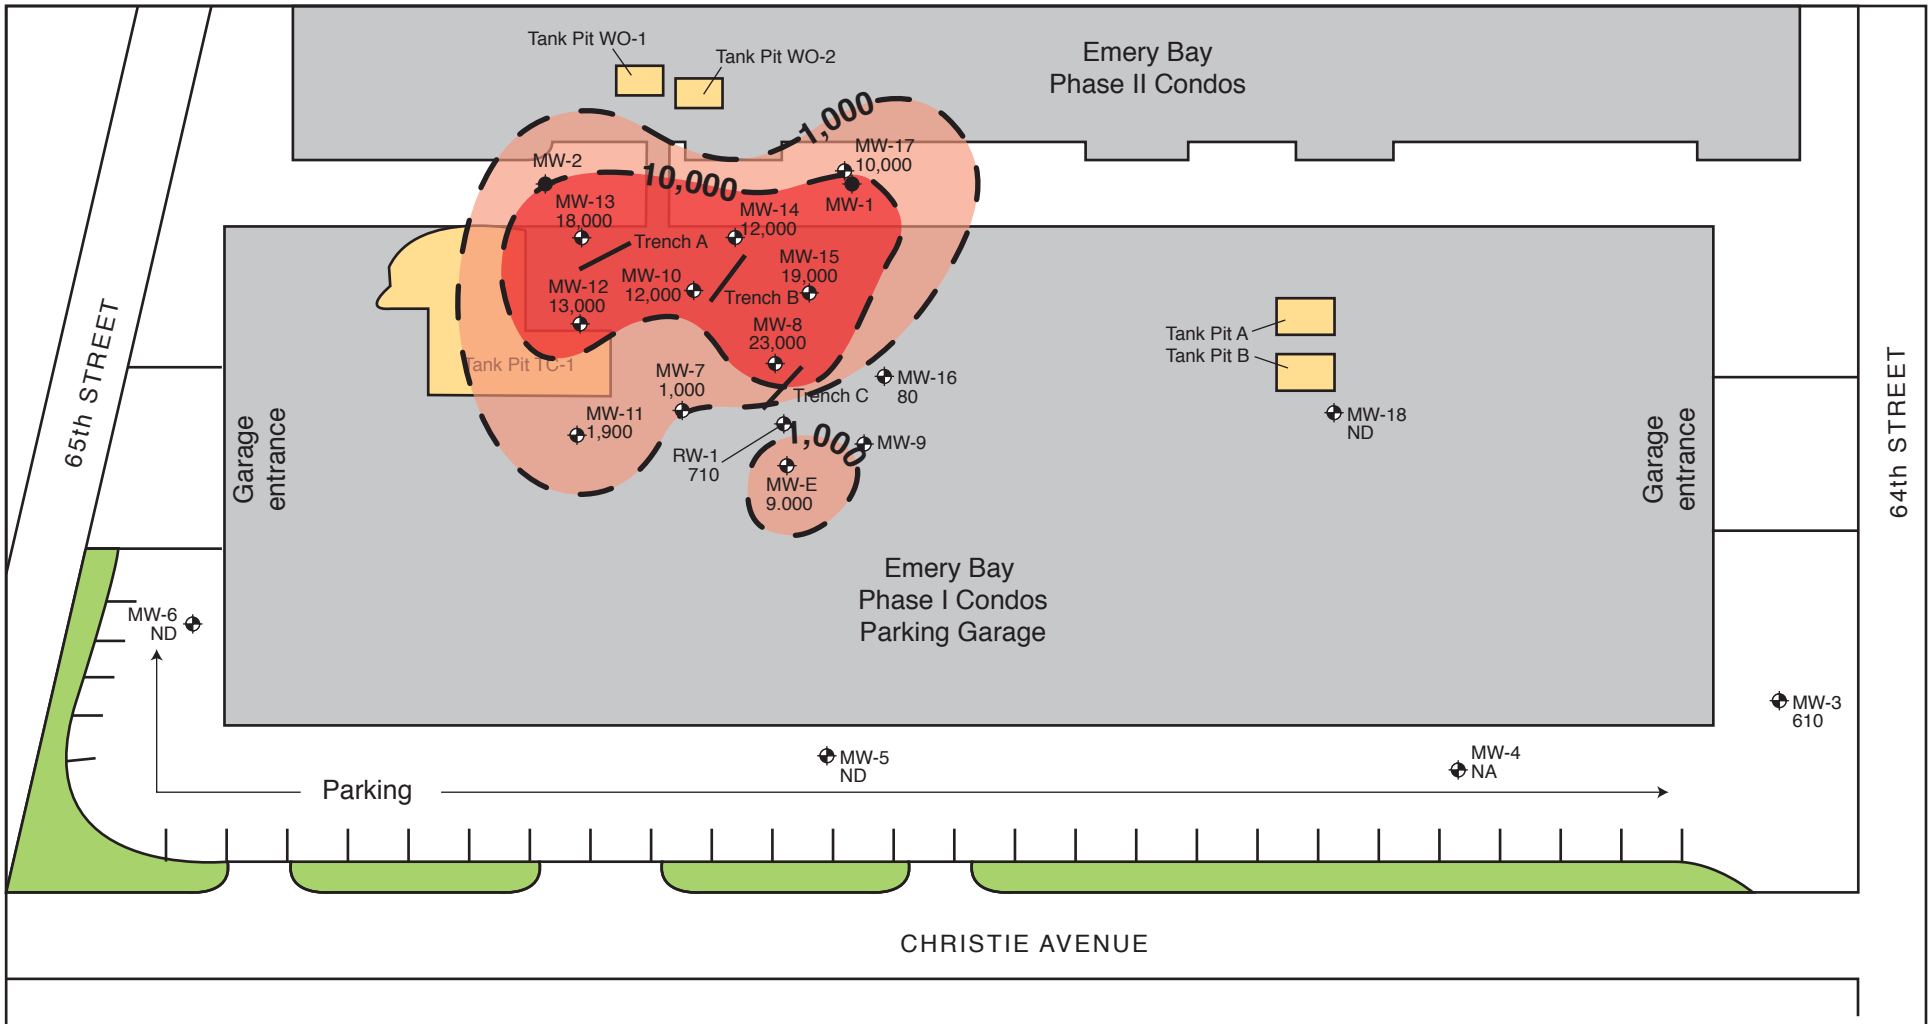
TOTAL PETROLEUM HYDROCARBONS AS GASOLINE—Q1, 2016

The highest concentrations of TVHg (23,000 µg/L in MW-8) and TEHd (11,000 µg/L in MW-13) for the current event compares to concentrations of 36,000 µg/L TVHg and 20,000 µg/L TEHd at MW-8 in March 2015. Concentrations of hydrocarbons in well MW-13 have decreased steadily since the September 2012 sampling event, with TVHg decreasing from 60,000 µg/L to 18,000 µg/L, and TEHd decreasing from 7,200,000 µg/L in 2012 to the current 11,000 µg/L. Concentrations of TVHg at well MW-13 have increased when compared to the 14,000 µg/L measured in March 2015. Concentrations of hydrocarbons in well MW-8 fluctuated since the March 2012 sampling event, with TVHg increasing from 380 µg/L in 2012 to 23,000 µg/L for the current event, and TEHd decreasing from 9,800 µg/L in 2012 to the current 1,200 µg/L.

Figures 6 and 7 are isoconcentration maps of TPHg and TEHd concentrations in groundwater based on the March 31, 2016 analytical results.

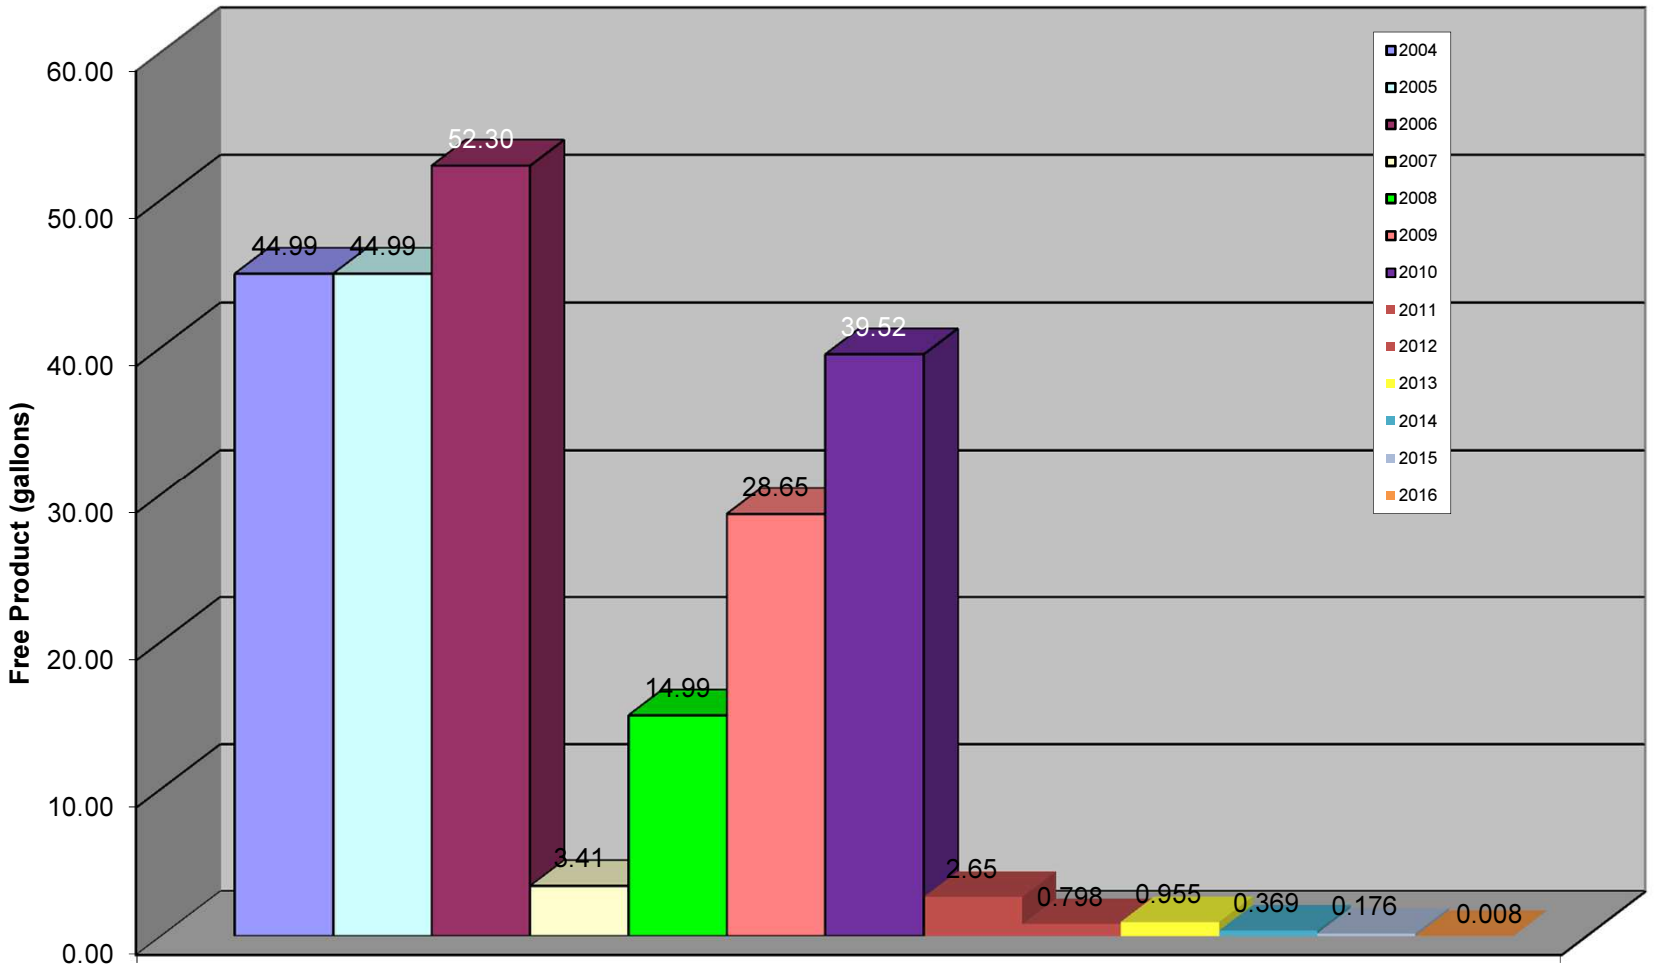
Figure 11
Total Free Product Extracted Per Year
6400 Christie Avenue, Emeryville, CA

- Stellar Environmental conducted active product removal on the source area wells, recovery well RW-1, and site monitoring wells except for MW-4 which was inaccessible. A total of approximately 560 gallons of groundwater that includes approximately 0.0078 gallons of free-floating petroleum product from all the wells was removed with the estimate based on free-product accumulation in the extraction drum after pumping each well. Although free product was noted by Blaine Tech Services in wells MW-8, MW-10, MW-11, MW-13 and MW-15, the only well noted to actually yield free product during the extraction process for the current event was well MW-10. The reduction of recovered product to the current volume of 0.0078 gallons represents the sixth consecutive sampling event that has shown a reduction of recovered product.

- A seventh application of surfactant should be conducted in wells MW-8, MW-10, MW-11, MW-13, and MW-15 in mid-July 2016. These are the only wells currently onsite that currently contain detectable free, degraded product that can be expected to respond to the surfactant. The timing of the surfactant application in July is recommended to allow the introduction of additional Nutrisulfate® in mid-late August, about 4 to 6 weeks prior to the second 2016 semi-annual monitoring event scheduled for the end of September 2016.
