# FIRST QUARTER 2011 GROUNDWATER MONITORING REPORT AND SITE CLOSURE PETITION

## R & H AUTO REPAIR
## 5315 SAN PABLO AVENUE
## OAKLAND, CALIFORNIA

Project No. 2010-06

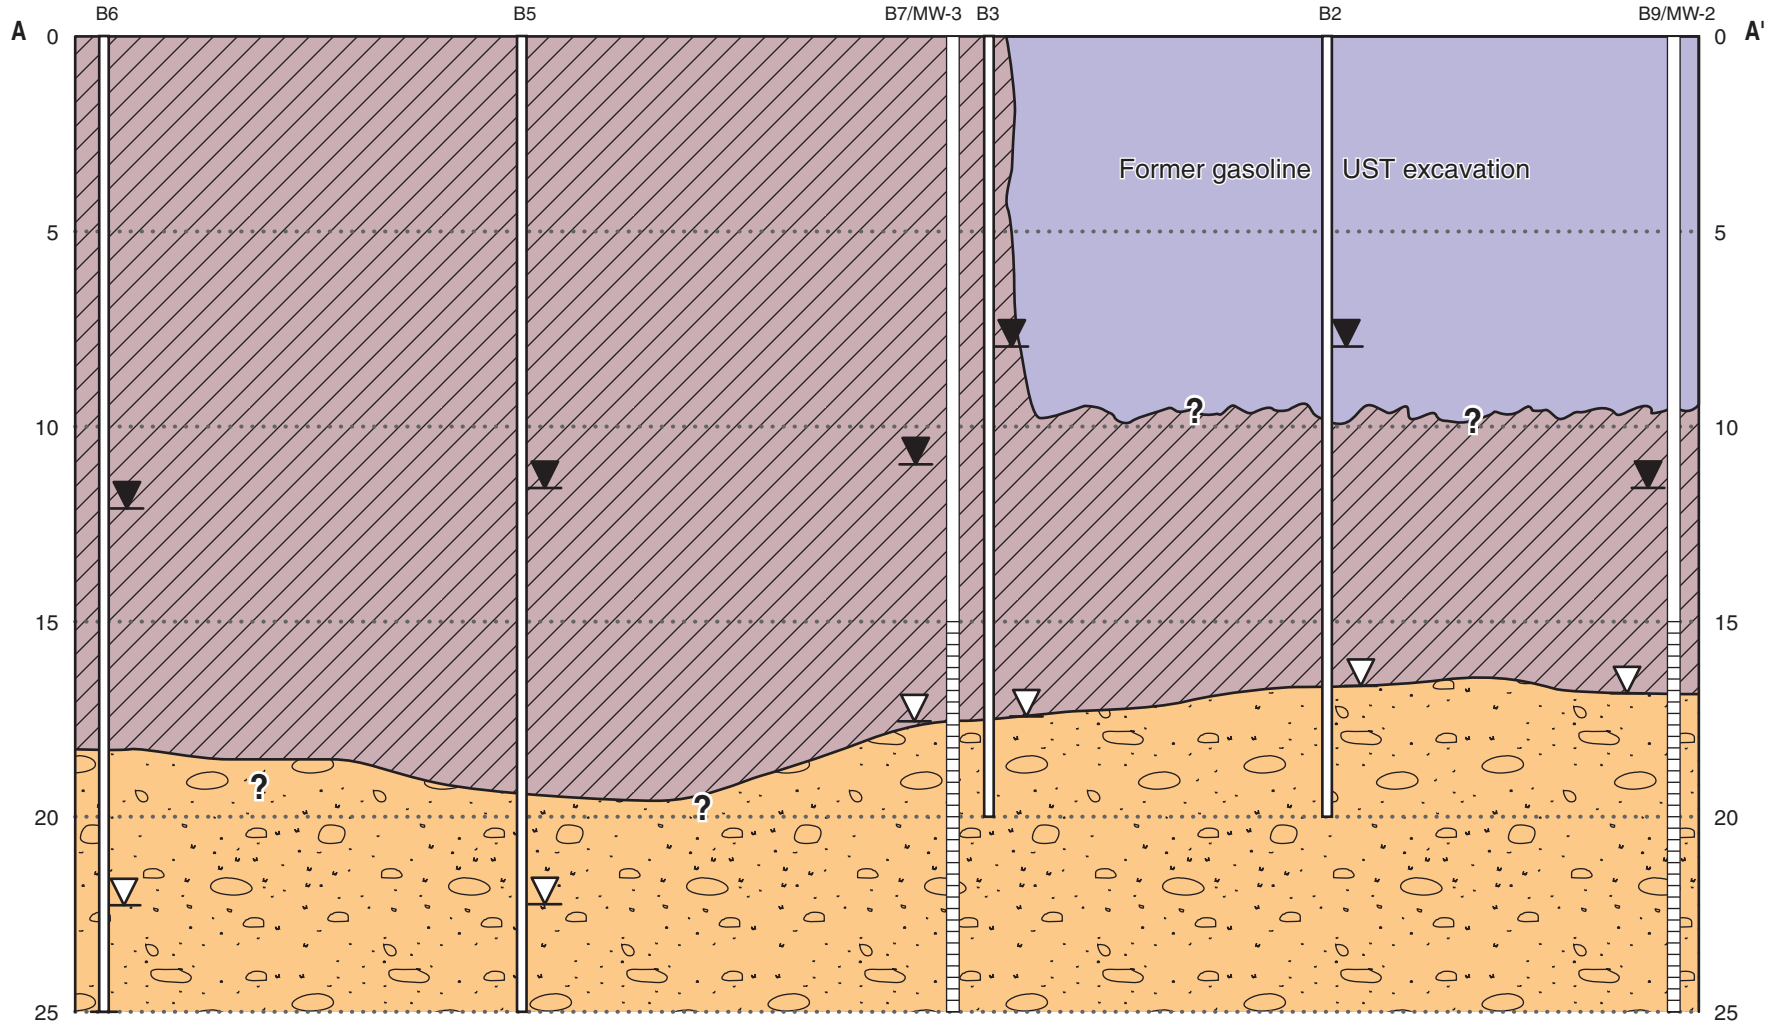
**Figure 3**

Site-specific lithology has been characterized to a depth of 20 feet bgs in onsite borings B1, B2, and B3; to a depth of 22 feet bgs in boring B4; and to 25 feet bgs in onsite and offsite borings B5 through B9. Subsurface lithology can be described as silty clay to gravelly clay fill with fragments of brick to approximately 2.5 feet bgs. The upper fill is underlain by native, low permeability, stiff, expansive, silty clay to about 17 feet bgs. Between 17 feet and 25 feet bgs, interbedded layers of moist to saturated sandy silt, silty sand, and clayey gravel are present. Geologic cross-section A-A' depicting the shallow site lithology is shown on Figure 3.

# GEOLOGIC CROSS SECTION AREA A-A'

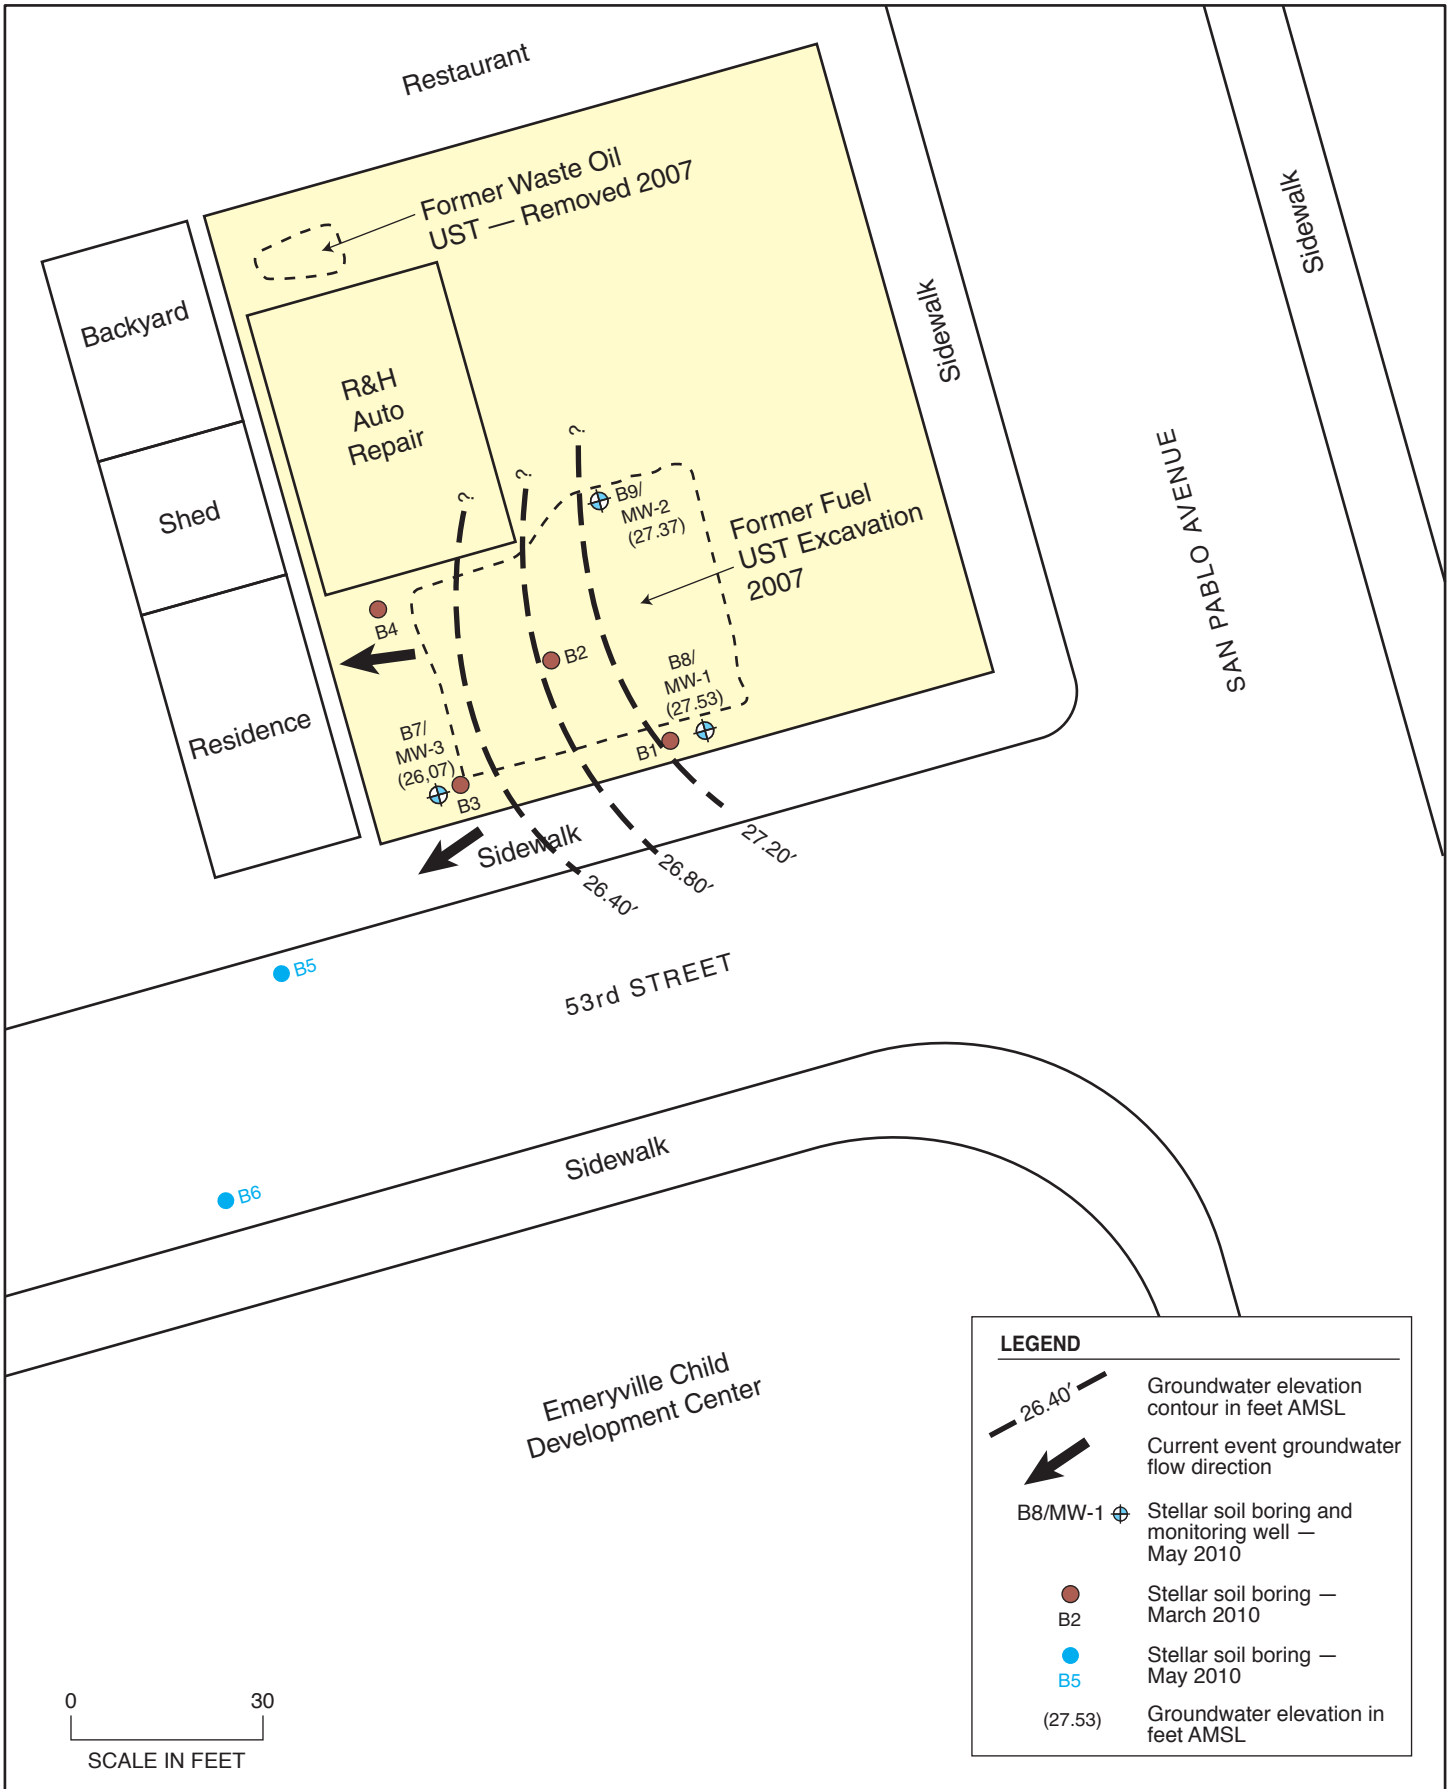
| | Figure 4 | |

Figure 4 is a groundwater potentiometric surface map for the current groundwater monitoring event that occurred on February 11, 2011 (activities discussed in Section 3.0).

# GROUNDWATER ELEVATION MAP, FEBRUARY 11, 2010

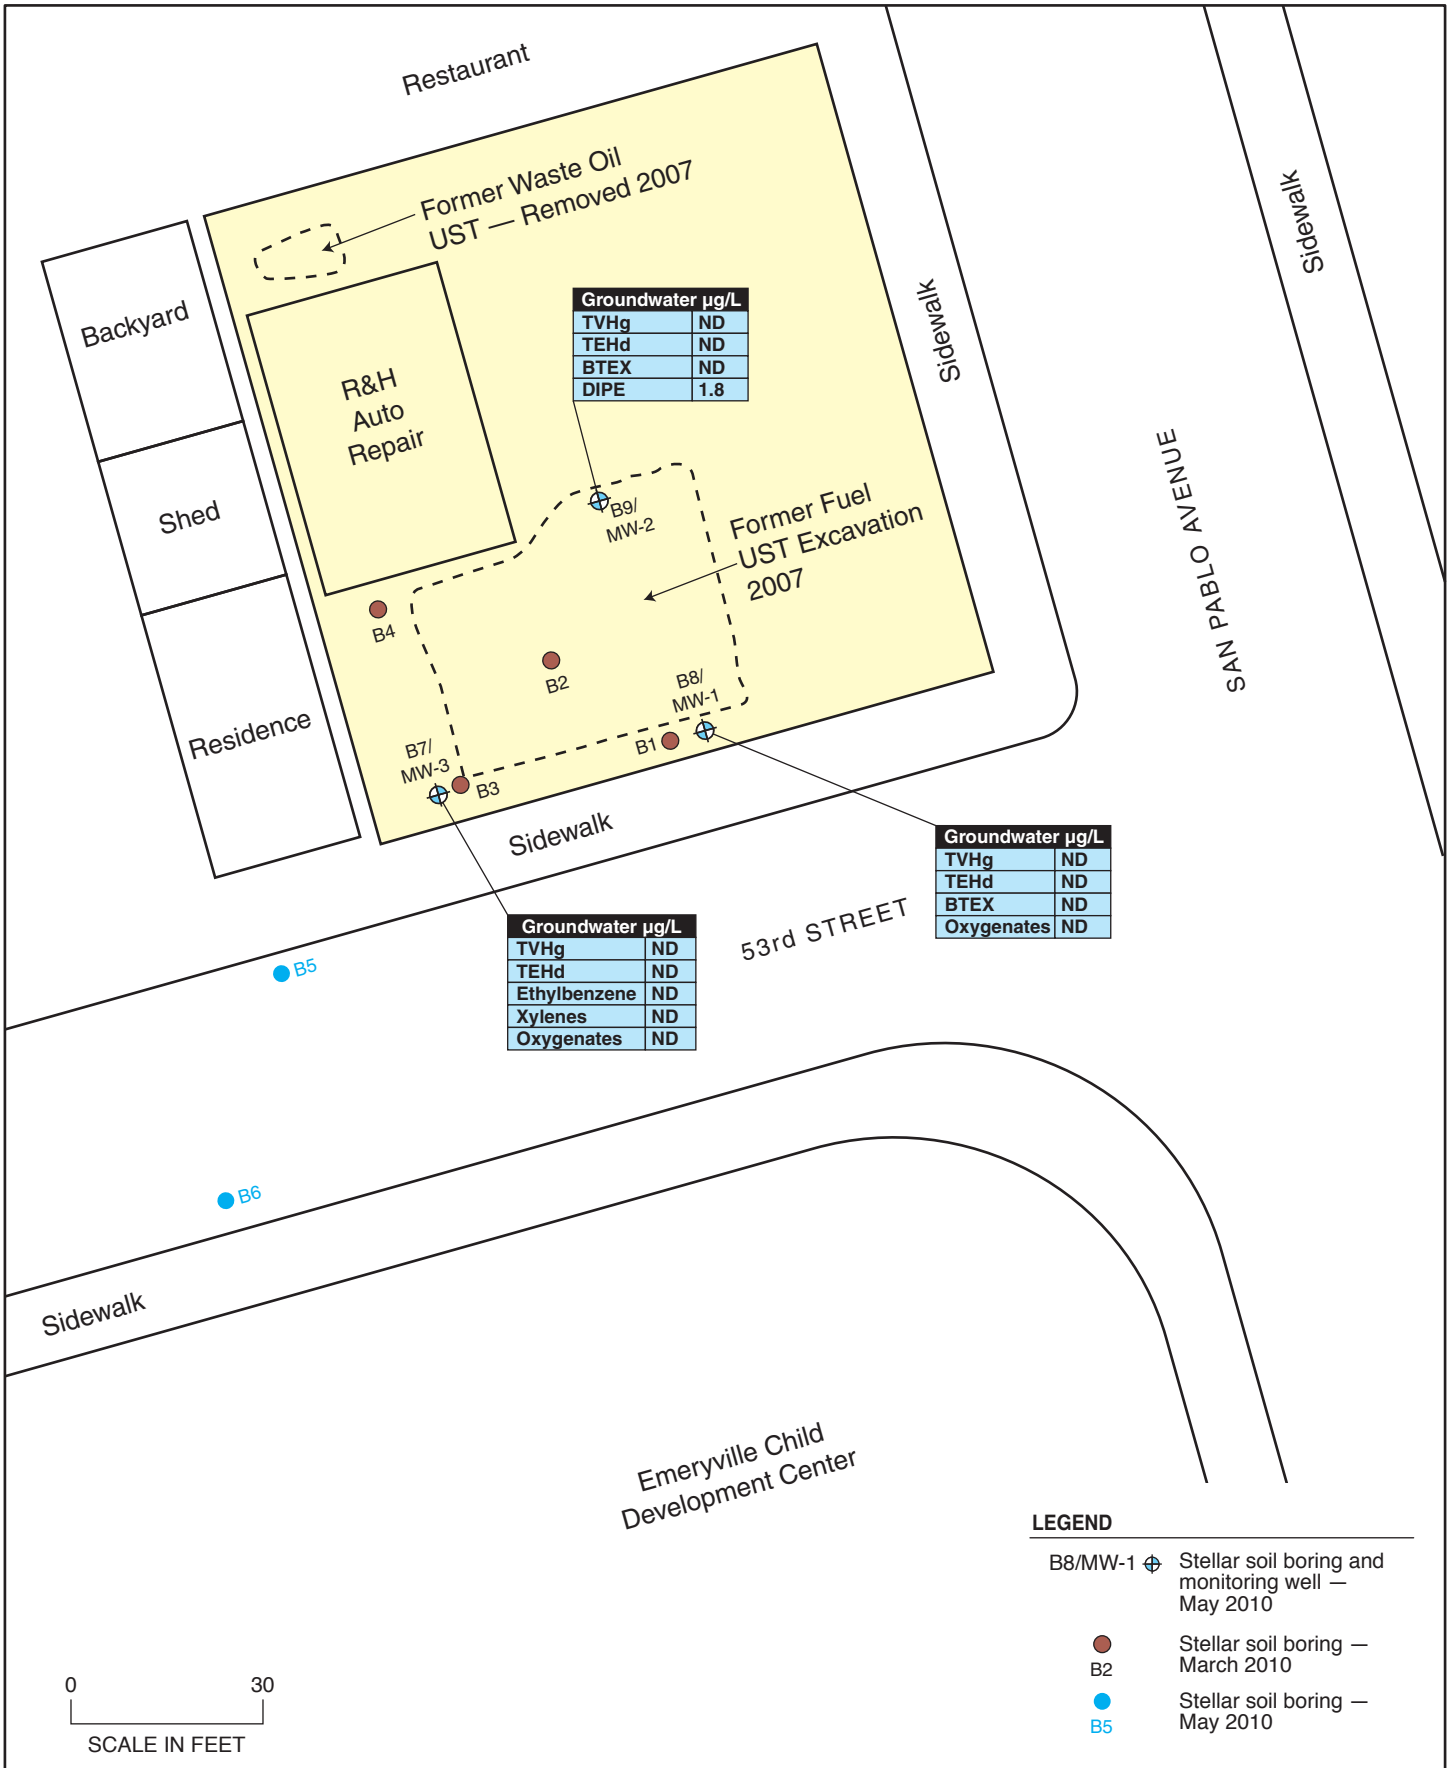
# CONTAMINANTS OF CONCERN IN MONITORING WELLS, FEBRUARY 11, 2011

Although well MW-3 contained 0.58 µg/L ethylbenzene and 0.64 µg/L xylenes for the first event (2nd Quarter 2010), no detectable concentrations of TVHg, TEHd and BTEX were found in any of the wells for the subsequent three consecutive quarters. With the exception of DIPE ranging between 1.6 µg/L and 2.1 µg/L in well MW-2 for all four sampling events, no fuel oxygenates have been detected in any of the wells.
