# GEOTECHNICAL INVESTIGATION ISLANDER MOTEL UPGRADE 2428 CENTRAL AVENUE Alameda, California

Resources for Community Development Alameda, California

> 16 June 2011 Project No. 750604801

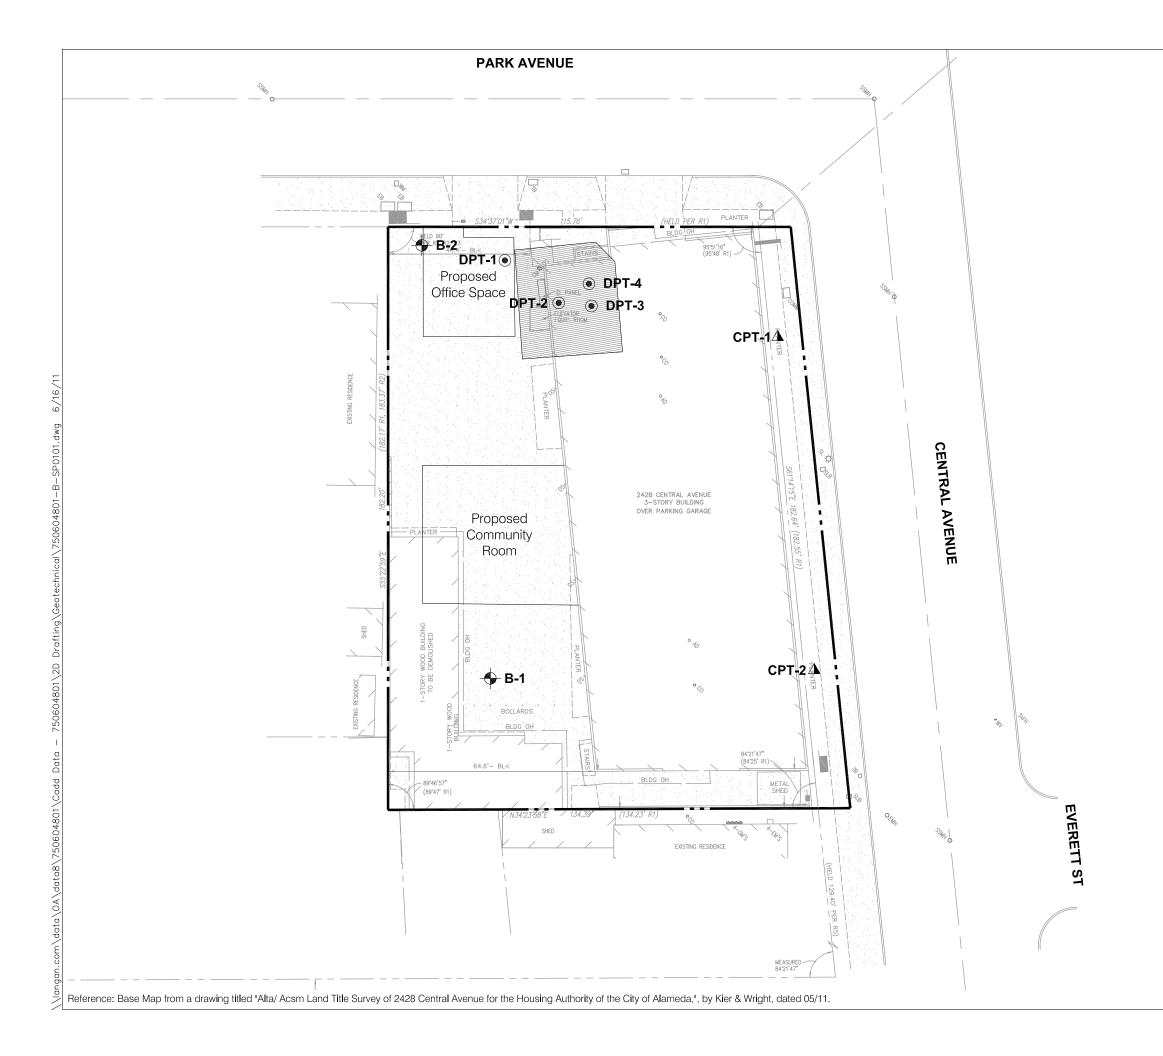
# ISLANDER MOTEL UPGRADE Alameda, California SITE PLAN Date 05/26/11 Project No. 750604801 Figure 2 Treadwell&Rollo

B-1 🔶	Approximate location of boring by Treadwell & Rollo, Inc., May 2011
СРТ-1 🛆	Approximate location cone penetration test by Treadwell & Rollo, May 2011
DPT-1 🖲	Approximate location of dynamic penetration test by Treadwell & Rollo, May 2011
	Approximate location of former underground storage tanks
	Property boundary

Prior to construction of the Islander Motel, the project site was occupied by a Chevron service station. Gettler-Ryan, Inc. prepared a groundwater monitoring assessment report, dated 9 October 1998, regarding the former service station and documented the location of four former underground storage tanks (USTs). This work was conducted in accordance with the environmental closure of the site. These tanks were removed and subsequently backfilled prior to construction of the motel building. Based on the site plan provided by Gettler-Ryan, Inc. it appears that the four tanks were located in the vicinity of the southwestern corner of the existing motel. The general location of the four tanks is also shown on the Site Plan, Figure 2.

To explore the subsurface conditions at the project site we drilled two borings and advanced two CPTs and four DPTs. The approximate locations of the borings, CPTs, and DPTs are presented in the Site Plan, Figure 2. Prior to performing the field investigation, we:

Four dynamic cone penetration tests were advanced at the site by our field engineer on 23 May 2011. We advanced the four DPTs at the locations of the former USTs. The location of the four DPTs are presented on the Site Plan, Figure 2. The purpose of the DPTs was to evaluate the condition of the tank backfill material.

As discussed in Section 6.1, the existing fill within the area of the former USTs is potentially liquefiable. The exact aerial limits of this fill are not currently known; however, Figure 2 presents our estimate of the portion of the site underlain by fill associated with tank backfill. Beneath a depth of 6.7 feet, we judge portions of this fill are potentially liquefiable. The top of the potentially liquefiable fill is about 4 <sup>1</sup>/<sub>2</sub> feet from the bottom of the existing footings.

The proposed structures (office building, community room, staircase, and elevator) may be supported on shallow isolated interior and continuous perimeter footings bearing in native Dune sand. New and existing footings within the portion of the site underlain by UST backfill (see Figure 2) should be underpinned or otherwise gain support in the dense native Dune sand beneath the fill. Underpinning is discussed further in the following section.

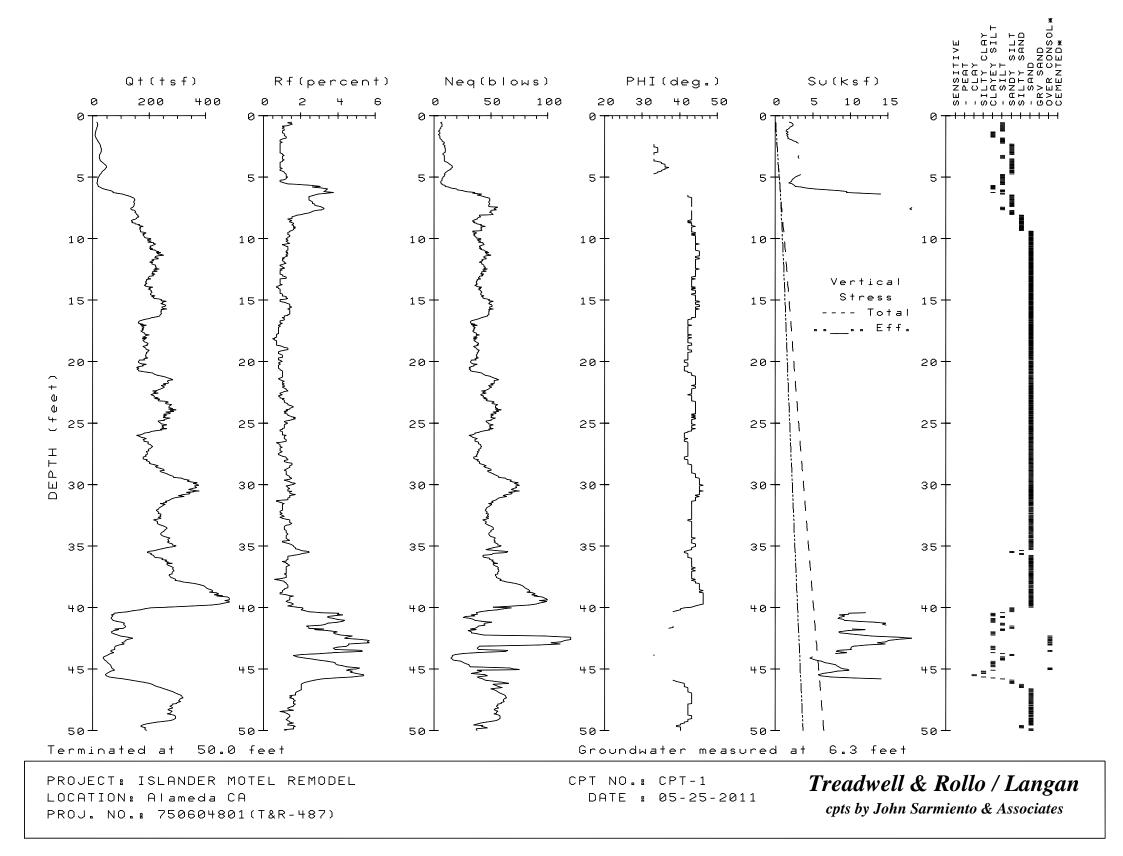
LOCAT PROJ.	'ION: Ala NO.: 750	ANDER M Imeda CA 0604801(T 50.0 feet		NODEL		TIME :	CPT-1 05-25-201 11:58:00 easured at	1	cpis by John Surmento & Associates			
DEPTH (feet)	Qt (tsf)	Qt' (tsf)	Fs (tsf)	Rf (%)	SPT (N)	SPT' (N')	EffVtStr (ksf)	PHI (deg.)	SU (ksf)	SOIL BEHAVIOR TYPE	DENSITY RANGE (pcf)

0.54	40.0	00.40	0.01	4 5	-		0.00		4.04		100 110	
0,51 1,02	13,9 14,2	22,16 22,66	0,21 0,15	1,5 1,0	7 6	11 9	0,06 0,11		1,84 1.88	Clayey SILT to Silty CLAY Sandy SILT to Clayey SILT	100-110	
1,53	8,9	14,29	0,10	1,0	4	7	0,16		1,00	Clayey SILT to Silty CLAY	90-100	
2,04	18,3	29,30	0,17	0,9	7	12	0,21		2,43		100-110	
2,53	28,3	45,34	0,25	0,9	9	15	0,27	33		Silty SAND to Sandy SILT	"	
3,02	27,6	44,11	0,26	0,9	9	15	0,32	33		"	"	
3,52	25,6	40,94	0,25	1,0	9	14	0,37	33		"	"	
4,01	45,9	73,42	0,41	0,9	15	24	0,43	36			110-120	
4,50	35,5	56,77	0,35	1,0	12	19	0,48	35		11	"	
5,06	19,8	31,65	0,24	1,2	8	13	0,55		2,60	Sandy SILT to Clayey SILT	"	
5,53	17,4	27,81	0,23	1,3	7	11	0,60		2,28	"	"	
6,03	53,1	84,90	1,74	3,3	21	34	0,67		7,03		130-140	
6,51	124,1	198,58	3,18	2,6	41	66	0,70	42		Silty SAND to Sandy SILT		
7,06	144,4	230,99	3,81	2,6	48	77	0,74	43	47.04		"	
7,52	135,0	215,94	4,34	3,2	54 52	86	0,78		17,94	Sandy SILT to Clayey SILT	"

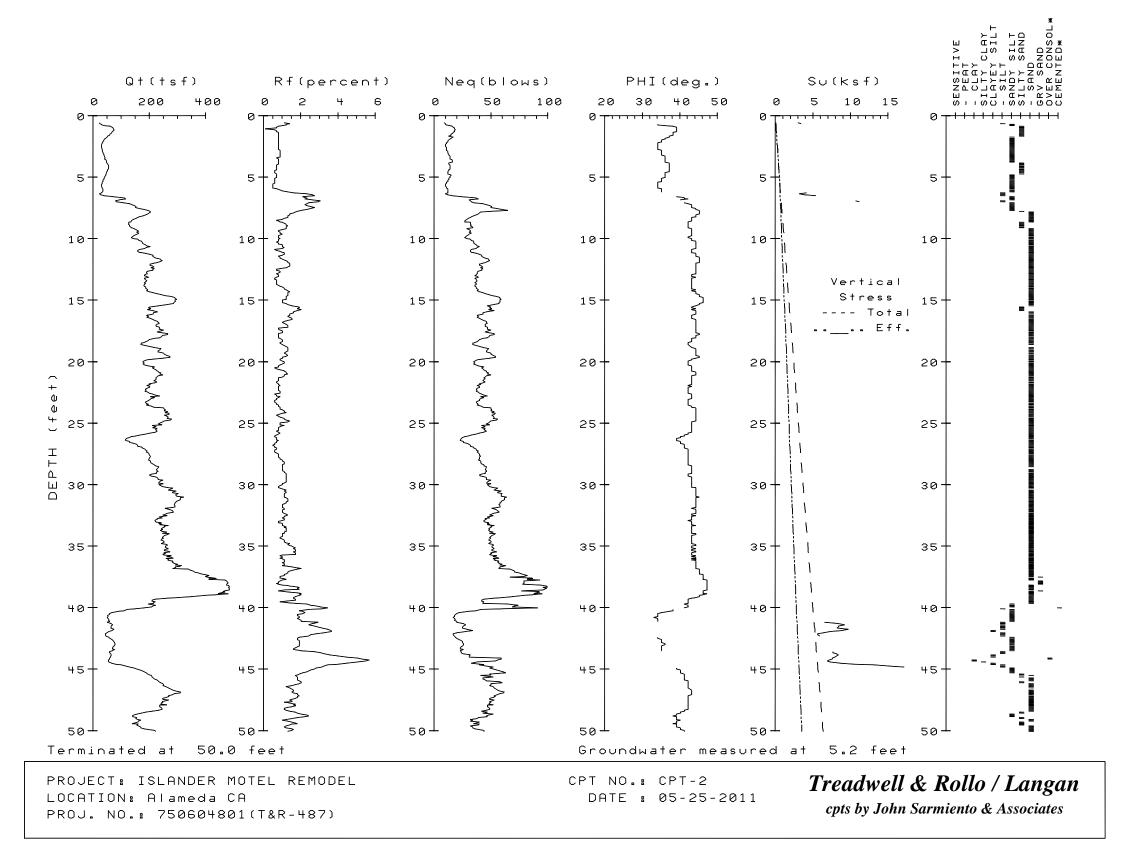
LOCAT PROJ.	10N: Ala NO.: 750	ANDER M Imeda CA 0604801(T 50.0 feet	OTEL REN "&R-487)	NODEL		CPT-2 05-25-201 10:54:00 easured at	1	cpis by foun summento & Associate			
DEPTH (feet)	Qt (tsf)	Qt' (tsf)	Fs (tsf)	Rf (%)	SPT (N)	SPT' (N')	EffVtStr (ksf)	PHI (deg.)	SU (ksf)	SOIL BEHAVIOR TYPE	DENSITY RANGE (pcf)
0,58	22,6	36,11	0,26	1,1	9	14	0,07		3.00	Sandy SILT to Clayey SILT	110-120
1,00	72,6	116,16	0,54	0,7	18	29	0,12	39		SAND to Silty SAND	"
1,52	60,5	96,80	0,50	0,8	15	24	0,17	38			"
2,05	36,8	58,90	0,29	0,8	12	20	0,23	35		Silty SAND to Sandy SILT	100-110
2,50	31,1	49,74	0,25	0,8	10	17	0,28	34		"	"
3,04	36,8	58,91	0,32	0,9	12	20	0,34	35		"	110-120
3,52	40,9	65,49	0,33	0,8	14	22 22	0,40	36 37			
4,02 4,56	55,4 49,3	88,70 78,93	0,41 0,31	0,7 0,6	14 12	22	0,45 0,51	37 37		SAND to Silty SAND	100-110
5,03	40,9	65,47	0,27	0,0	14	22	0,56	36		Silty SAND to Sandy SILT	"
5,57	31,5	50,35	0,17	0,5	10	17	0,58	34		"	90-100

6,04	36,3	58,11	0,31	0,9	12	19	0,60	35		11	110-120
6,51	40,5	64,80	1,08	2,7	16	25	0,64		-	Sandy SILT to Clayey SILT	130-140
7,00	83,6	133,70	2,43	2,9	33	52	0,67		11,09	"	"
7,56	164,6	263,28	4,15	2,5	55	88	0,71	44		Silty SAND to Sandy SILT	
8,06	186,1	297,68	2,57	1,4	37	60	0,75	44		SAND	
8,51 9,04	137,6	220,16 214,34	0,97 1,63	0,7	28 34	44 54	0,77 0,80	43 42		SAND to Silty SAND	110-120 120-130
9,04 9,55	134,3 163,2	214,34 255,16	1,63	1,2 0,9	34 33	54 51	0,80 0,84	42 43		SAND to Silly SAND SAND	120-130
10,06	159,4	244,11	1,33	0,8	32	49	0,87	43		"	
10,50	185,5	278,95	1,77	1,0	37	56	0,90	44		"	
11,03	157,8	232,19	1,36	0,9	32	46	0,93	43			
11,57	222,6	319,82	2,10	0,9	45	64	0,96	45		"	"
12,07	202,4	283,41	2,88	1,4	40	57	1,00	44		11	130-140
12,57	210,9	292,50	1,57	0,7	42	59	1,03	44			110-120
13,00	182,2	250,54	1,45	0,8	36	50	1,05	43			
13,51 14,01	186,2	253,44 250,77	1,39 2,04	0,7	37 37	51 50	1,07 1,11	43 43			120-130

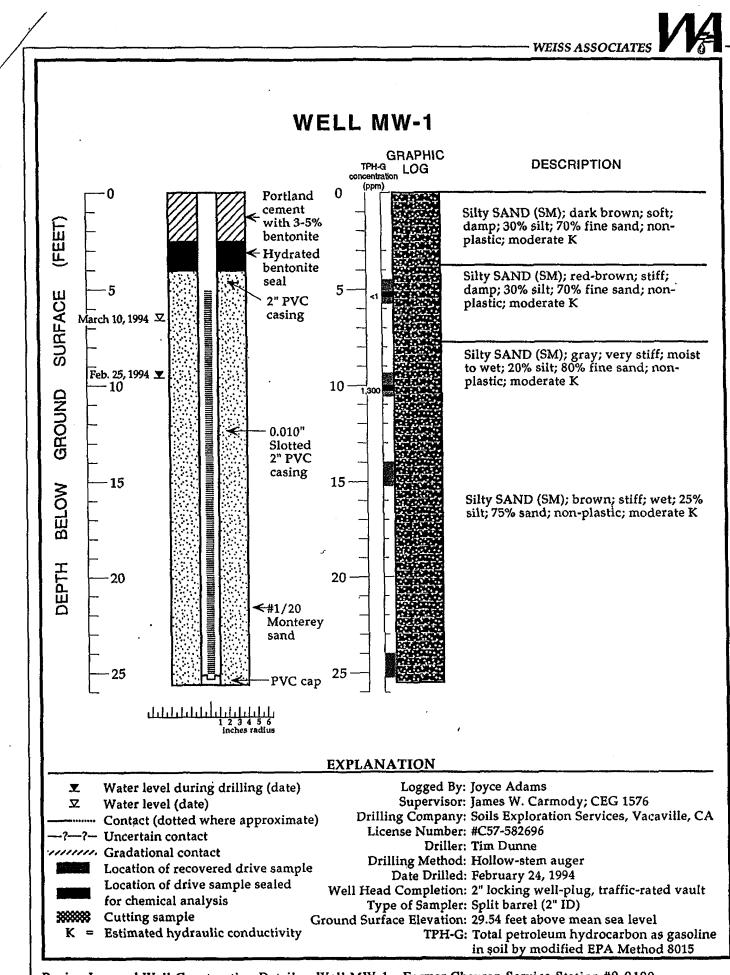
Boring Log and Well Construction Details - Well MW-1 - Former Chevron Service Station #9-0100, 2428 Central Street, Alameda, California

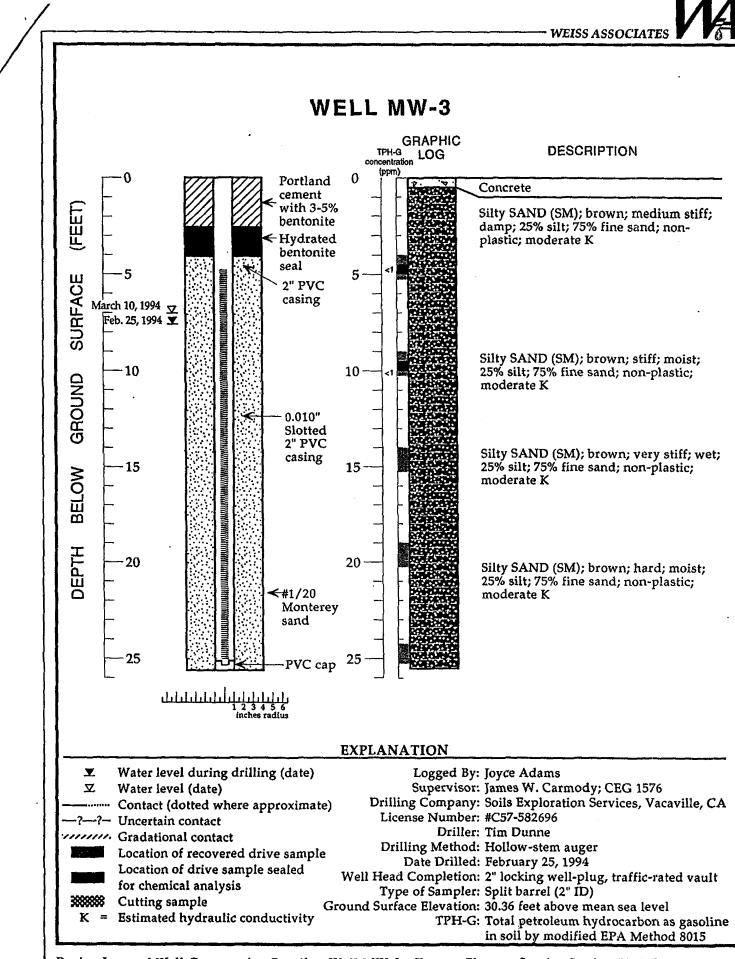
Boring Log and Well Construction Details - Well MW-3 - Former Chevron Service Station #9-0100, 2428 Central Street, Alameda, California
