PES Environmental, Inc.
Engineering & Environmental Services

Subject: Report of Results
Subsurface Investigation
39155 and 39183 State Street, Fremont, California

Project No.: 1098.007.01.012

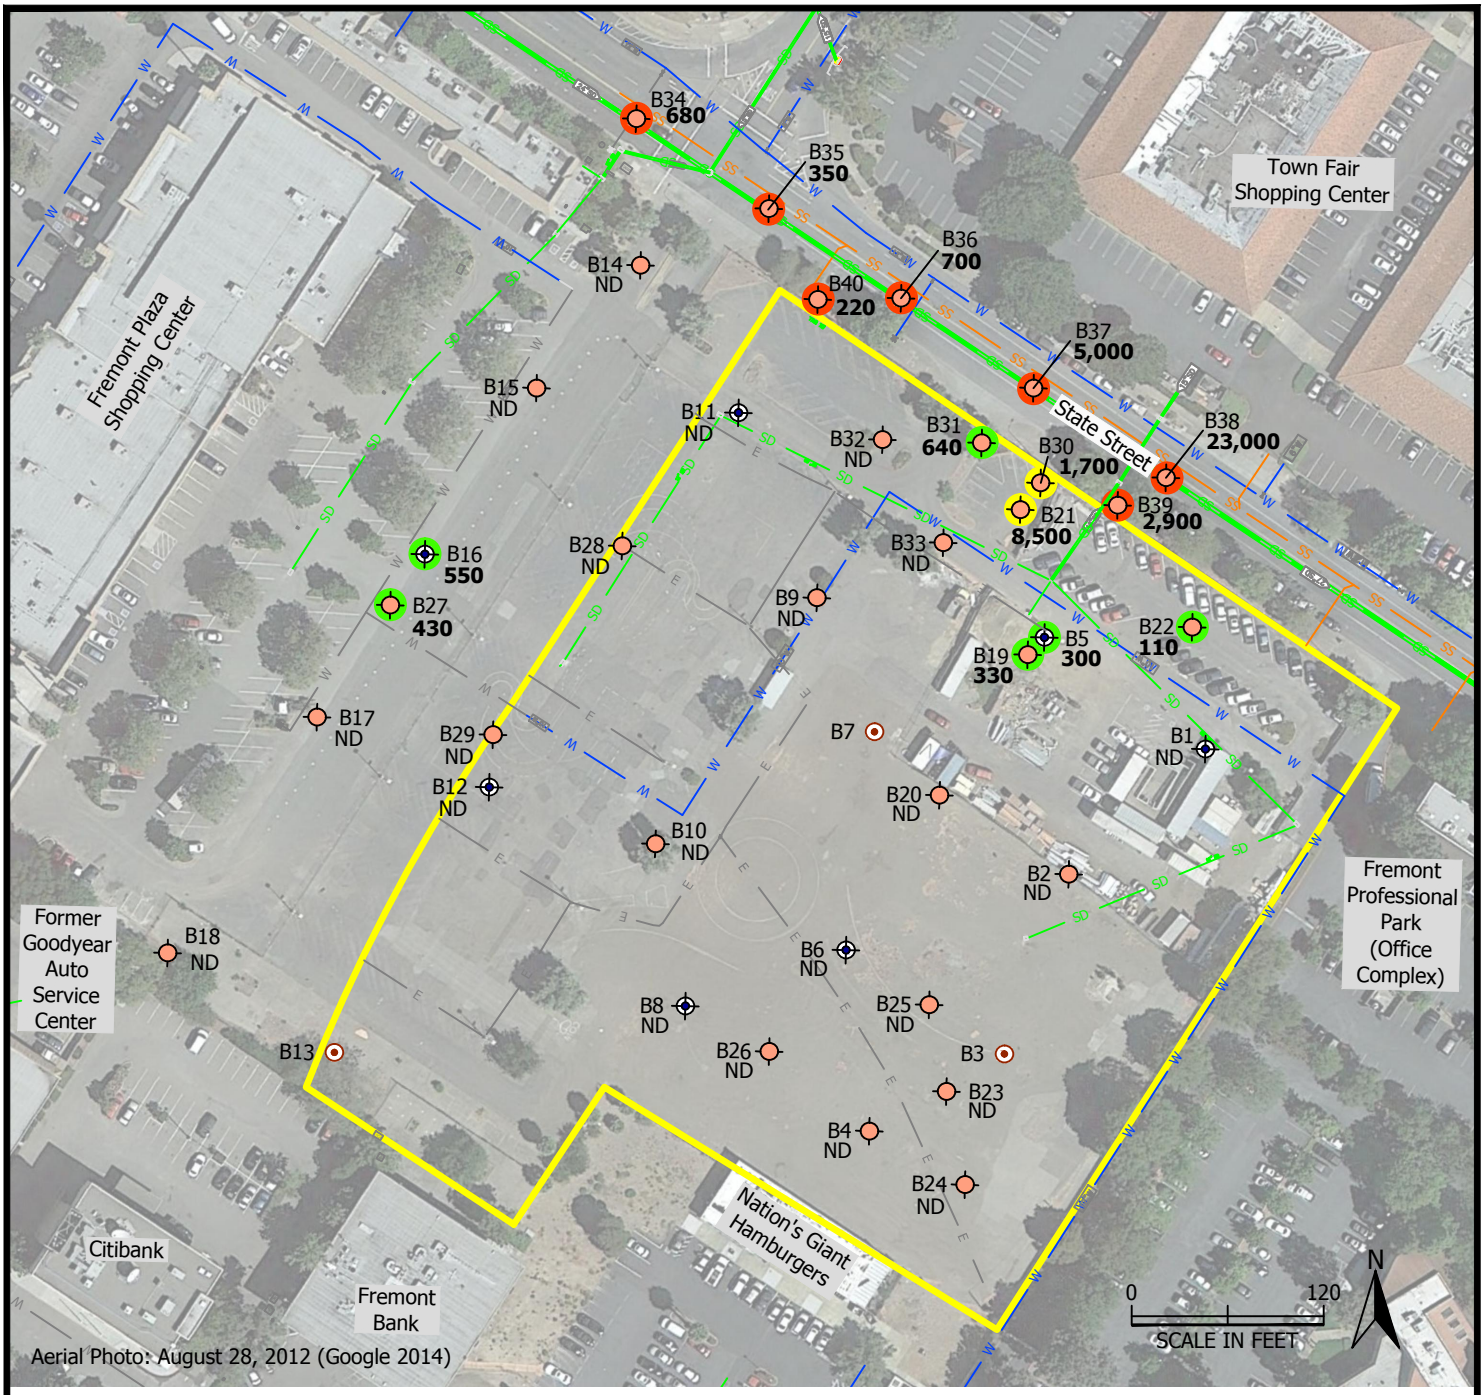
PLATE
3

As shown on Plate 3 and summarized on Table 1, all of the soil vapor samples collected within State Street (adjacent to the sewer) and in the sidewalk contained PCE and all detections exceed the residential ESL. The maximum off-site concentration of PCE was 23,000 $\mu g/m^3$ in boring B38.

Based on the results of the investigation described herein, soil vapor PCE concentrations above the site-specific soil vapor screening level are limited to a small area on the northeastern portion of the site, adjacent to State Street. The pattern of detections and the high concentrations of PCE in soil vapor samples collected within State Street adjacent to the sewer line point to the State Street sewer as the source of the PCE in soil gas. In other words, a PCE vapor cloud appears to be emanating from the State Street sewer and has locally migrated onto the subject property. The only benzene detection that exceeded the site-specific soil vapor screening level was an isolated low concentration occurrence in the southern portion of the site. Testing in the vicinity of the sample was unable to identify a source area or widespread contamination.
