> Re: Data Gap Investigation Work Plan and Focused Conceptual Model; East Bay Bridge Center, 3839 Emery Street, Emeryville, CA 94608. Fuel Leak Case No. RO0003210; Geotracker Global ID T10000008569

Attached is the Data Gap Investigation Work Plan and Focused Conceptual Model for the East Bay Bridge Center, located at 3839 Emery Street in Emeryville, California. This report was prepared for Federal Realty Investment Trust by Cornerstone Earth Group. I declare, under penalty of perjury, that the information and/or recommendations contained in the attached report is true and correct to the best of my knowledge.

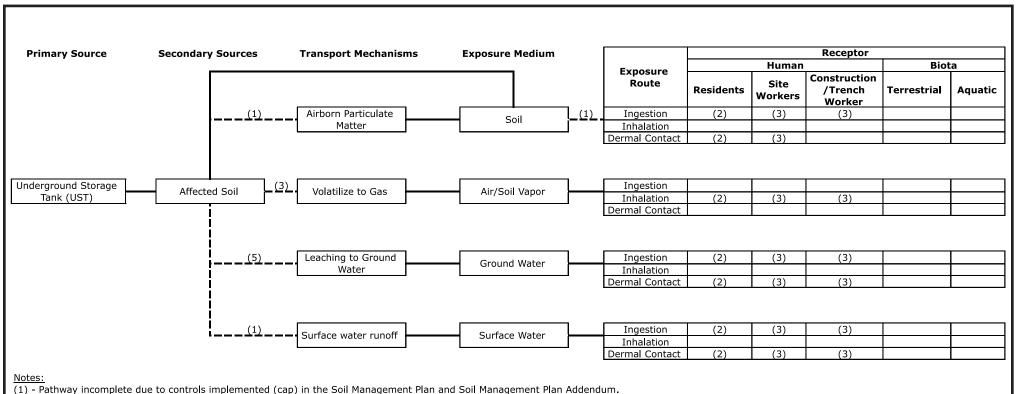
(2) - Incomplete pathway - The Site has established commercial usage.

(3) - Incomplete pathway - Soil Management Plan and Soil Management Plan Addendum provide measures to prevent ingestion, inhalation, and
