CITY OF EMERYVILLE REDEVELOPMENT AGENCY

RE: 1258 - 64th Street, Emeryville, California

(Approximately 5,350 sq. ft. vacant lot)

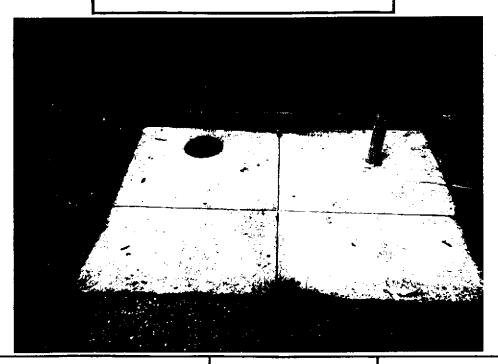
VIEW OF GAS METER IN SIDEWALK OF 64TH STREET

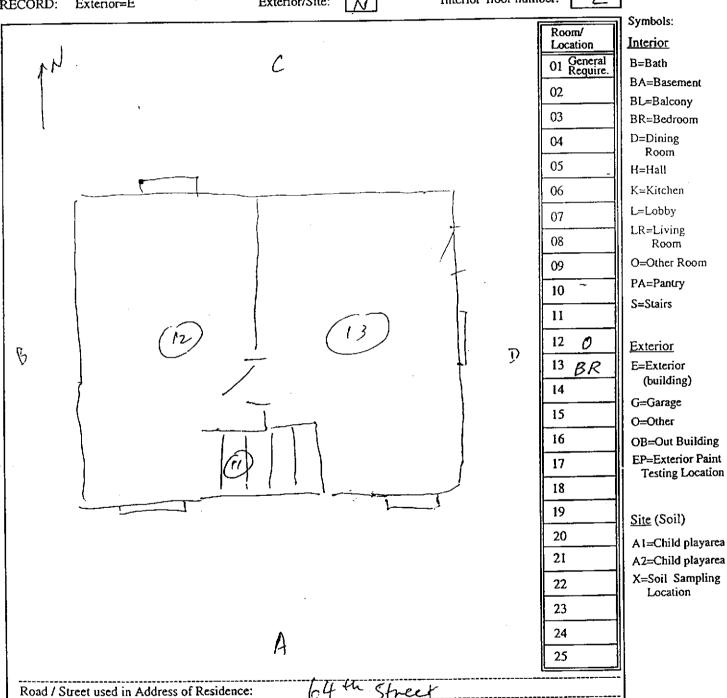
RECORD: Exterior=E Exterior/Site: Interior floor number: Z

Note: Sketch a separate plan for the perimeter of the property, showing the exterior outline of the building and any out-buildings. Sketch a separate plan for each floor of the dwelling unit begining with the Basement. Label each room/location.

Stairs are numbered as rooms. Label children's bedrooms with child ID number and label playroom.
