Work Plan for Off-site Investigation at Former Westinghouse

Property Located at 5815 Peladeau Street, Emeryville, California

Workplan to Conduct Additional Off-site Investigation/Remediation At 5815 Peladeau Street Emeryville, California

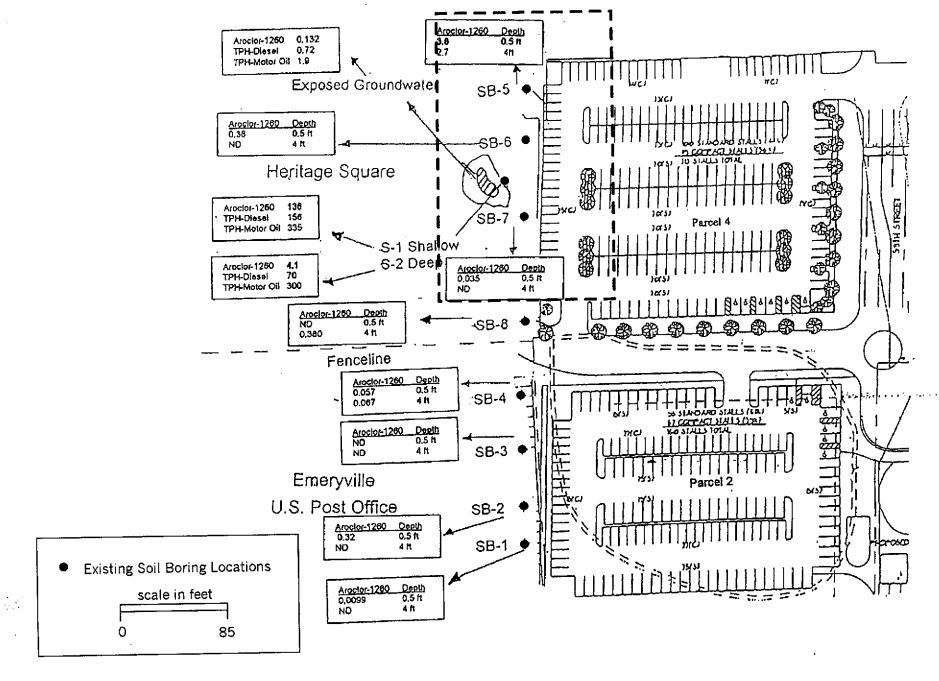
Figure 1: Existing Soil Boring Locations

This document has been prepared by SOMA Environmental Engineering, Inc. (SOMA) on behalf of CBS Corporation (CBS), successor by corporate name change to Westinghouse Electric Corporation. This report has been prepared based on the Alameda County Department of Environmental Health (ACDEH) and Regional Water Quality Control Board (RWQCB) request dated August 25, 1999. As specified in this letter by ACDEH and RWQCB, upon completion of the work proposed in this workplan, both agencies (ACDEH and RWQCB) will issue the site final closure letter. This workplan summarizes the procedure for further site characterization for delineation and remediation of polychlorinated biphenyls (PCB) impacted soils at the Heritage Square property located immediately north of the former Westinghouse Property at 5815 Peladeau Street, Emeryville, California, (the "Property"), see Figure 1.

cleanup criterion for residential purposes, see Fugure-1. However, some of the samples collected at the Heritage Square property showed the PCB concentration above the recommended cleanup levels.
