Date	02 May 1995	Transmitted via						
То	Ms. Amy Leach	□ Messenger						
	Alameda County Health Care Services Agency	⊠ U.S. Mail						
	1131 Harbour Bay Parkway	□ Overnight Mail						
	Alameda, CA 94502	□ Fax						
		Fax #						
Projec	t Number	Total Pages						
Projec	t Name							
_								
Item	Description							
		•						
Remai	·ks							
Subject: Clark's Home of Garden Site, Hayward, CA

Enclosed are the results from the testing of material submitted on November 2, 1994 from your project 2611.

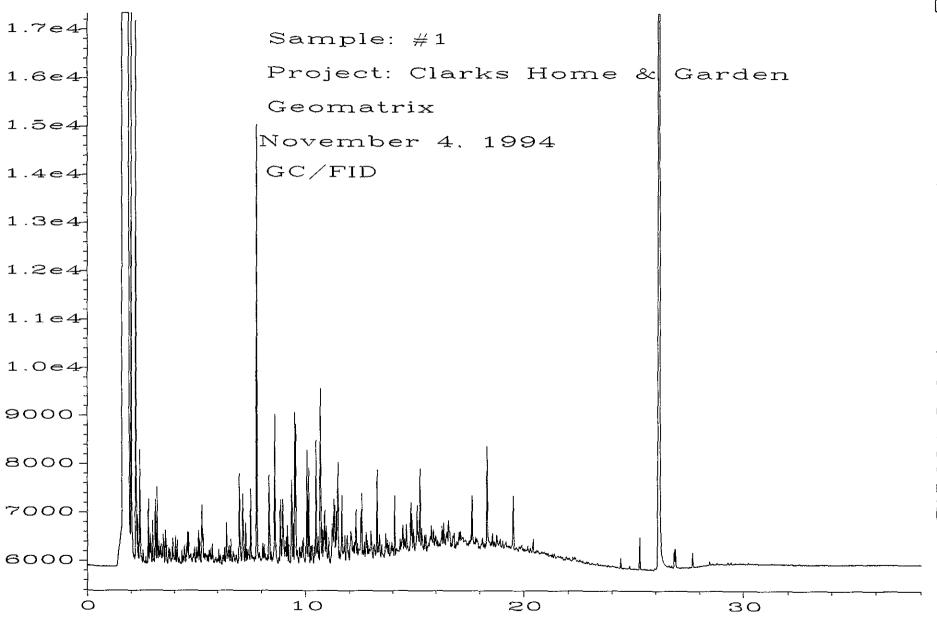
The low and medium boiling compounds appeared as a ragged pattern of peaks eluting from n-C₇ to n-C₁₈ showing a maximum near n-C₁₁. A regular pattern of the n-alkanes is not seen for this product. The product appears to have undergone chemical or biological degradation.

The large peak seen near 25 minutes on the GC/FID trace is pentacosane, added as a quality assurance check for this GC analysis. There is a second internal standard peak seen on the GC/ECD trace at about 26 minutes which is dibutyl chlorendate.

Both products appear to be very heavily degraded.
