Re: **Formal Request for Review for Site Closure**
Former Chevron Service Station 9-0517
3900 Piedmont Avenue
Oakland, California

SUBJECT: Site Conceptual Model and
RBCA Evaluation Report for
Chevron Service Station #9-
0517.

COPIES	DATED	DESCRIPTION
1	12/14/00	Site Conceptual Model and Risk-Based Corrective Action Evaluation for Chevron Service Station #9-0517, 3900 Piedmont Avenue, Oakland, California.

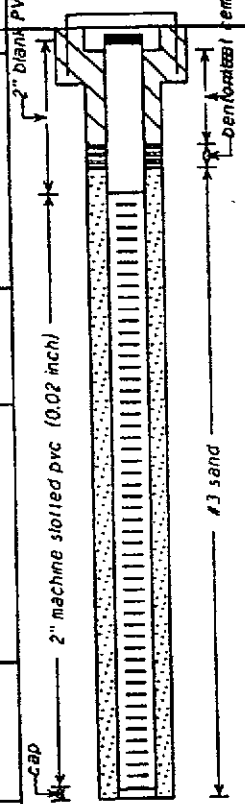
PROJECT: <i>Former Chevron Service Station #9-0517</i>	LOCATION: <i>3900 Piedmont Avenue, Oakland, CA</i>
G-R PROJECT NO.: <i>346420.02</i>	SURFACE ELEVATION: <i>86.09 feet MSL</i>
DATE STARTED: <i>07/21/98</i>	WL (ft. bgs): <i>12.0</i> DATE: <i>07/21/98</i> TIME: <i>13:55</i>
DATE FINISHED: <i>07/21/98</i>	WL (ft. bgs): <i>7.4</i> DATE: <i>07/22/98</i> TIME: <i>16:00</i>
DRILLING METHOD: <i>8 in. Hollow Stem Auger</i>	TOTAL DEPTH: <i>16.5 Feet</i>
DRILLING COMPANY: <i>Bay Area Exploration, Inc.</i>	GEOLOGIST: <i>Barbara Sieminski</i>

CL	PAVEMENT - asphalt. SANDY CLAY (CL) - dark brown (10YR 3/3), moist, stiff, low plasticity; 60% clay, 30% fine to coarse sand, 10% fine gravel. Color changes to yellowish brown (10YR 5/3) at 3 feet.

GC	CLAYEY GRAVEL WITH SAND (GC) - olive (5Y 5/4) mottled light olive brown (2.5Y 5/4), moist, dense; 50% fine to coarse gravel, 30% fine to coarse sand, 20% clay.		
10	0	10	MW2-11

ML	SANDY SILT (ML) - light olive brown (2.5Y 5/6) mottled light gray (2.5 Y 7/2), moist to saturated, stiff, low plasticity; 45% silt, 30% fine sand, 25% clay.	
15	10	13	MW2-16

CL	CLAY (CL) - light olive brown (2.5Y 5/6), moist, stiff, low plasticity; 70% clay, 25% silt, 5% fine sand.	
20							(* = converted to equivalent standard penetration blows/ft.)

In July 1998, GR installed two on-site (MW-1 and MW-2) and two off-site (MW-3 and MW-4) groundwater monitoring wells to evaluate soil and groundwater conditions at the subject site. Soil encountered in borings MW-1 through MW-4 consisted predominantly of interbedded clays, silts and clayey gravels to the total depth explored of 20 feet bgs. Groundwater was encountered within the sandy silt layer at depths of approximately 10.2 to 12.0 feet bgs and stabilized at depths of 7.4 to 9.1 feet bgs.
