Treadwell & Rollo

6 July 2004
Project 3830.01

Subject: Geotechnical Investigation
Cox Cadillac Site Development
Oakland, California

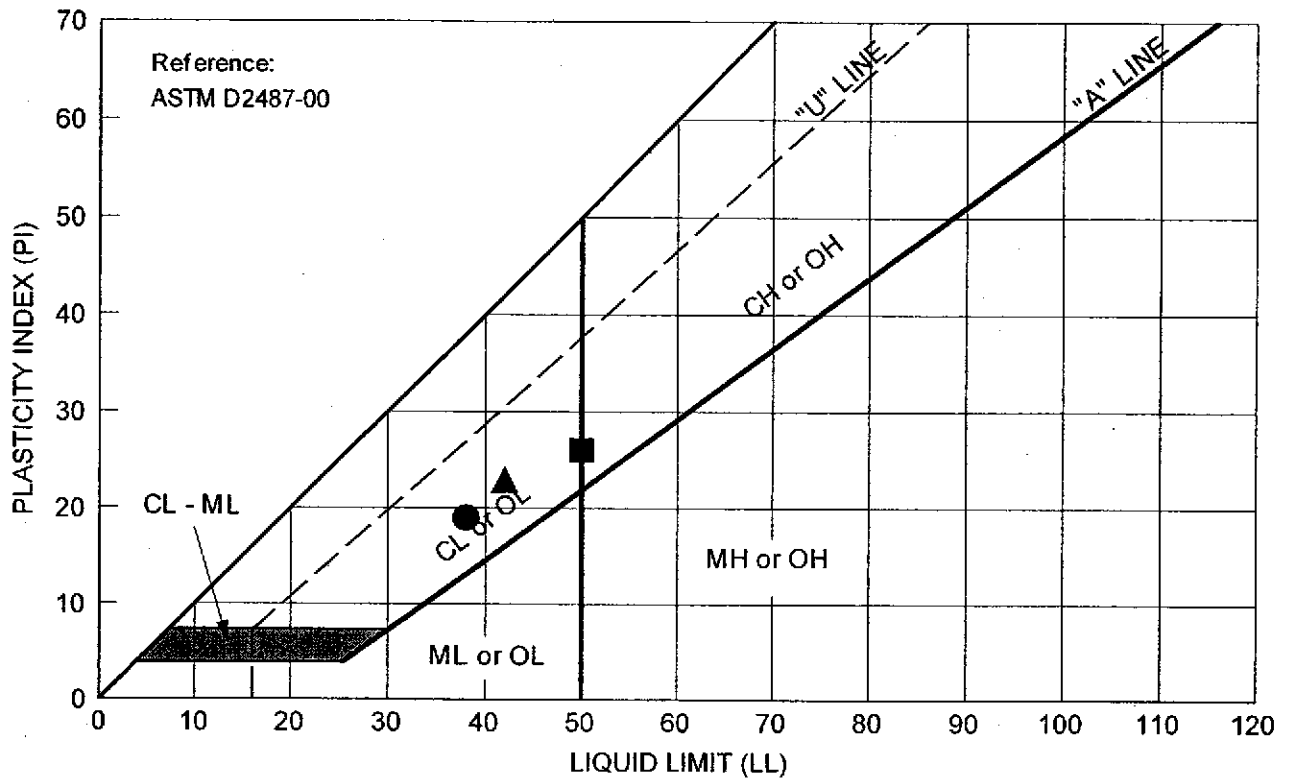
Date 05/05/04 Project No. 3830.01 Figure B-1

Symbol	Source	Description and Classification	Natural M.C. (%)	Liquid Limit (%)	Plasticity Index (%)	% Passing #200 Sieve
●	TP-4 at 2.5 feet	CLAY with SAND (CL), orange, orange-brown, and dark brown [FILL]	29.4	38	19	---
▲	TP-6 at 2 feet	CLAY with SAND (CL), dark gray	31.2	42	23	---
■	TP-7 at 2.5 feet	CLAY with SAND (CL/CH), orange-brown	26.7	50	26	---

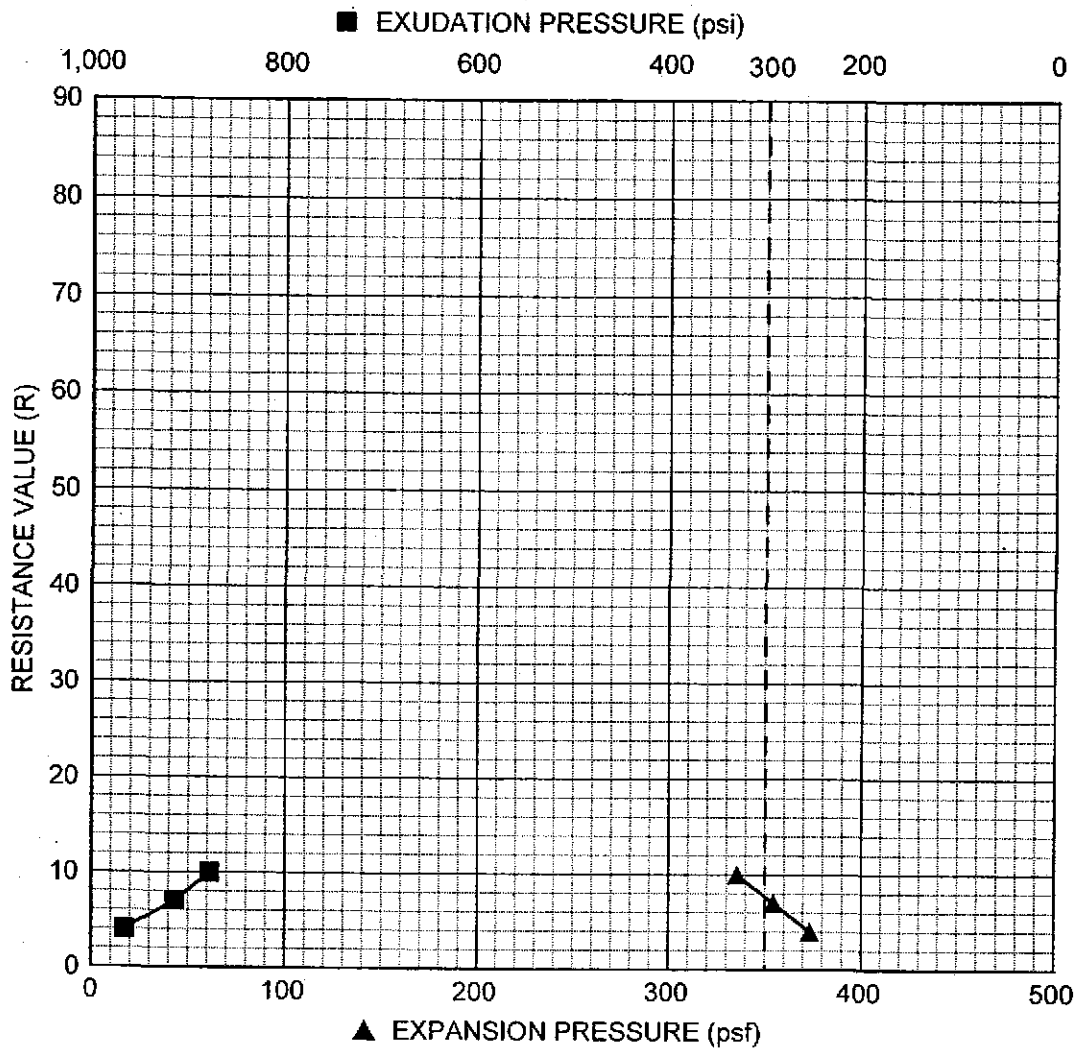
Specimen ID:	A	B	C	D
Water Content (%)	20.5	21.5	22.0	—
Dry Density (pcf)	105.1	102.4	101.7	—
Exudation Pressure (psi)	329	291	253	—
Expansion Pressure (psf)	61	43	17	—
Resistance Value (R)	10	7	4	—

Sample Source	Sample Description	Sand Equivalent	Expansion Pressure	R value
TP-5 at 2.5 to 3.5 feet	SANDY CLAY (CL), mottled orange-brown and olive-brown	—	43 psf	7
