**Transmittal
Additional Information in Support of
LTCP Evaluation
1650 65th Street
Emeryville, California
Fuel Leak Case No. RO0000440
Geotracker Global ID T0600100511**

SUBJECT: Additional Information in Support of LTCP Evaluation
1650 65th Street
Emeryville, California
Fuel Leak Case No. RO0000440
Geotracker ID T0600100511

SUBJECT: Conservative LECR Estimates for Residual Constituents of Concern
1650 65th Street
Emeryville, California
Fuel Leak Case No. RO0000440
Geotracker ID T0600100511

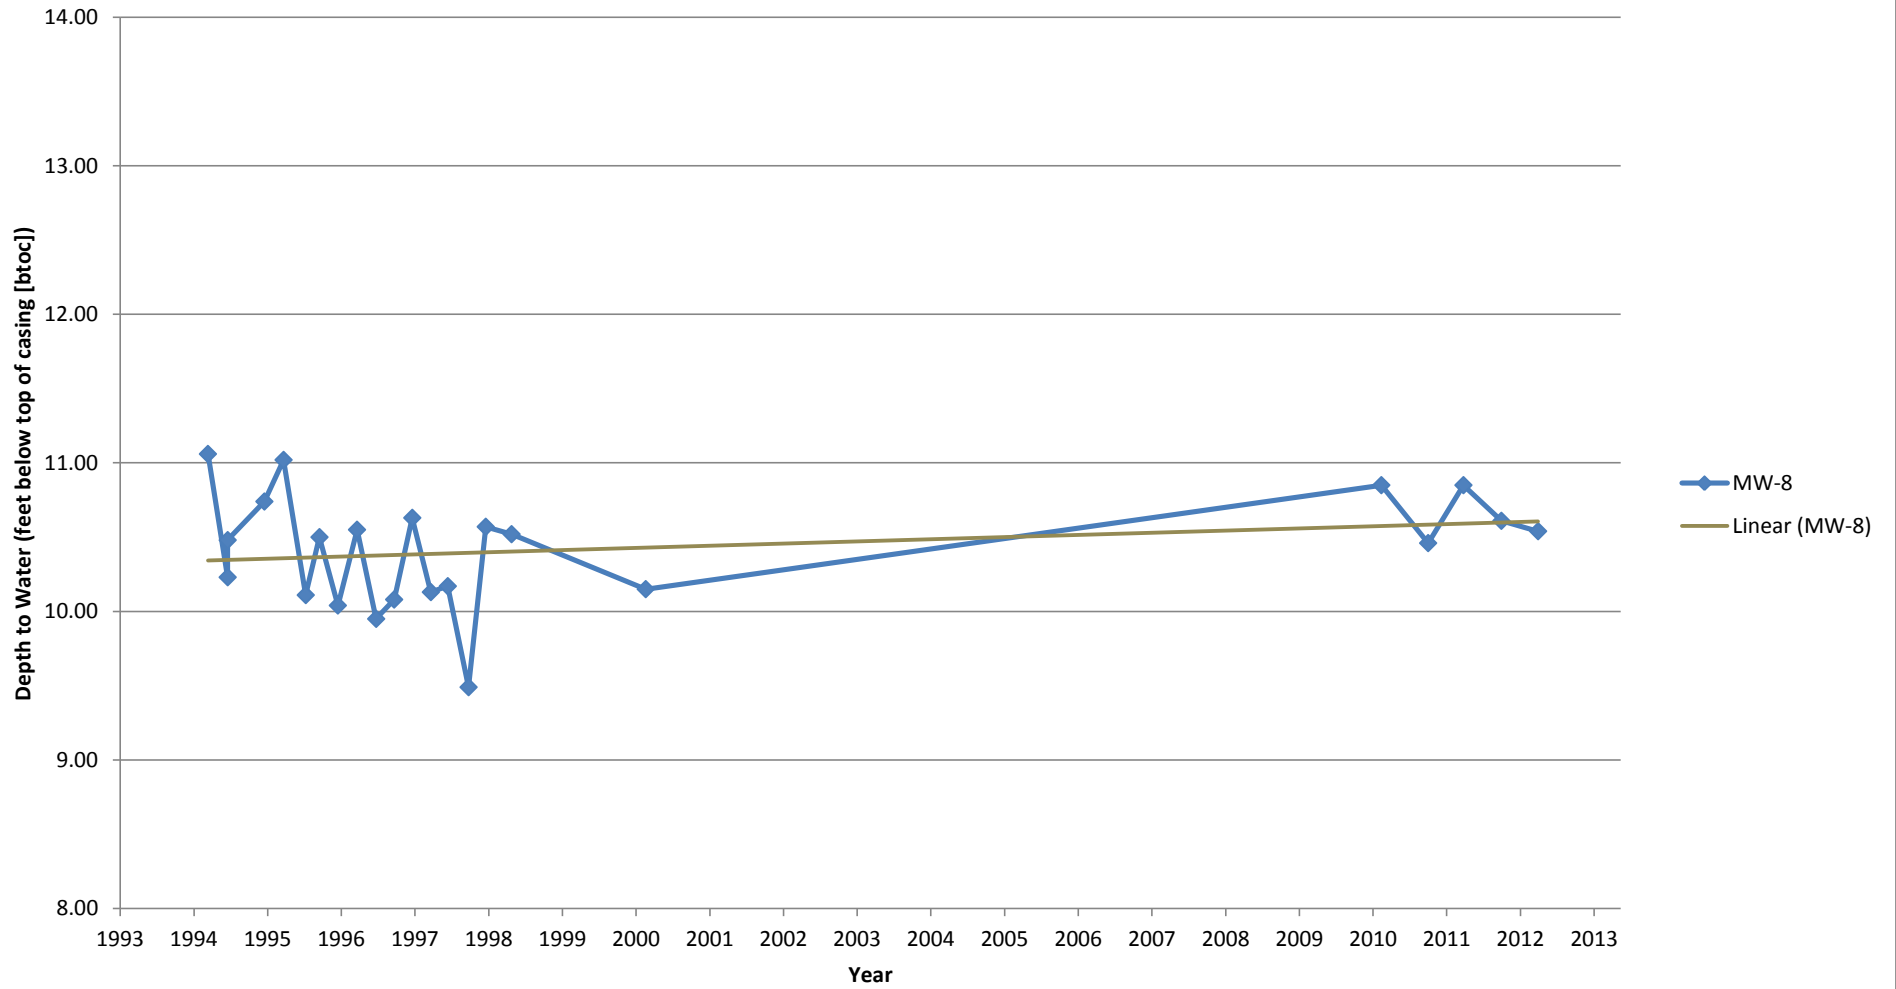
HISTORICAL DEPTH-TO-WATER MEASUREMENTS OVER TIME, WELL MW-8

Depth-to-water Measurements at Well MW-8

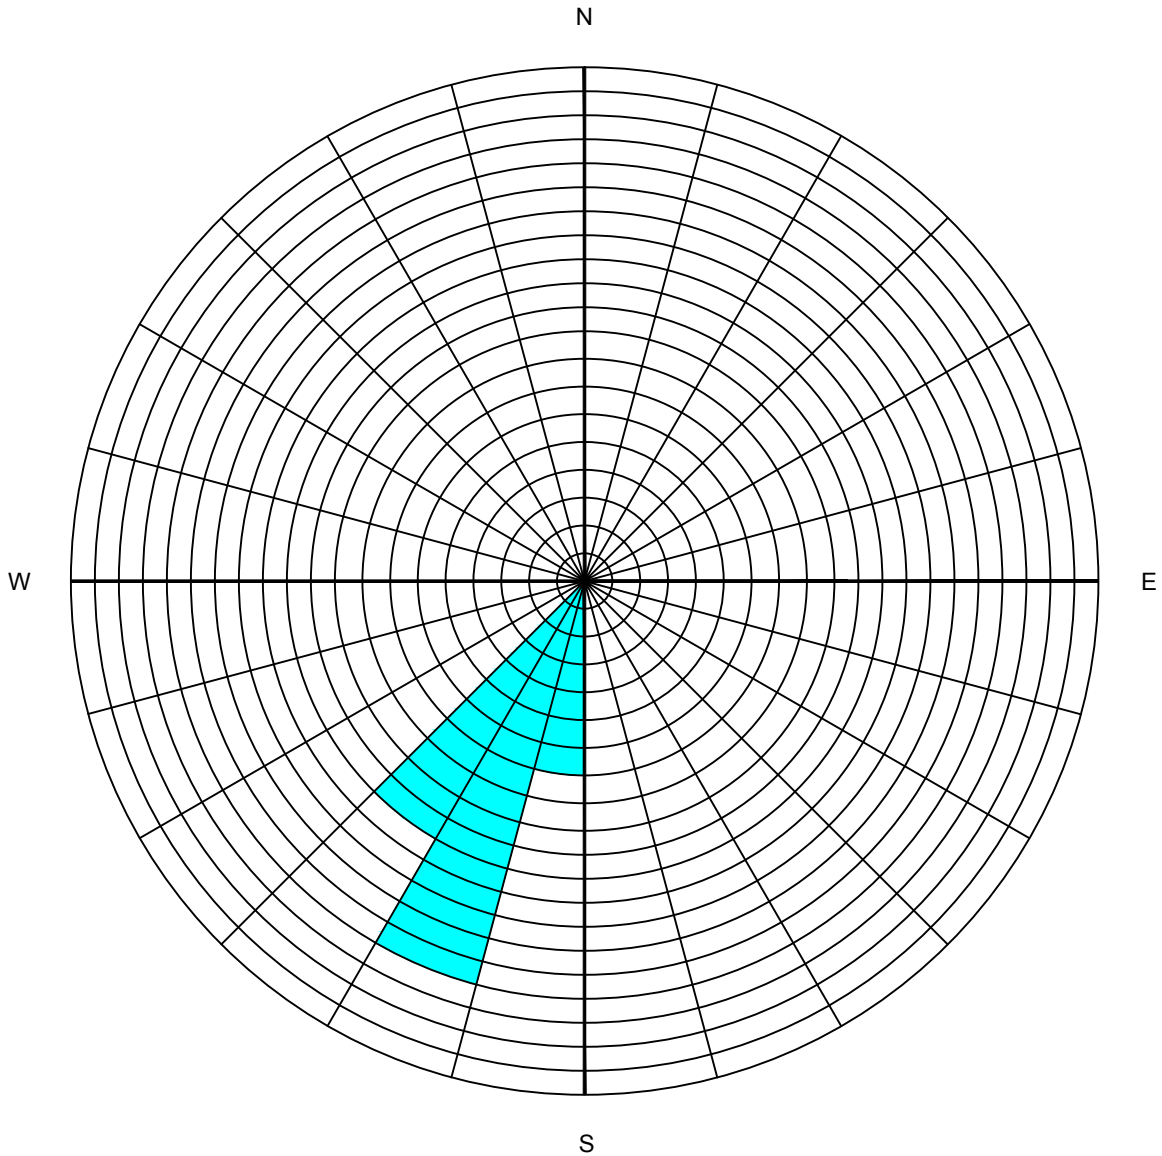
ROSE DIAGRAM - HISTORICAL SHALLOW GROUNDWATER FLOW DIRECTION

ESTIMATED GROUNDWATER FLOW DIRECTION
February 1990 to November 2012

Each shaded area represents data from
one groundwater monitoring event

Flow direction interpreted from
groundwater elevation contour maps
presented in historical periodic
groundwater monitoring reports.
