### MEMORANDUM

Phase 1 and 2 Environmental Site Assessment

1173 28th Street Oakland, California Project 3259:01

SUBJECT: Summary of Pindings

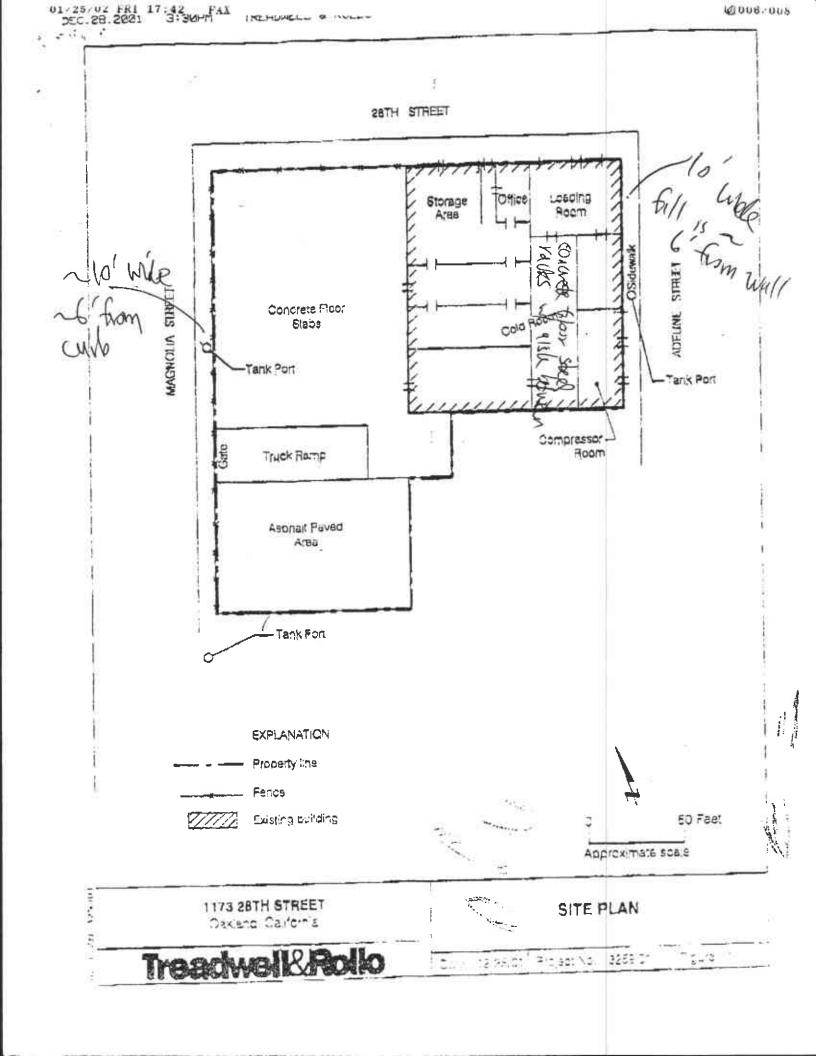
The site currently consists of an asphalt-payed parking area, a truck ramp, the floor slabs of previous buildings and an empty industrial building. These features are shown on the attached Figure 1. The existing building was partially gutted by fire in 1992. The northwest part of this building is currently used for storage of testing equipment and materials, presumably by Testing Engineers, located across 28th Street to the north. The rest of this building contains materials and debris left from the fire. The compressor room contains the refrigeration plant for the cold storage and meat packing rooms in the rest of the building. Assorted hazardous materials and suspected hazardous materials are present in several parts of the building, particularly in the compressor room. These materials were listed in our memo to you dated 4 December 2001, and should be profiled and appropriately disposed. Ports in the sidewalk suggesting the presence of underground storage tables were observed in three locations; on Adeline Street adjacent to the

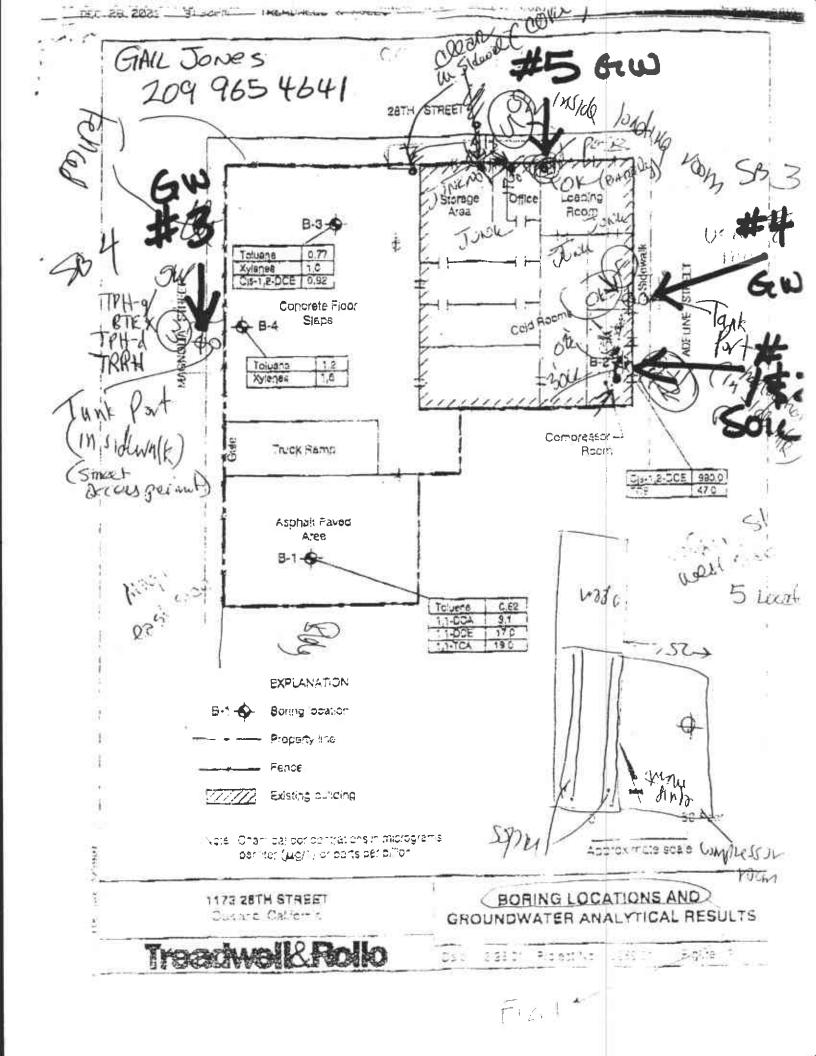
On 6 December 2001, we advanced four soil bonngs at the site to collect samples of soil and groundwater. The locations are shown in Figure 2. Soil and groundwater were sampled for:

In soil samples, lead was found at 110 milligrams per kilogram (mg/kg) at one foot below ground surface (bgs) in boring B-2. Lead was found in other samples in this and the other borings at concentrations well below regulatory or weste-disposal concerns. The result in boring B-2 incloses that shallow soil in the vicinity of this boring may require disposal as a California hazardous waste if disposed off site. No other metals or ammonia were found in soil at levels of regulatory or waste-disposal concern. In addition, no other parameters tested were detected in soil samples.

Also detected in B-3 were toluene and xylenes, at 0.77 and 1.0 ug/l, respectively. Toluene and xylenes were also detected at low concentrations in B-4 and B-1 (toluene only). The presence of these compounds indicates contamination by petroleum hydrocarbons at low levels, which may be the result of leakage from the tank under the sidewalk along Magnolia Street or some other source.

The particular chemical suites found in the groundwater samples indicate more than one source of contamination. Comparing the cis-1.2-DCE/TCE state to B-2 with the cis-1.7-DCE in B-3 suggests a source near B-2 and migration of the contamination toward B-3. However, comparing
