August 19, 1996 STID 5840

### REMEDIAL ACTION COMPLETION CERTIFICATION

Fircrest Property, Fircrest Ave., Newark, CA 94560 RE:

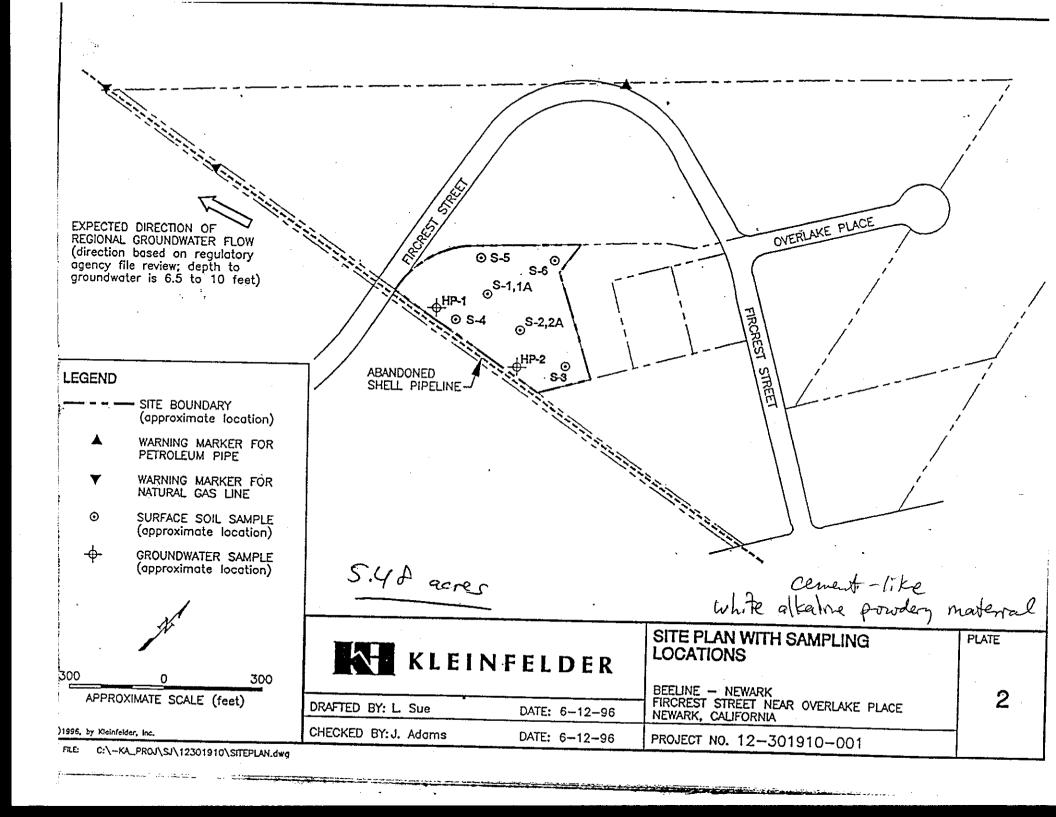
Furthermore, during a walk of the site there were 4 areas where a white powdery material was deposited. This material was found to be alkaline and it presumed to be a cement like material. This type of dumping is common around construction sites during the cleaning of mixers and equipment. It should not have any negative effect on the current or future use of the property. A map of the site is attached.
