RE: 6000 S CORPORATION, 6000 STEVENSON BLVD.

The document entitled "Work Plan, Sampling of Foundry Sands, 6000 Stevenson Boulevard, Fremont, California" prepared by Levine Fricke for 6000 S Corporation has been reviewed. The purpose of this phase of the investigation is to screen foundry sands for Soluble Threshold Limit Concentrations (STLCs) in order to determine appropriate off-site disposal options. Previous analytical data indicate elevated soluble lead concentrations in the sands above the STLC value.

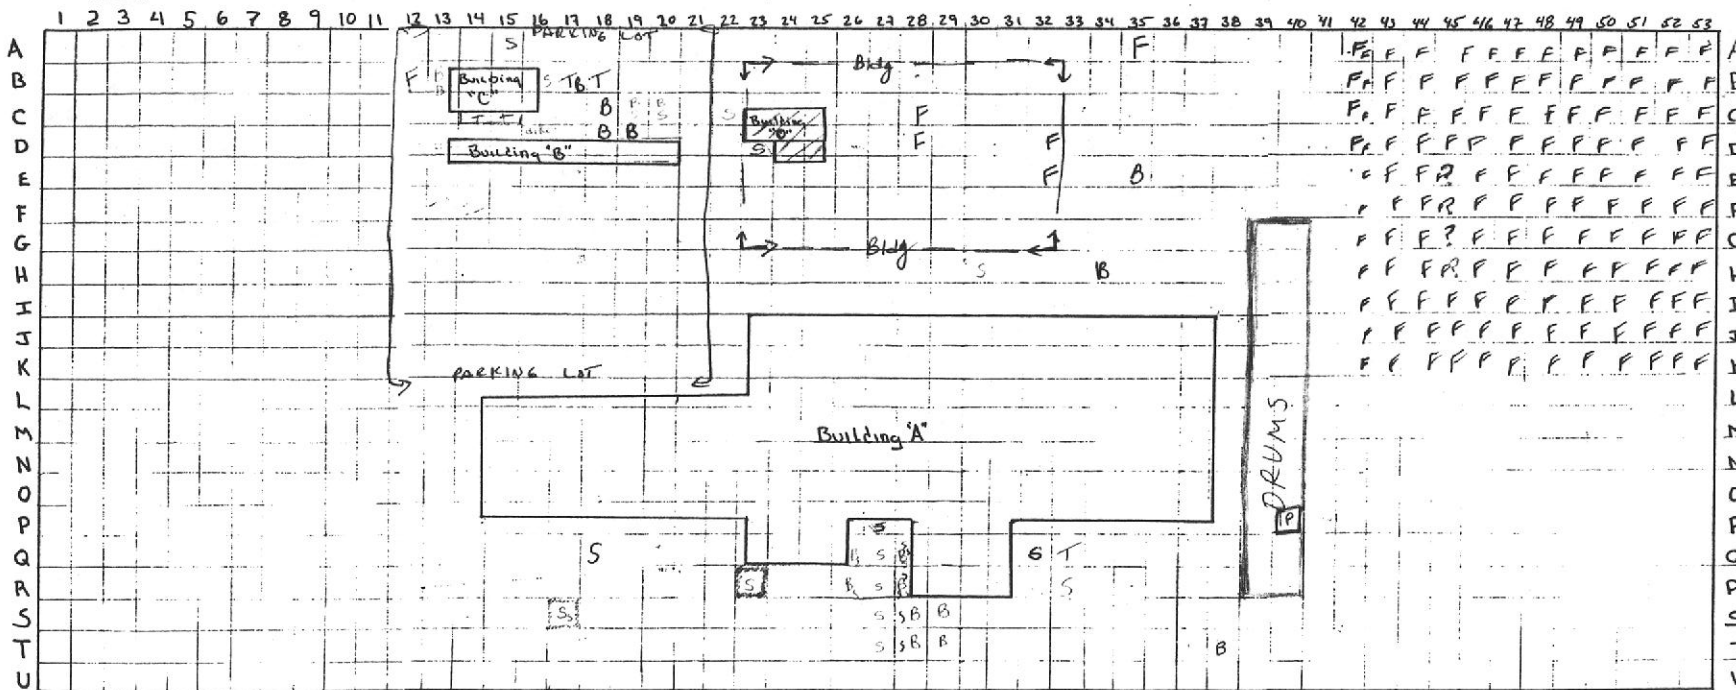
Grids NOT SET TO MAP SCALE

TRUE MAPS at 1" = 100'

1. Storage of materials at coordinate S-17 show no barrels, but, there is a visible stain on the concrete.
2. There is staining of the concrete at coordinate R-23, but no ✓ discernable storage of barrels.
3. A storage area extends from coordinates G-39,G40 down to ✓ coordinates R-39,R-40. Bulk goods are present and barrels at P-40.
4. Visible staining at coordinates P,Q,R,S,T-28. ✓
5. Heavy activity with staining at coordinate H-30. ✓
6. Building "B" shows barrels and staining at coordinate C-19&20. ✓
7. Staining occurs at building "D" C-22. ✓
8. Barrel storage at T-37. ✓

Structure "D" is missing leaving only a partial foundation. Extensive grading has taken place from coordinates A-22, G-22 to A-34, G-34.

1. What appears to be industrial scraps and compacted trash now occupy coordinates E-45 to H-45. ✓
2. Tanks have been installed at coordinate Q-32 with staining at R-32. ✓
3. Barrels are visible at coordinates S-28&29 to T-28&29 and, ✓ coordinates P-26&28 to Q-26&28 with a fair amount of staining on the concrete. ✓
4. Stain remains on concrete at S-17 but storage area has been removed.

1. Tanks no longer at Q-32, but stain remains at R-32.
2. Barrels no longer at coordinates P-26,28 to R-26,28 but staining remains at that location and extending down to T-28.
3. Stain on concrete at coordinate Q-18.
4. Barrels have been moved to coordinate E-35.
5. Fill has been dumped at coordinates A-35, C&D-28.
6. Staining is visible at D-23 where building "D" once stood.
7. Two large tanks appear at C-14 ?
8. Five tanks appear at B-17,18. ✓
9. Staining on parking lot at A-15
10. A fill "material" has been dumped at B-12.
11. Barrels occupy a section of B-13.

1. A stain with a circular pattern is visible at Q-32.
2. Stain evident at P, Q, R, S, T-28.
3. Fill "material" has been dumped at coordinates A, B, C, D-42 and at coordinates D, E-32.
4. Tanks have been removed from coordinates C-14,15 and, B-17,18.
5. Barrels are visible at coordinates B-17, C-18 and, D-18.
6. What appears to be a skeleton of a tank is visible on C-16.
7. Barrels are placed on soil at coordinate H-34 and, D-19.

3. Extensive dumping of fill "material" covers coordinates A-42 thru 53 down to K-42 thru 53. No barrels are visible at these coordinates.
4. It appears that the stains at coordinates P, Q, R, S-27 have tried to have been removed as a fill material is visible at the leading edge of the loading dock. material has been removed and placed somewhere, but stains remain.
