ENVIRONMENTAL ASSESSMENT

**23718-23942 SAKLAN AVENUE
HAYWARD, CALIFORNIA**

**VENTURE PROPERTIES
P. O. BOX 710277
SAN JOSE, California 95171**

**PROJECT NO. 9330A
SEPTEMBER, 1989**

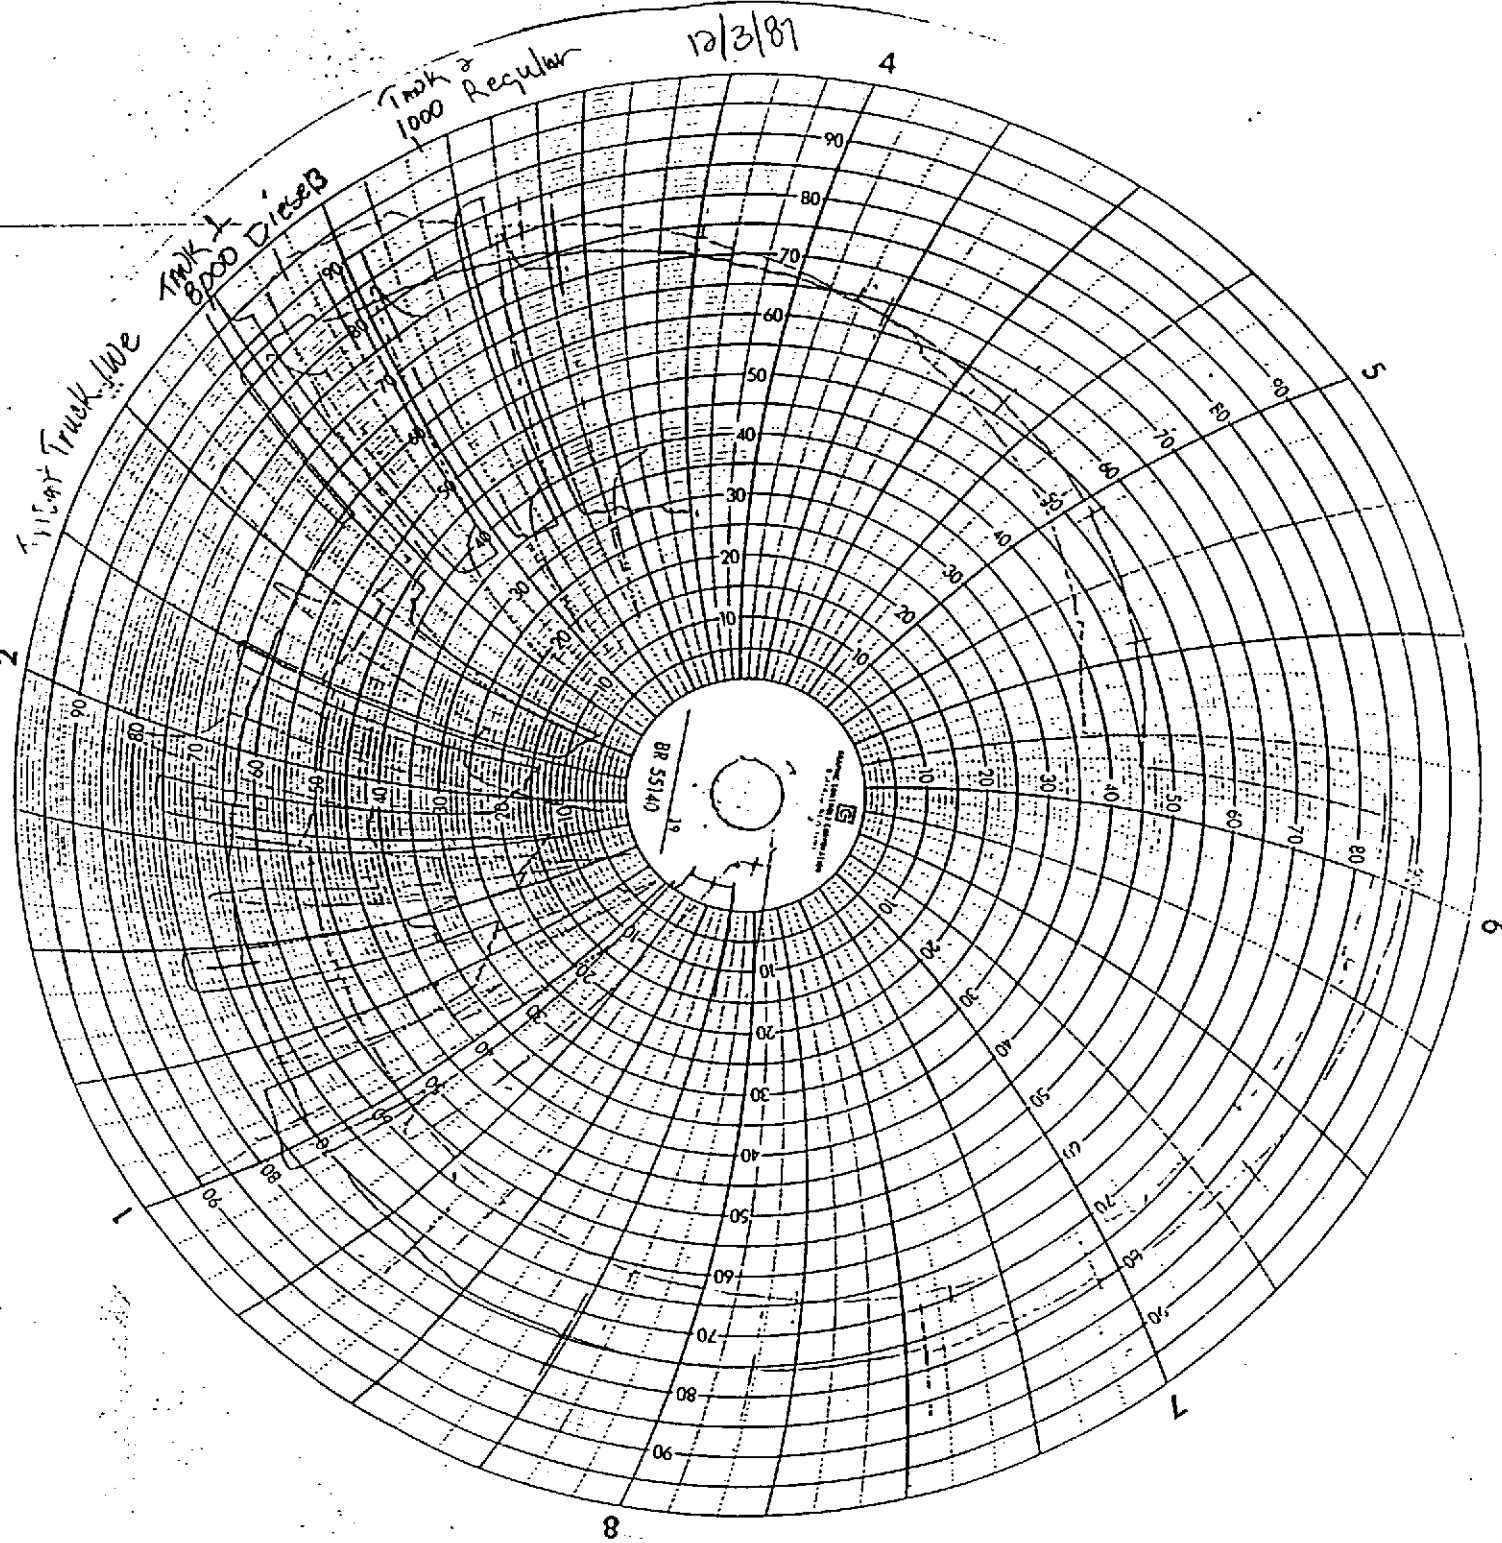
DT truck 102e

6 TWK# 3 10000 Diesel

Three underground fuel storage tanks are located on the Trident Truck site. According to the owner of Trident, these tanks are integrity tested for leakage on an annual basis. A copy of the most recent testing results showing each tank to be tight is attached to this report. The tanks and pump island will also be removed when Trident relocates.
