RE: Ambassador Apartments  
3610 Peralta St, Emeryville, California  
Site Management Plan

SITE MANAGEMENT PLAN (REVISED)  
The Ambassador Apartments  
3610 Peralta Street  
Emeryville, California

Date:  
June 11, 2014

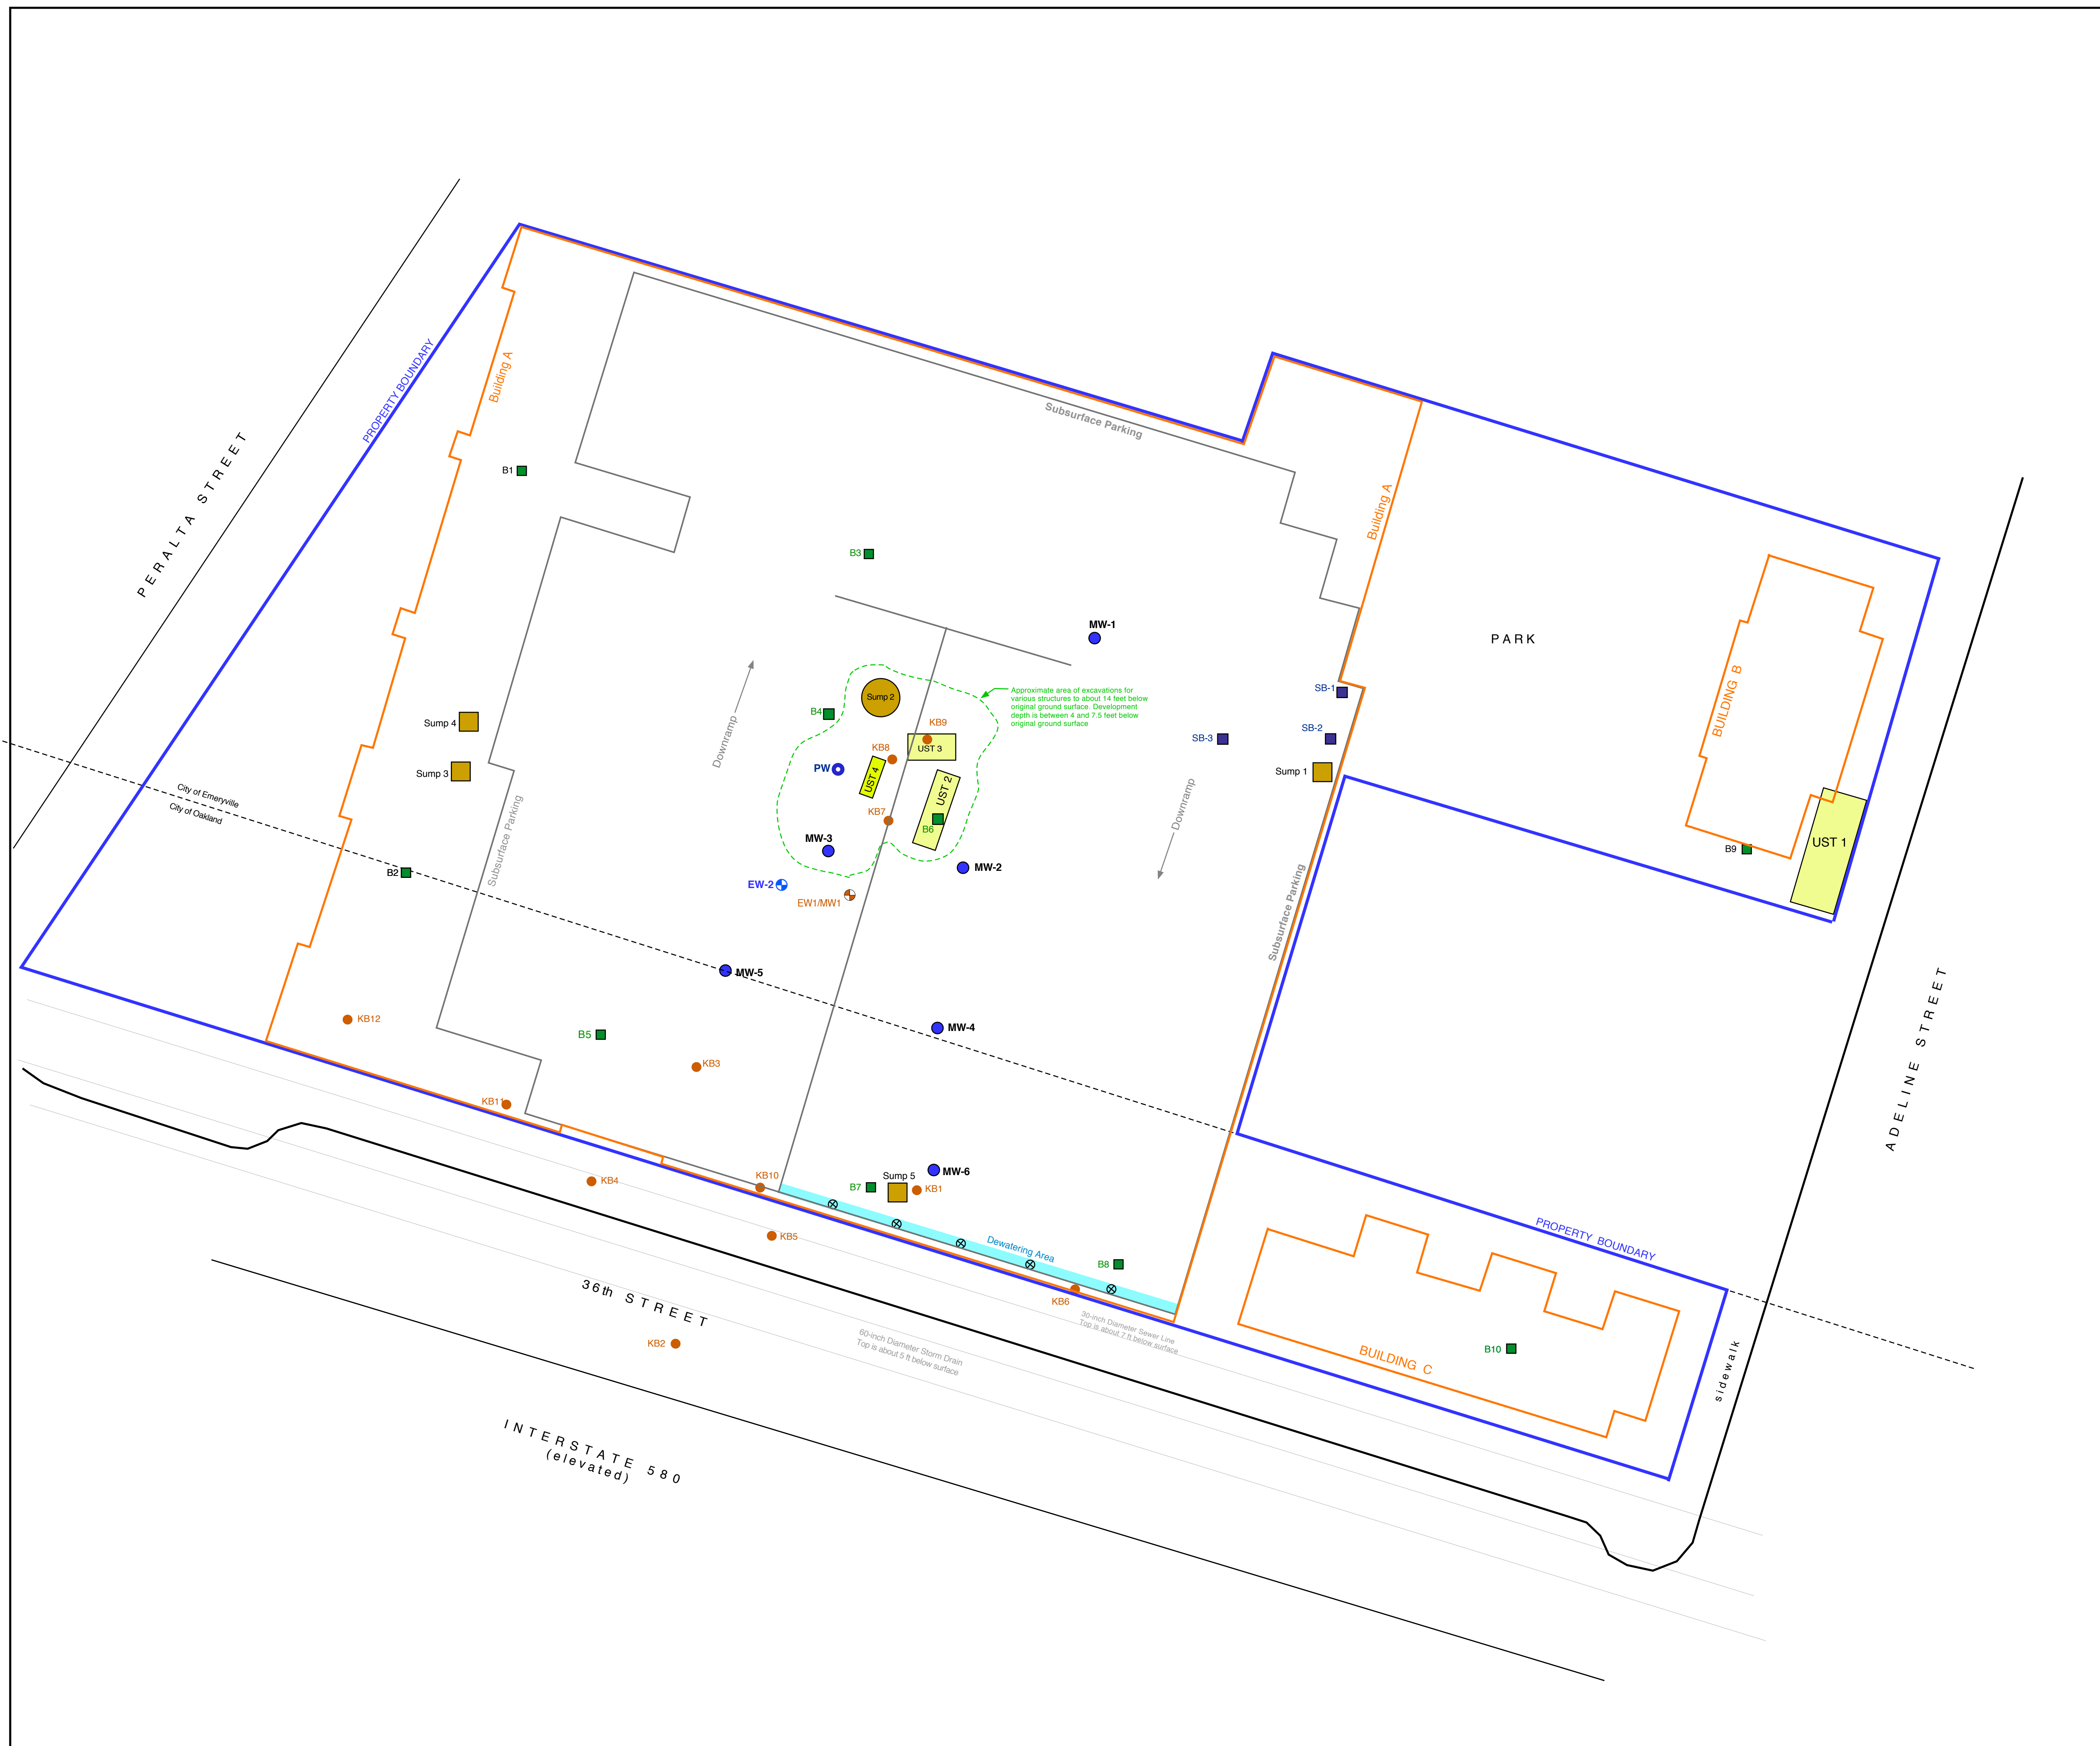
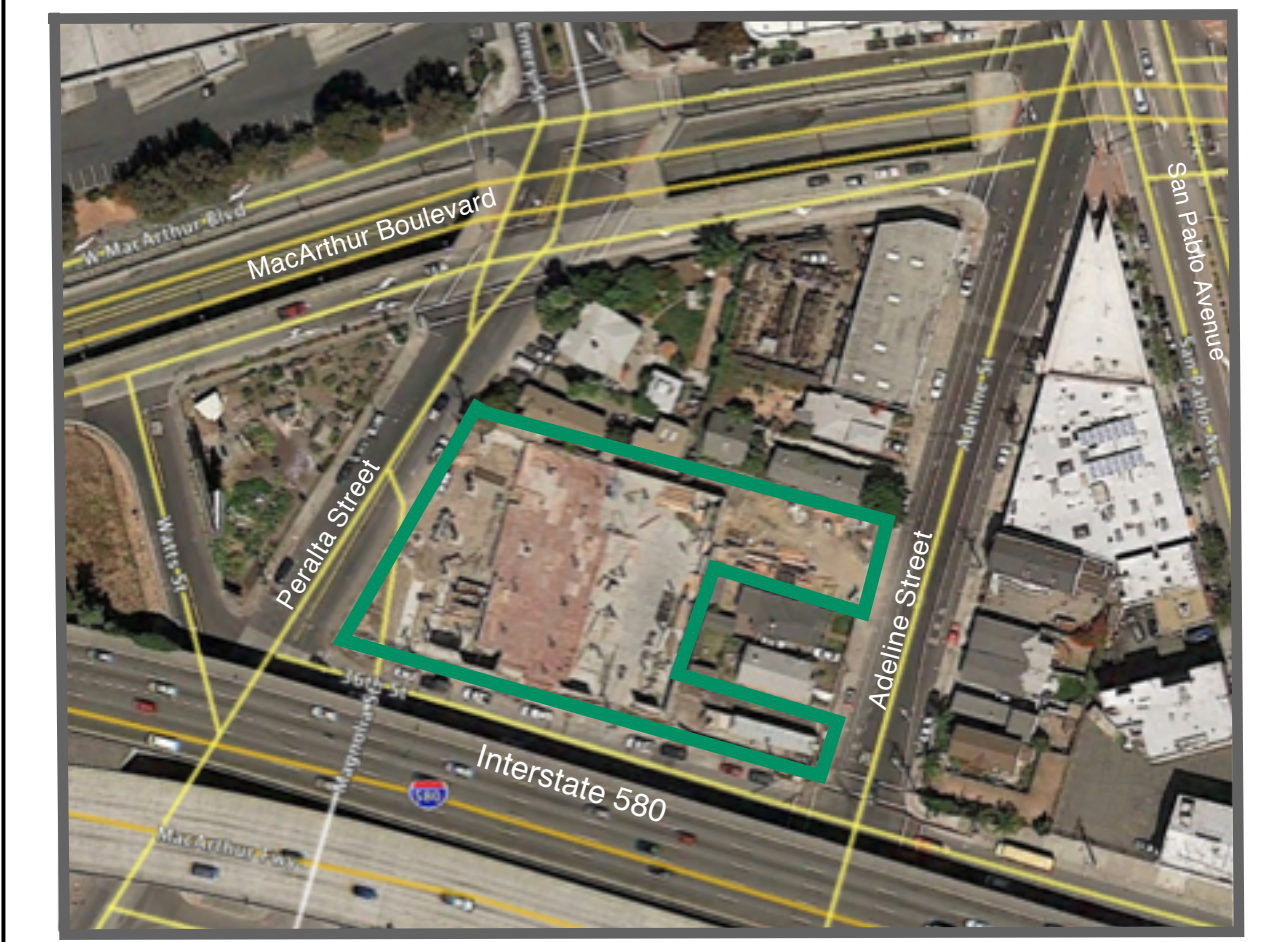
**FIGURE 4**

- EXPLANATION**
- EW1/MW1 Extraction Well by Kleinfelder, 1996
  - EW2 Extraction Well by Adanta, 2012
  - MW-6 Monitoring Well by Kleinfelder (2007) Location taken from Demolition Plan (Building A) by Kava Massih Architects
  - PW Production Well (1905) Location inferred from Google Earth Image (May 20, 2012)
  - Dewatering Well WSP Consulting Engineers (2012)
  - KB12 Soil Boring by Kleinfelder 1996 and 2008
  - B-1 Soil Boring by Clayton 2003
  - SB-3 Soil Boring by PES Environmental 1996
  - UST removed
  - Sump 5 Sump or Drain, as described and located by Clayton 2003, 2005

**SAMPLE AND STRUCTURE LOCATION MAP**

The Property has been developed with a multi-story apartment complex for low and very low-income families. The apartment complex includes 69 apartments in three buildings. Building A consists of a multi-layer structure with apartments constructed above two levels of parking. Buildings B and C are constructed at grade, and are two-story buildings. There is a small courtyard area in the northern portion of the Property between Buildings A and B. The relative positions of the three buildings at the Property are depicted on Figure 4.

The entire area noted above is beneath the parking structure for Building A (See Figure 4). Four cross-sections (A-A', B-B', C-C' (Figure 5) and D-D' (Figure 6)) were prepared to show borings, excavation areas and soil analytical data relative to current site features such as current grade, building foundations and new use areas.
