**SECOND QUARTER
GROUND WATER MONITORING**

**Harcros Pigments Plant
4650 Shellmound Street
Emeryville, California**

July 1, 1993

PROJECT NO: HP19801W

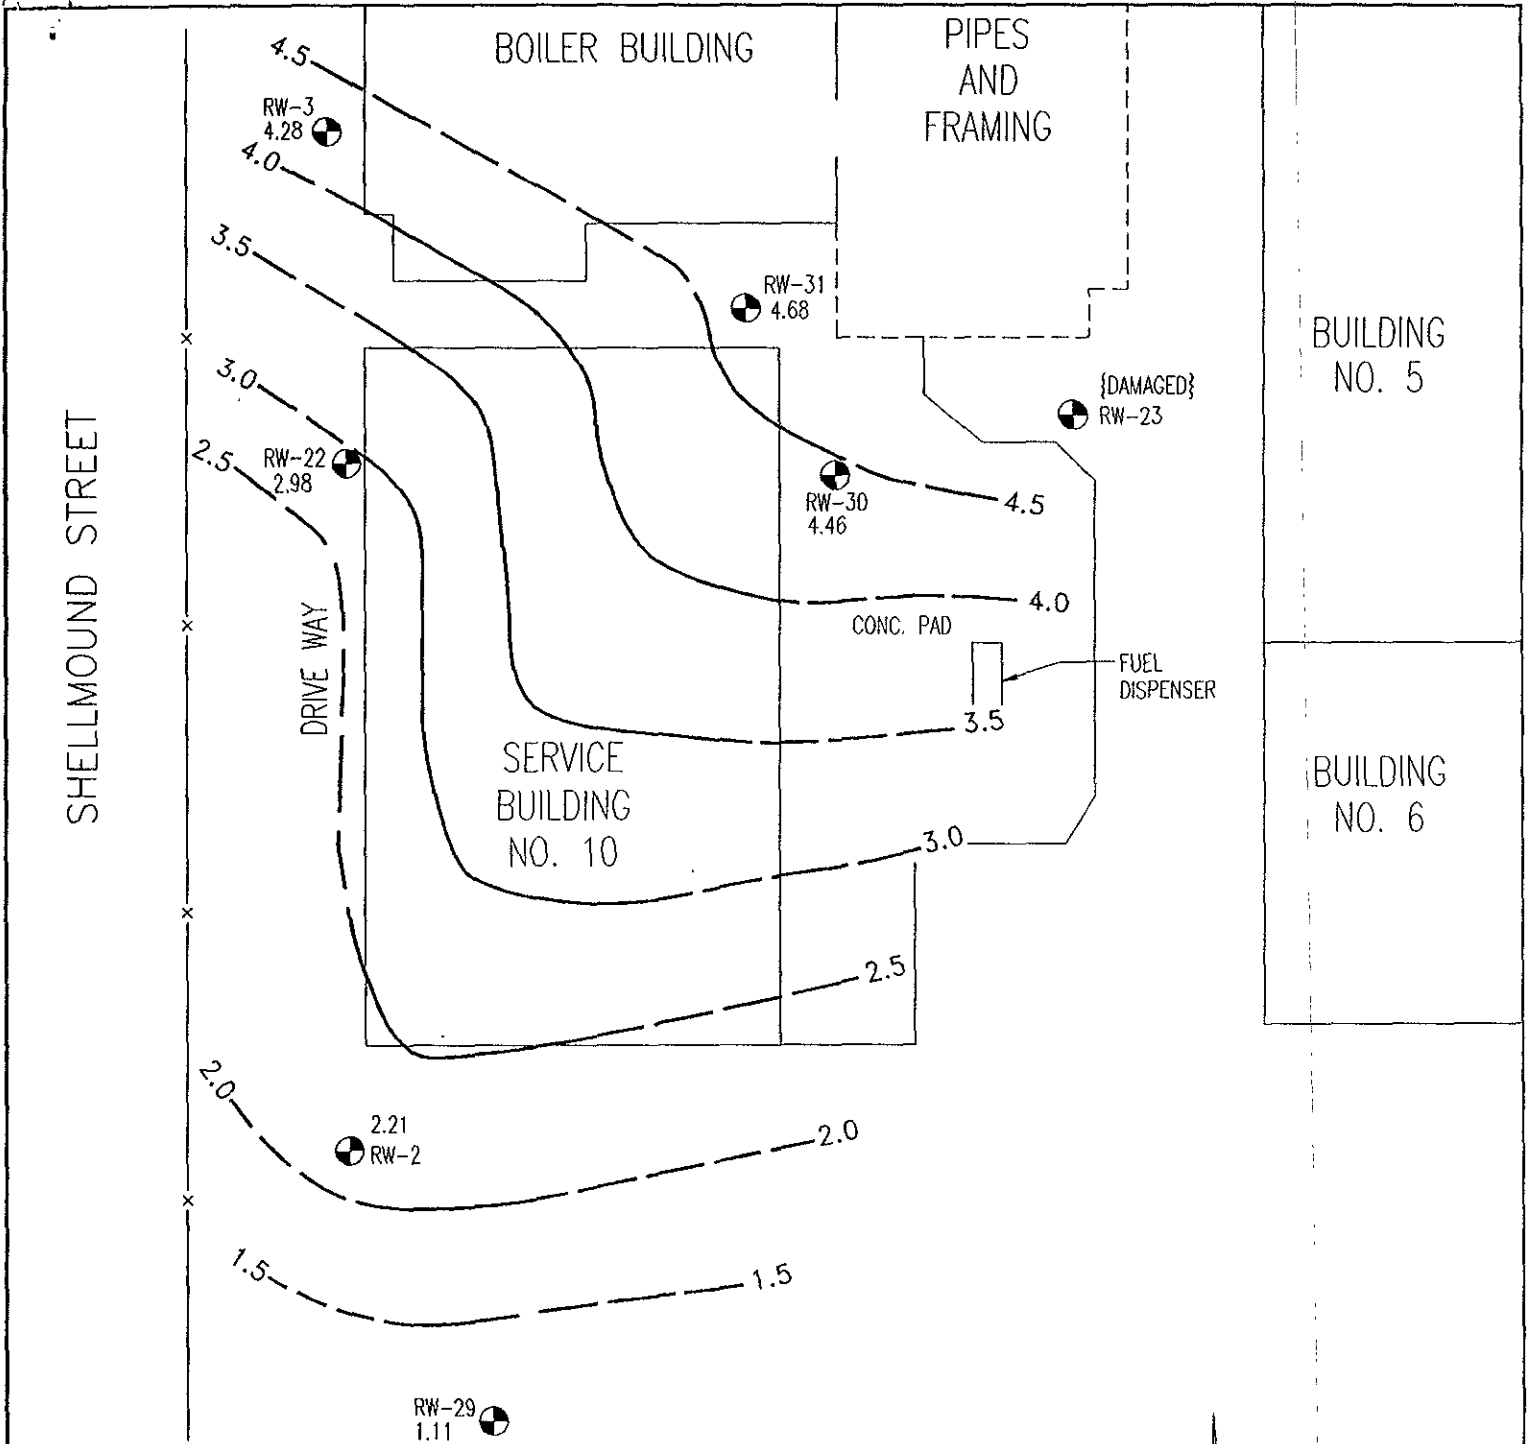
| | DATE: 05/93 | ELEVATION OF GROUND WATER MAY 19, 1993 | |

Water levels were measured on May 19, 1993, in six on-site monitoring wells (Table 2). The depth to ground water at the Site has historically been about two to six feet below ground surface (bgs). The depth to ground water measured on May 19, 1993, ranged from 2.40 ft. to 5.90 ft. bgs. Ground water elevations calculated from these water levels indicated the direction of ground water movement at the Site was to the south at a gradient of about 0.02 (Figure 4). This flow direction and gradient is generally consistent with historical measurements. The local flow direction towards the south differs from the regional flow direction to the west, possibly due to the influence of Temescal Creek, located about 170 ft. south of Service Building No. 10.

- RW-2 2.42 MONITORING WELL LOCATION AND DESIGNATION WITH GROUND WATER ELEVATIONS IN FEET (ABOVE MEAN SEA LEVEL).
- 4.0 LINE OF EQUAL GROUND WATER ELEVATION.(DASHED WHERE INFERRED)
