SECOND QUARTER 2007 SITE MONITORING REPORT

**REDWOOD REGIONAL PARK
SERVICE YARD
OAKLAND, CALIFORNIA**

**EAST BAY REGIONAL PARK DISTRICT
OAKLAND, CALIFORNIA**

Project No. 2007-17

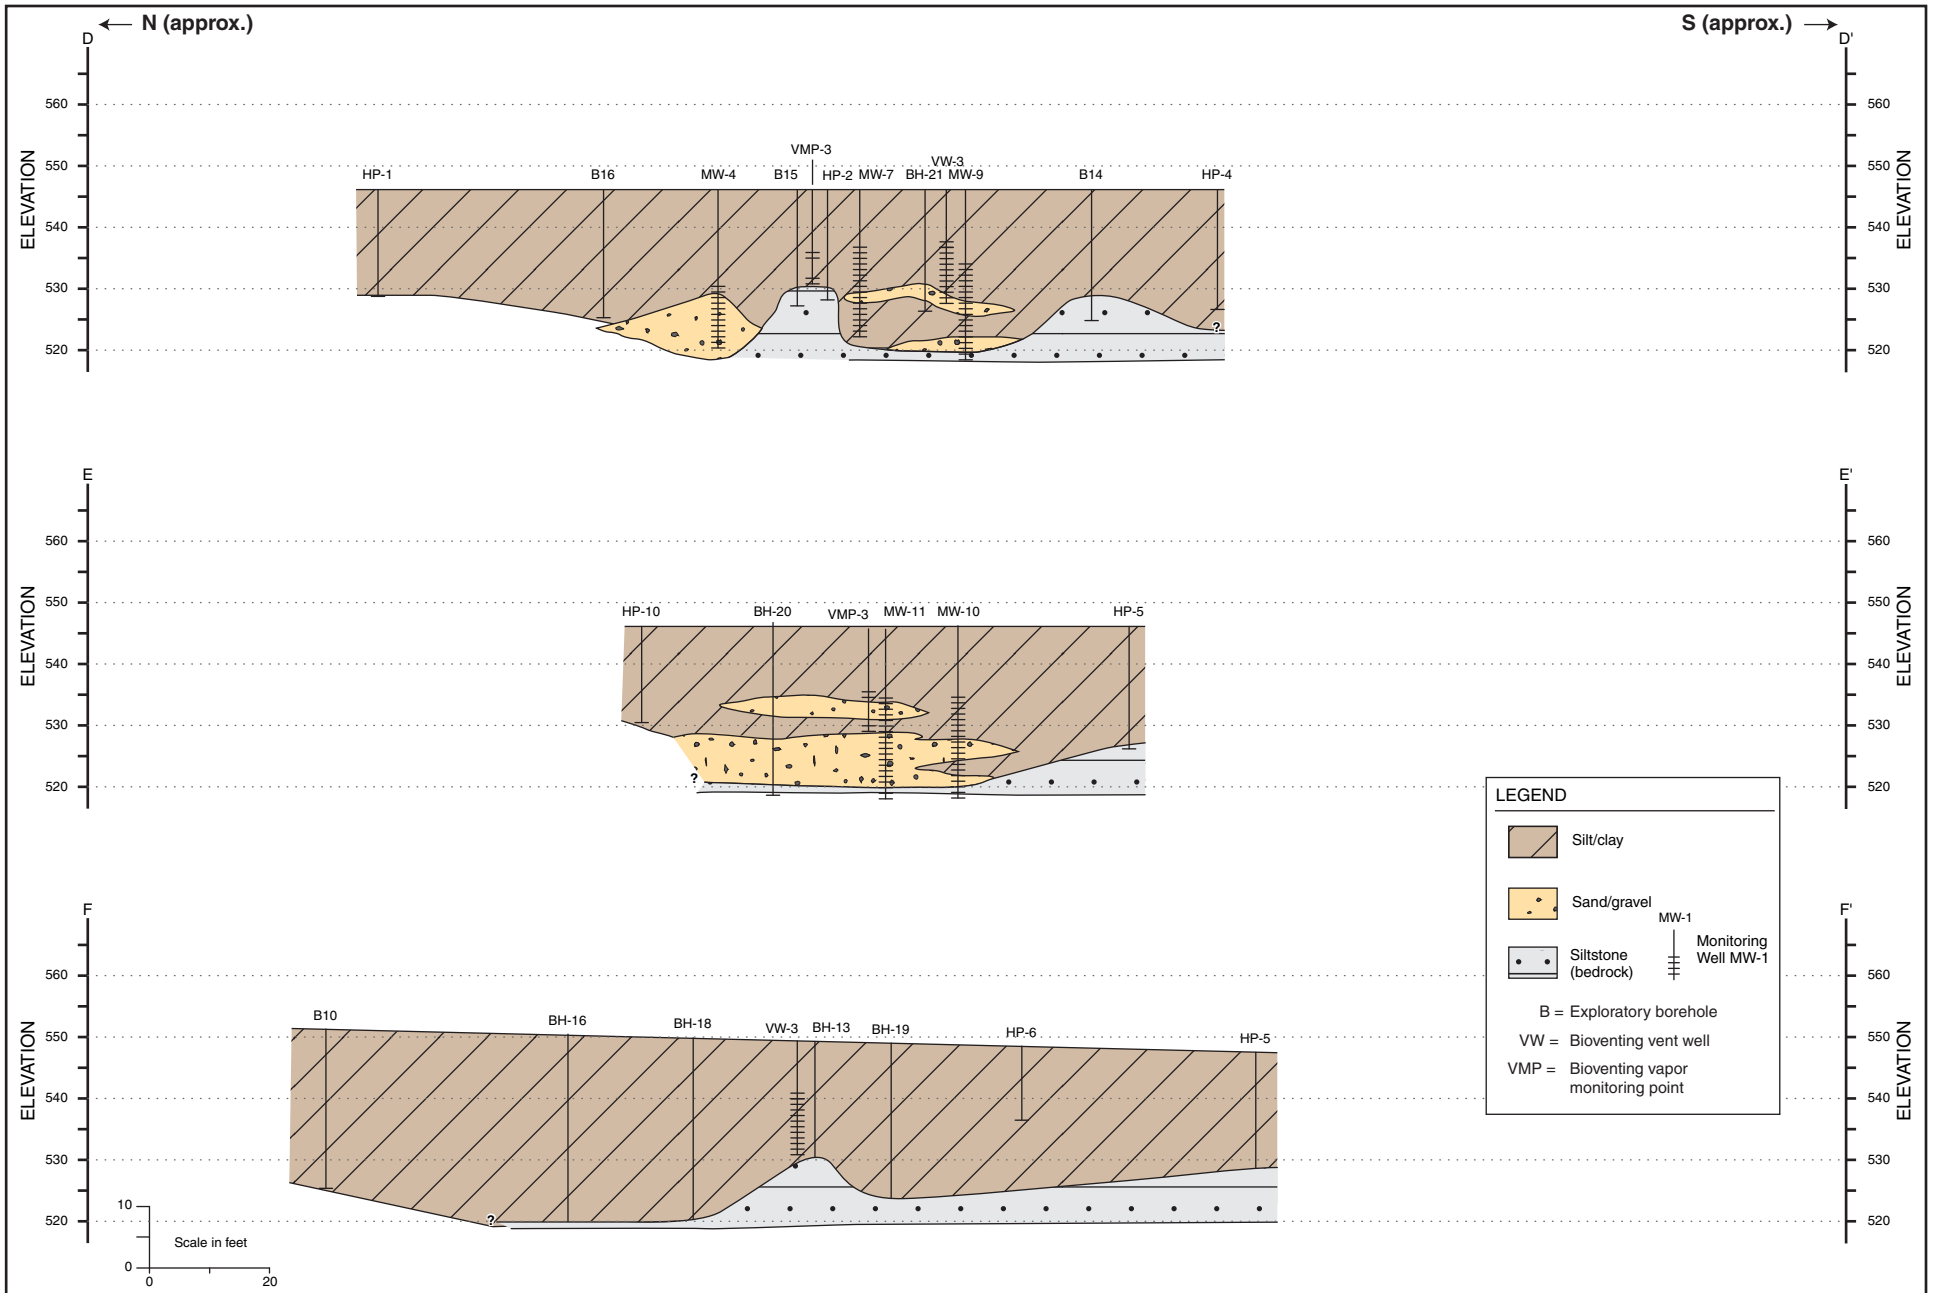
Figure 3 shows the location of geologic cross-sections. Figure 4 shows three sub-parallel geologic cross-sections (A-A' through C-C') along the long axis of the groundwater contaminant plume (i.e., along local groundwater flow direction). Figure 5 shows three sub-parallel geologic cross-sections (D-D' through F-F') roughly perpendicular to groundwater direction. In each figure, the three sub-parallel sections are presented together for ease of comparison. Due to the small scale, these sections show only lithologic conditions (i.e., soil type and bedrock depth). Additional information on water level depths, historical range of water levels, and inferred thickness of soil contamination were presented in a previous report (SES, 2004c) for cross-section B-B'.

GEOLOGIC CROSS SECTIONS — D-D' through F-F'
Redwood Regional Park Service Yard, Oakland, CA
