Subject: Remedial Action Workplan for Installation of a Permeable Reactive Barrier for Hydrocarbon Contamination Treatment, Redwood Regional Park Service Yard 7867 Redwood Road, Oakland, California
Alameda County Fuel Leak Case No. RO0000246.

PLAN VIEW OF PROPOSED REMEDIAL EHC-O BARRIER TREATMENT WALL & TPH PLUME
7867 Redwood Rd, Oakland, CA

CROSS SECTION A-A' SHOWING LOCATION OF TREATMENT WALL
Redwood Regional Park Service Yard, Oakland, CA

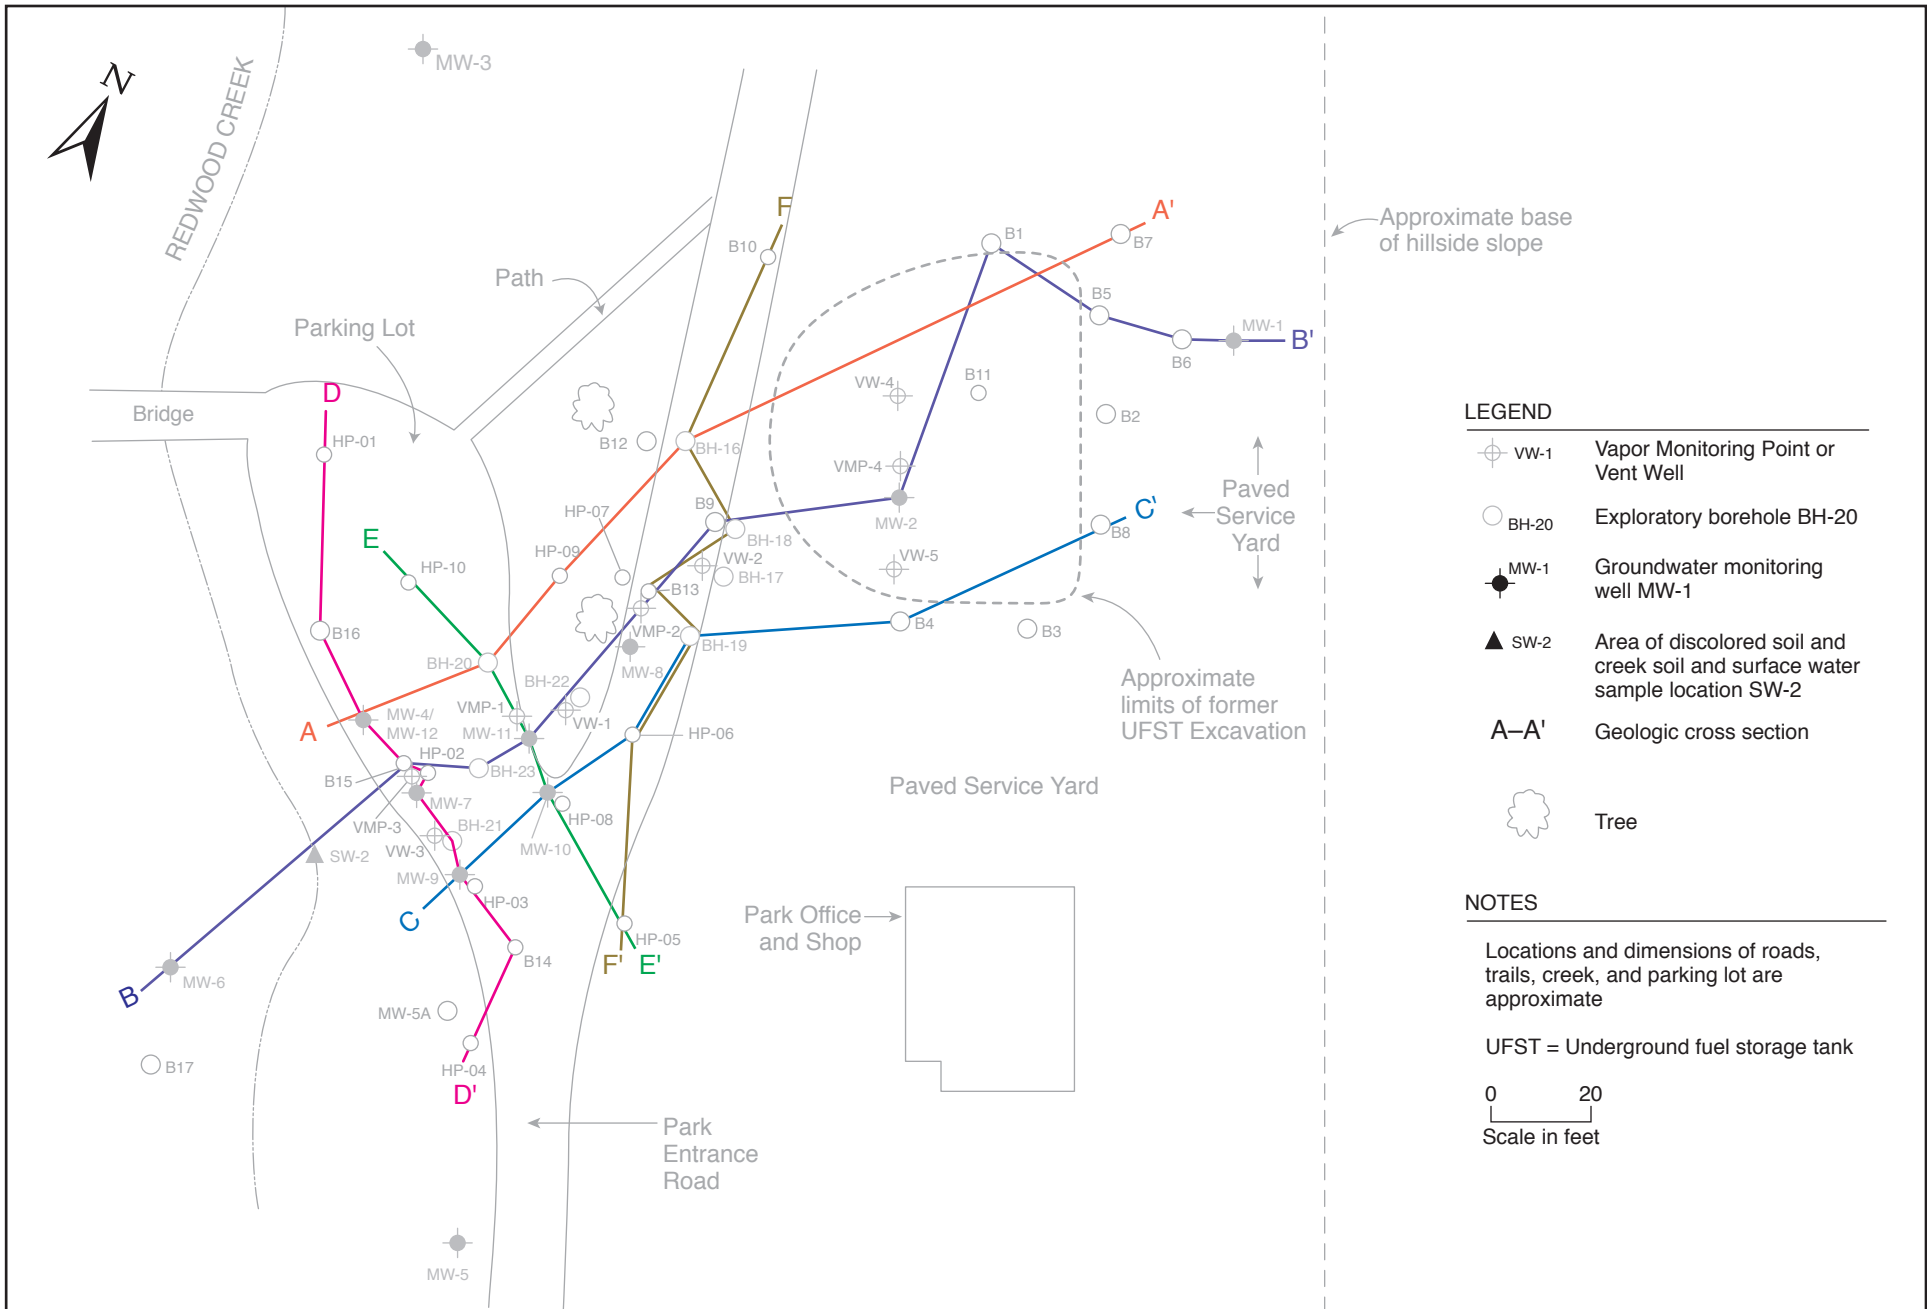
GEOLOGIC CROSS-SECTION LOCATIONS
Redwood Regional Park Service Yard, Oakland, CA

Attached Figure 2 is site plan showing the location of the PRB in relation to the site wells and Redwood Creek. Figure 3 is a site plan showing the location of cross-section A-A which is presented in Figure 4. Figure 4 illustrates the variable depth of the PRB in relation to the contaminated zone and Redwood Creek.
