CONTINUED SOIL AND WATER AND OFFSITE
INVESTIGATION AT GERMAN AUTOCRAFT
301 E. 14TH STREET, SAN LEANDRO, CALIFORNIA

CASE CLOSURE SUMMARY
Leaking Underground Fuel Storage Tank Program

Site facility name: San Leandro Chrysler Plymouth

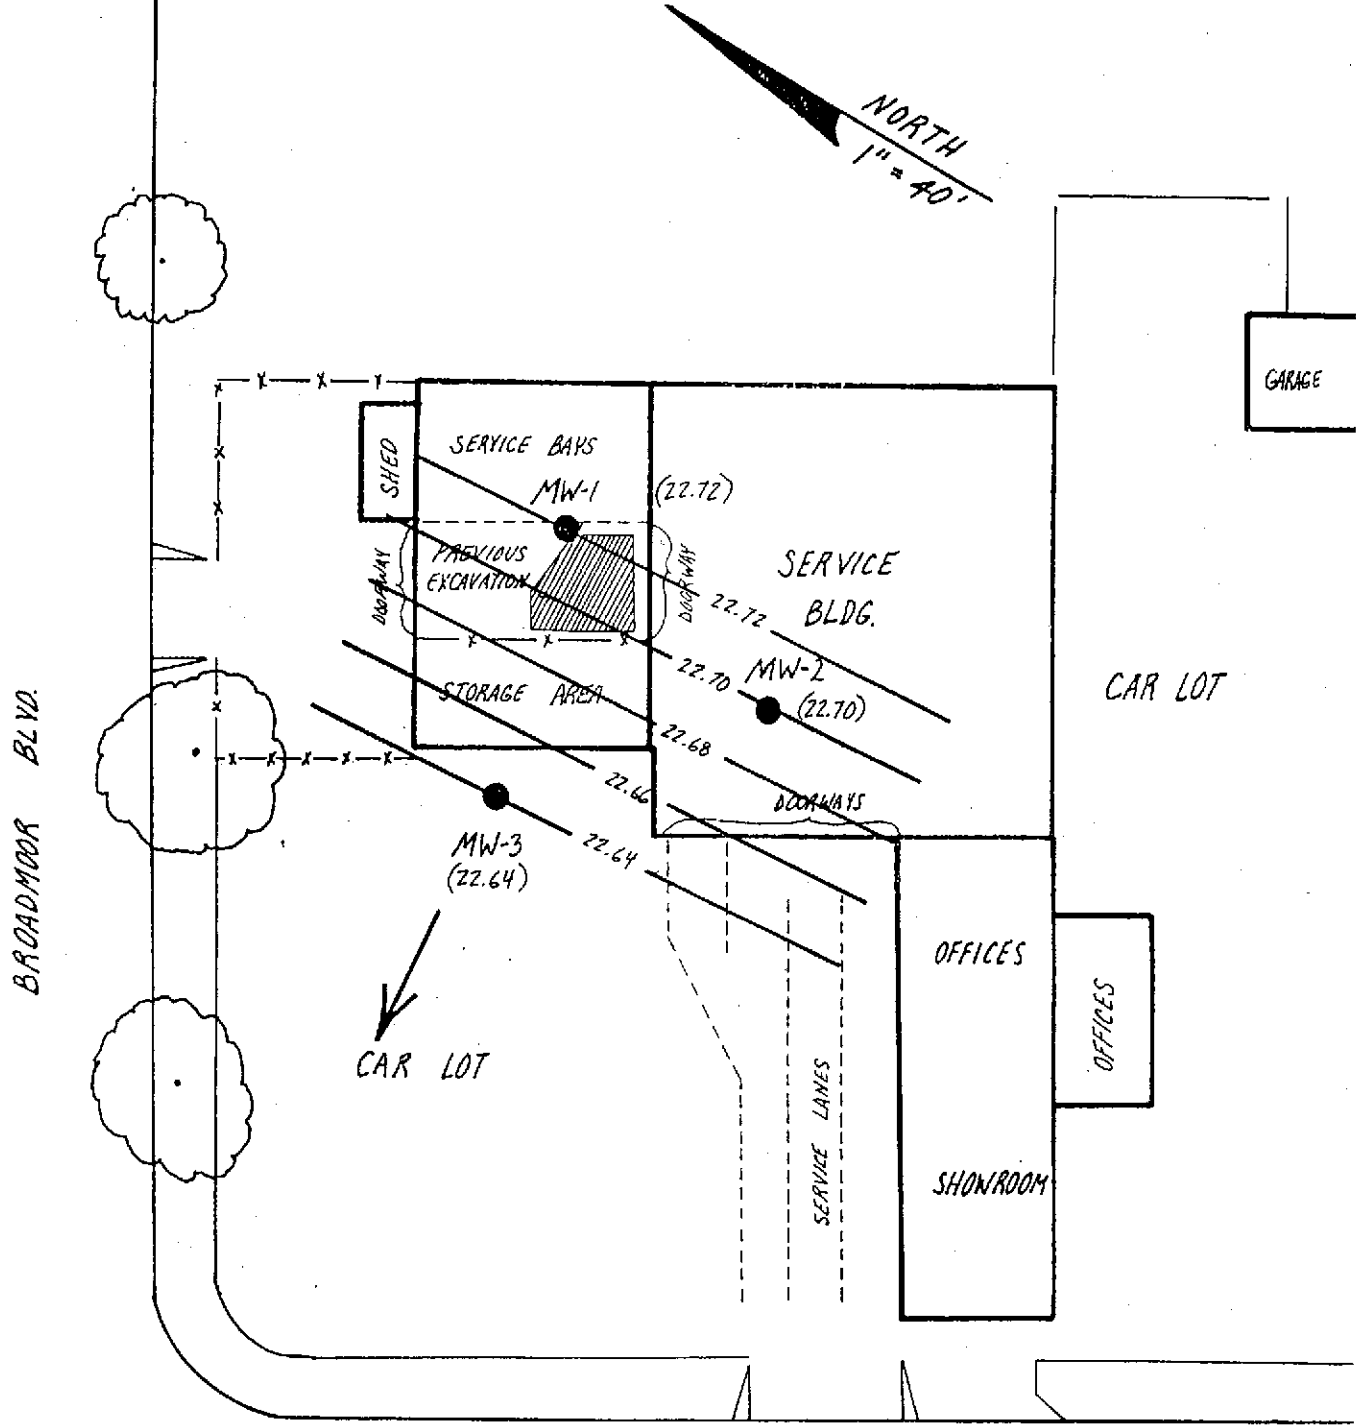
FIGURE 4. Shallow Groundwater Table Contour Map, measured on November 30, 1995.

232 E. 14TH ST. - Former Chrysler Dealership
EAST 14TH STREET

Cause and type of release: tank failure indicated following "Leak Locator" test. Results indicated failure of the 550 gallon gasoline tank (-0.3 gph). It should be noted that the exact location(s) of the USTs on site is limited. The information submitted to this office indicates that all three tanks are located in the general area of the service bays and the storage area inside the building as indicated in Figure "4".

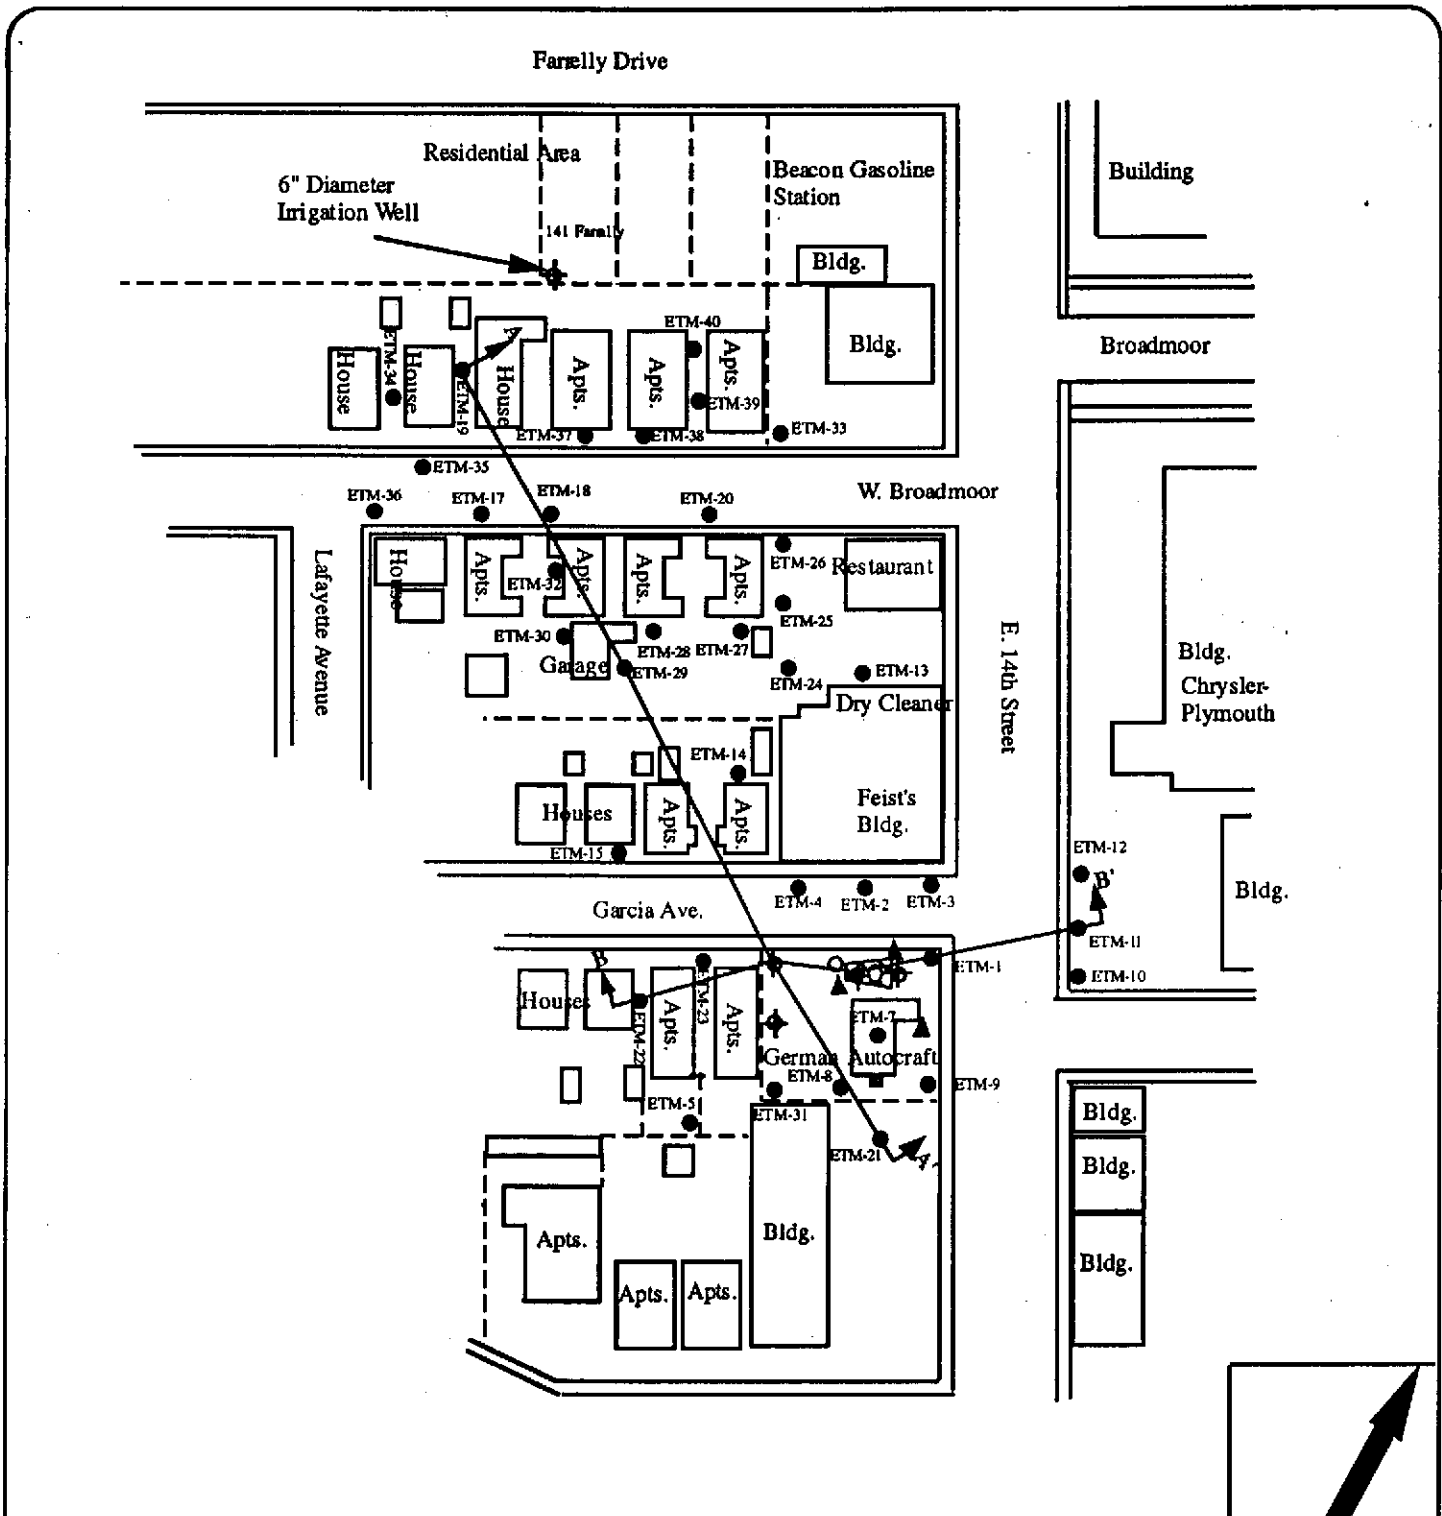
Figure 3
Project No.
94-52
Date: 7/96

- ▲ Previous Groundwater Sampling Location (1990)
- Groundwater Sampling Location (1994-95)
- Grab Groundwater Sampling Location 1995-96
- A A' Schematic Cross-Section (Figures 4 and 5)

GREATER VICINITY MAP
German Autocraft
301 East 14th Street
San Leandro, California

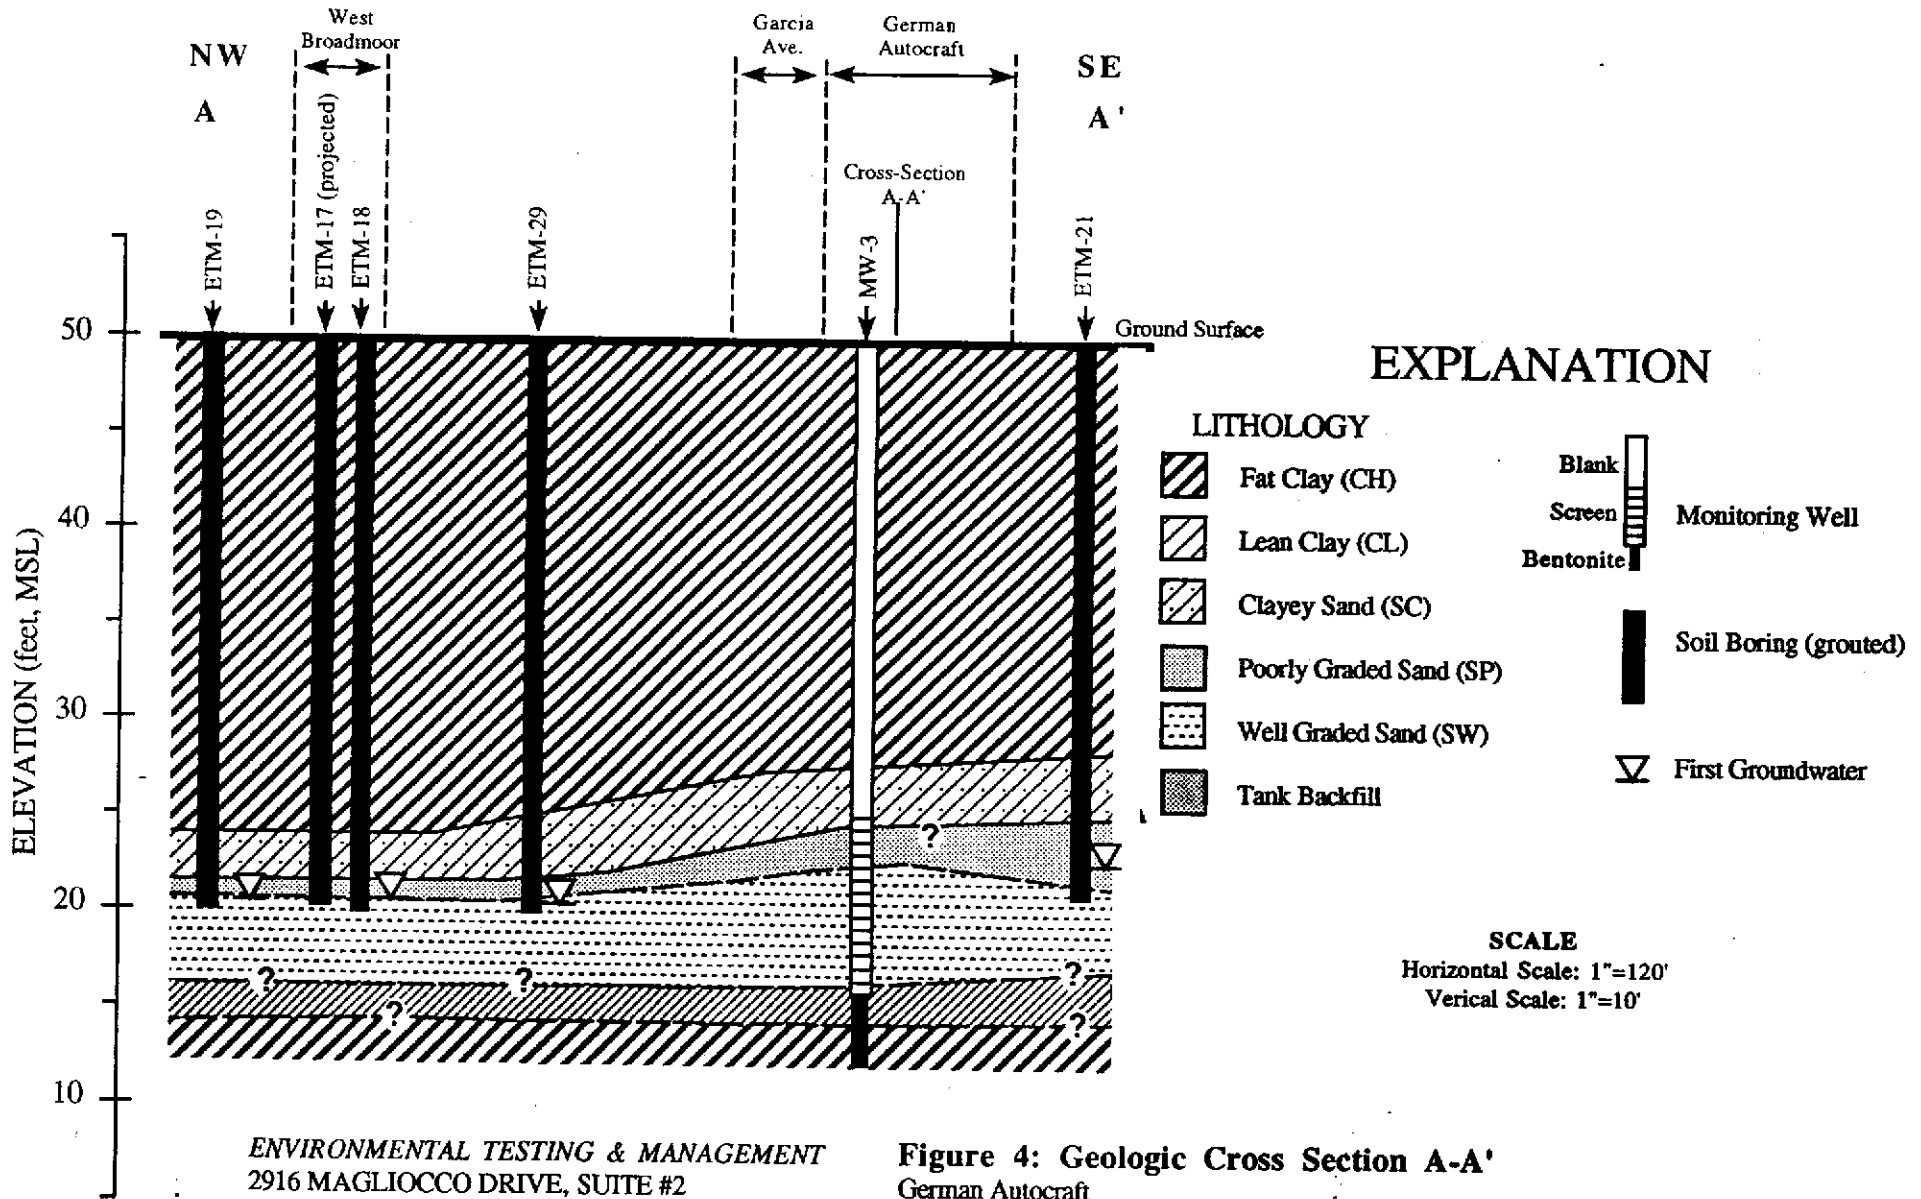
Figure 4: Geologic Cross Section A-A'
 German Autocraft
 301 E. 14th Street
 San Leandro, California

SCHEMATIC CROSS-SECTION A-A'

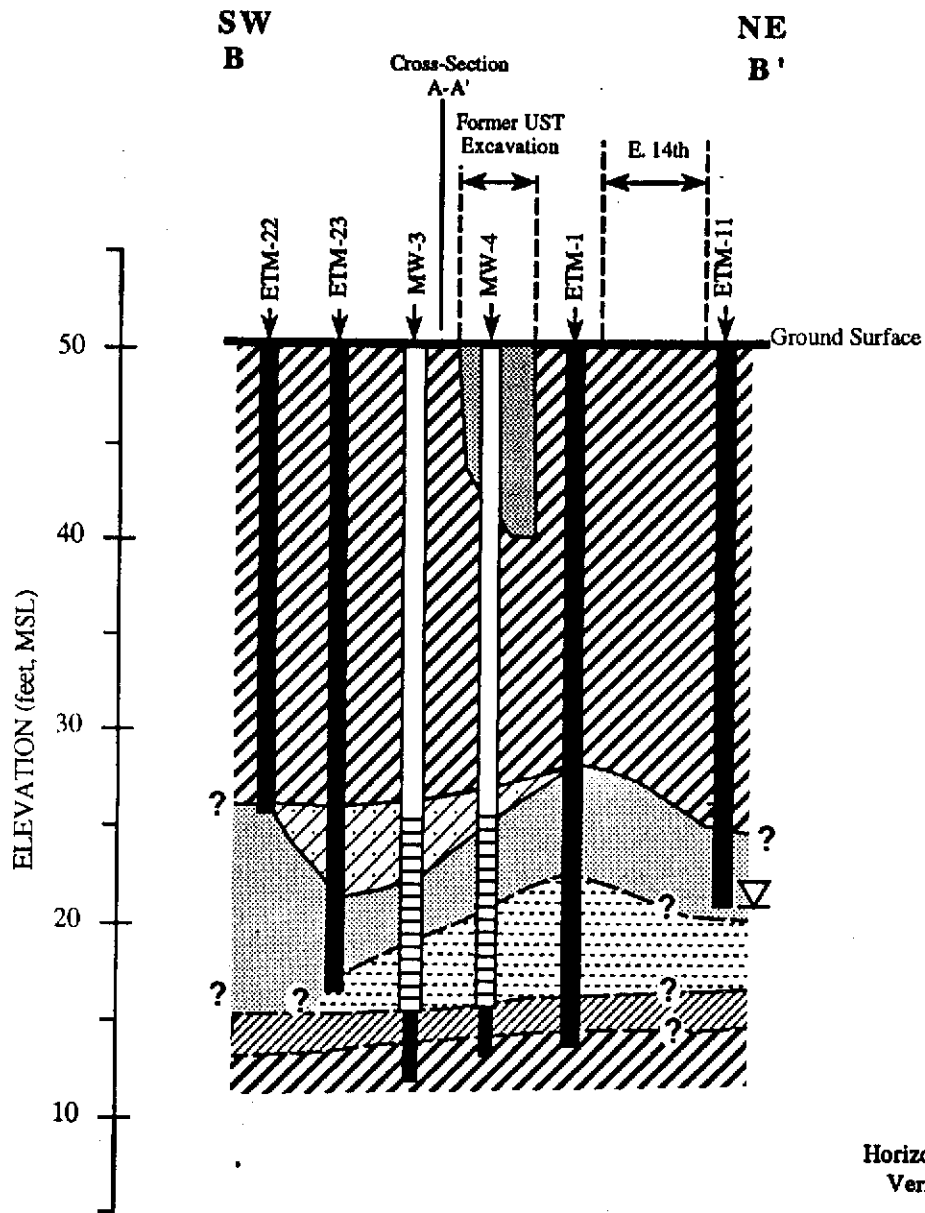
SCALE
Horizontal Scale: 1"=120'
Vertical Scale: 1"=10'
