**Re: Data Gap Investigation Report  
Former Penske Truck Leasing Facility  
725 Julie Ann Way, Oakland, California  
Alameda County Site ID RO0000354  
Stantec PN: 185702640.200.0003**

**Reference: Data Gap Investigation Report  
Former Penske Truck Leasing Facility 725 Julie Ann Way, Oakland, California  
Alameda County Site ID RO0000354**

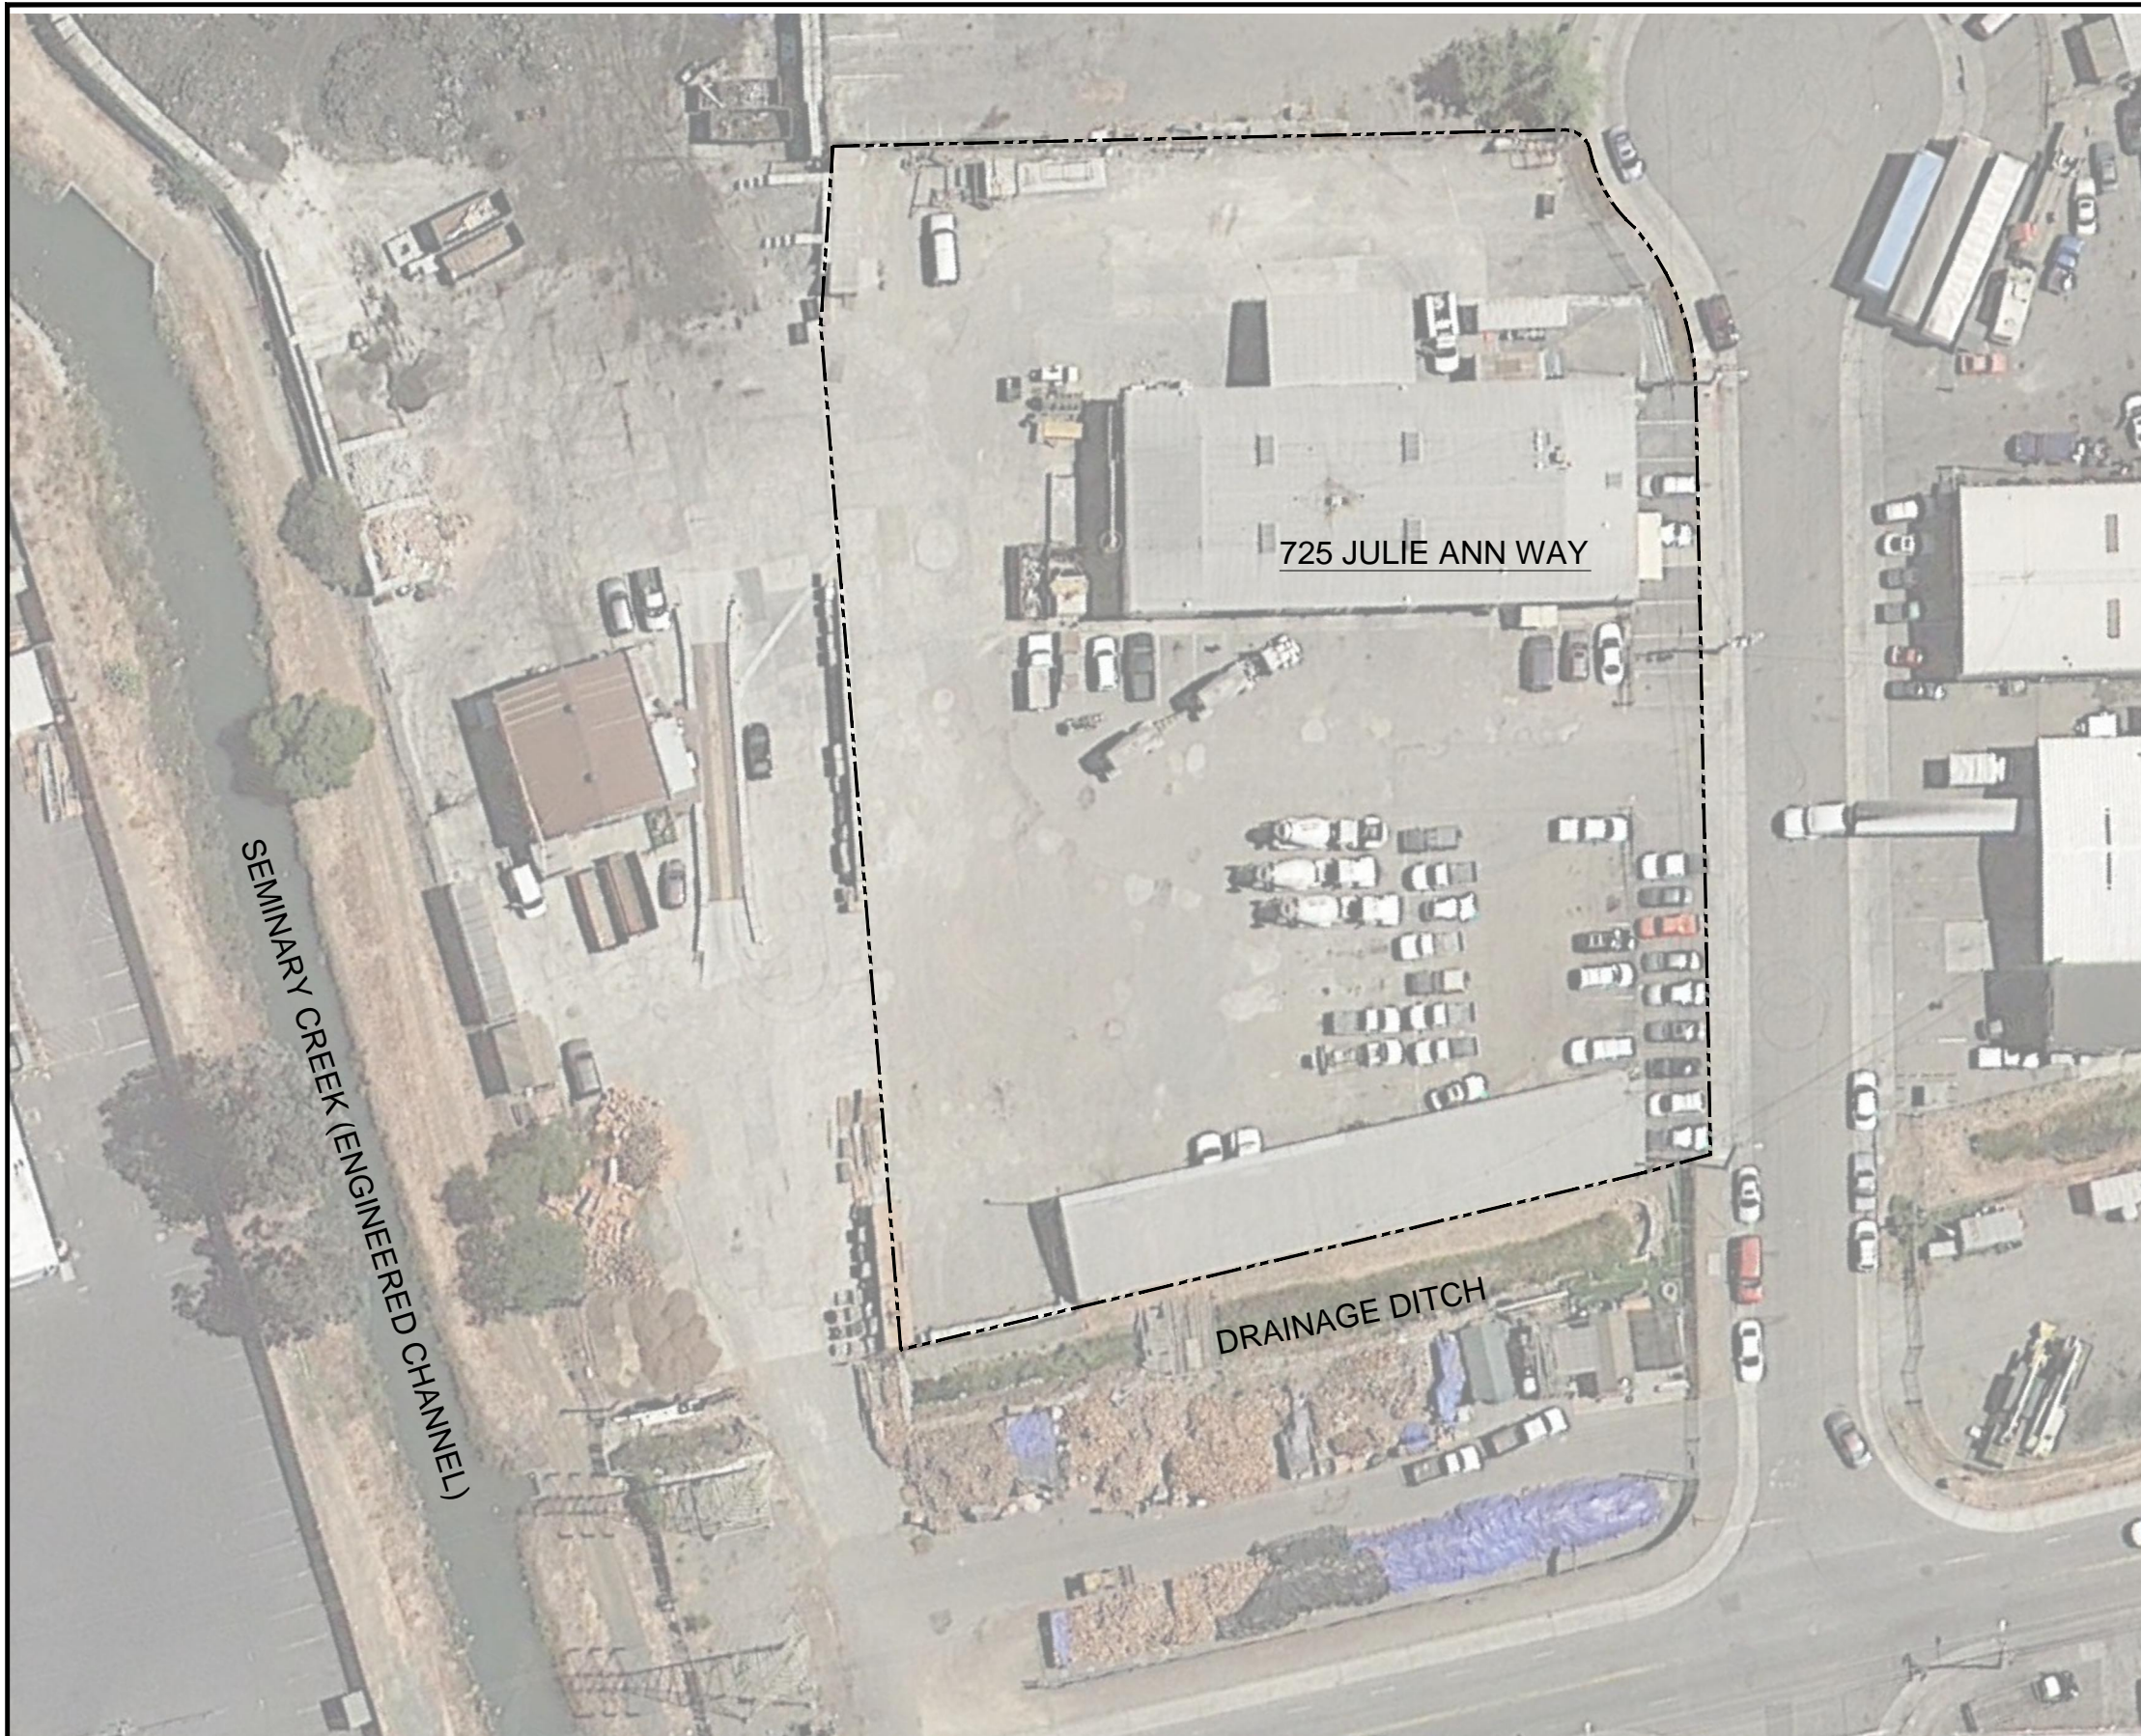
ALL GROUND SPOT ELEVATIONS AND SURFACE CONTOURS BY MID COAST ENGINEERS - FIGURE 1 TITLED "TOPOGRAPHIC MAP FOR PENSKE" JOB#10018TP DATED DECEMBER 4, 2014

Stantec contracted with Mid-Coast Engineers, a California licensed land surveyor, to survey the elevations of the bottom of the adjacent drainage channel and the western portion of the former Penske property. The survey was performed on December 1, 2014, and survey data are illustrated on Figure 4. Site elevations within 25 feet of the western property boundary ranged from 11.53 feet (North American Vertical Datum of 1988 [NAVD 88]) along Julie Ann Way to 10.34 feet at the northeastern corner of the property. Surveyed elevations of the bottom of the drainage channel ranged from 4.02 feet adjacent to a bridge across the channel formed by old telephone poles to 5.17 feet adjacent to the culvert headwall at the northwest boundary.

Stantec met with the site tenant to mark the boring locations as proposed in the Work Plan. Half of the structure along the property boundary adjacent to the drainage channel is an open carport-type structure and the other half is divided into office space and storage rooms (see Figure 4). The configuration of the office space and the storage room spaces required that borehole locations be revised from those proposed in the Work Plan. The final boring locations are shown on Figure 4.

Locations of the soil borings SB-9 through SB-14 are illustrated on Figure 4. Soil borings were advanced to depths ranging from 5 to 8 feet below ground surface (bgs) as summarized below:

TPHg and toluene were the only petroleum hydrocarbon constituents detected in the groundwater samples. Analytical results are summarized in Table 1, illustrated on Figure 4, and summarized below:
